# Los Angeles City Fire Department Preliminary Summary Report

### Injuries/Commercial Structure Fire

**May 16, 2020  
Boyd Incident  
CA-LFD-001073**

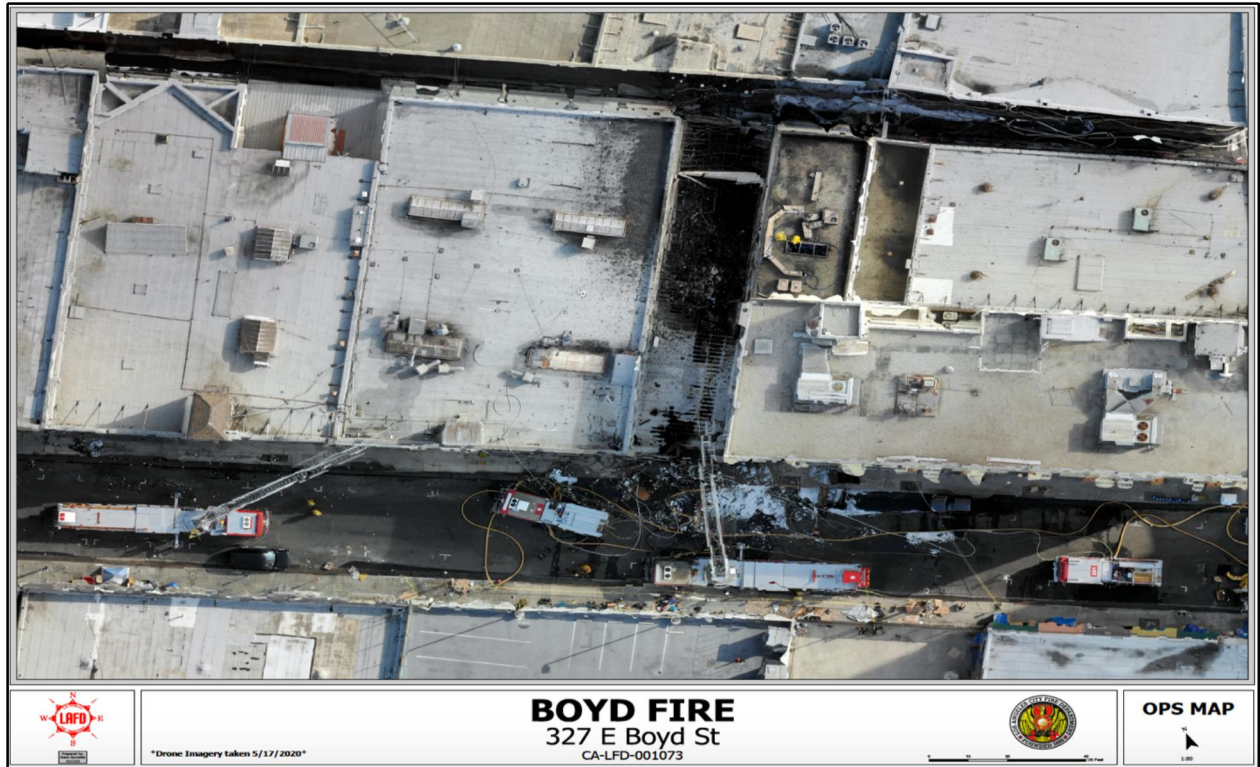
Aerial drone imagery of apparatus placement

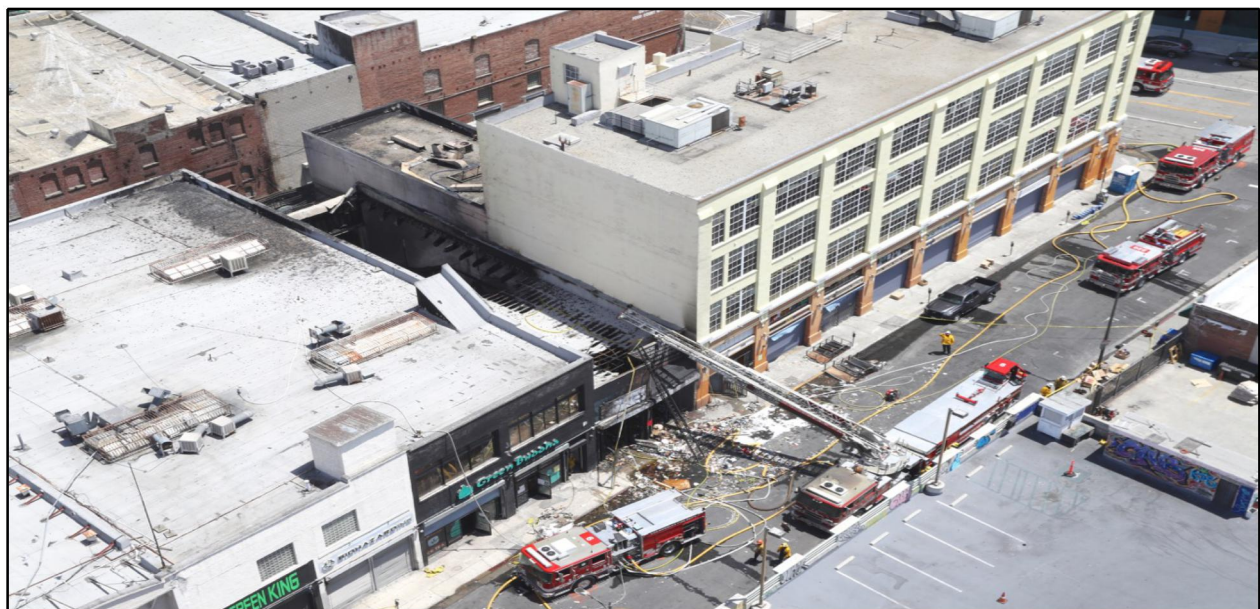
Aerial drone imagery from West (Bravo) perspective

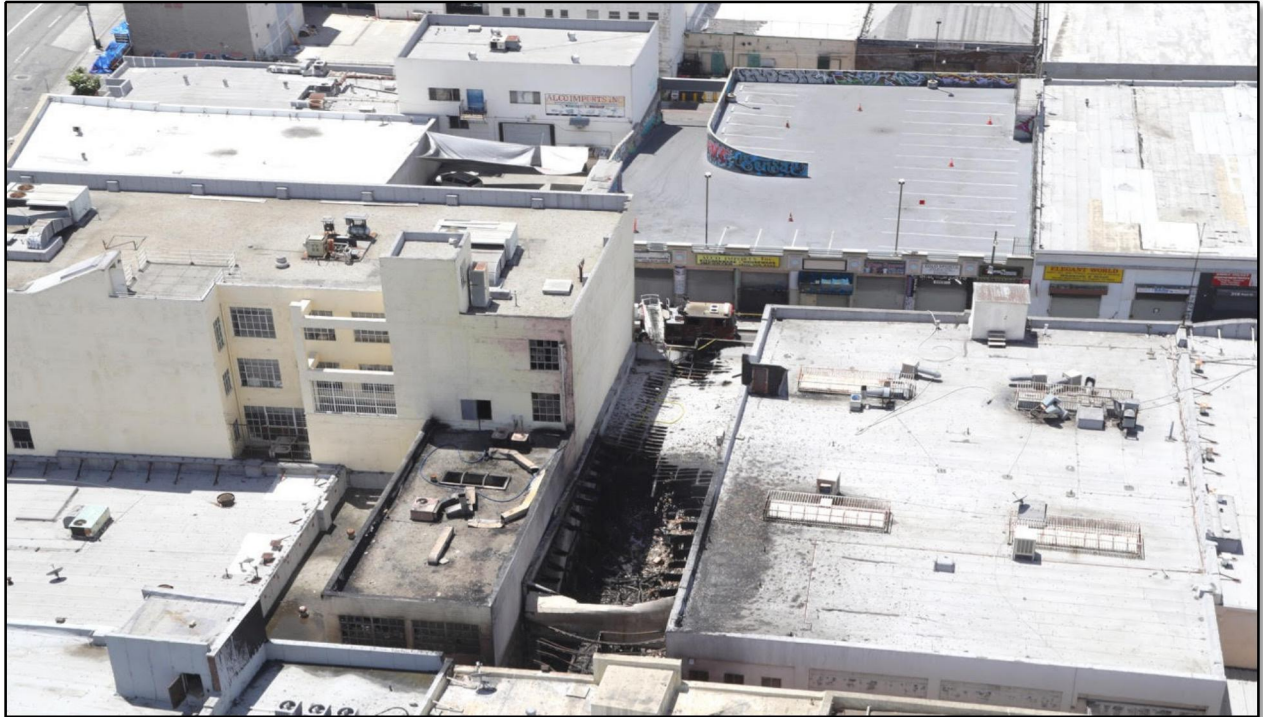
Aerial drone imagery from North (Charlie) perspective

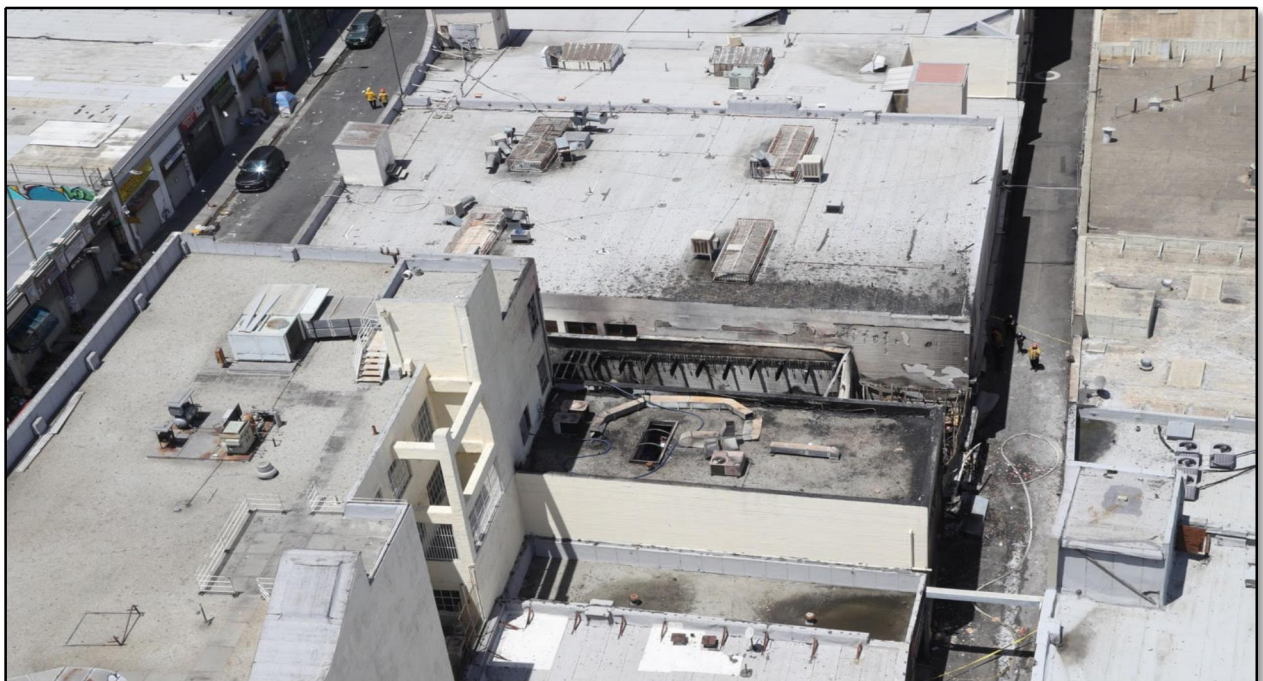
Aerial drone imagery from East (Delta) perspective
