October 17th of 1966 was a most tragic and mournful day in the history of the New York City Fire Department (FDNY). This would be a day that claimed the lives of 12 members of the department and touch the heart and soul of every member of the department.

There were Many Warning Signs

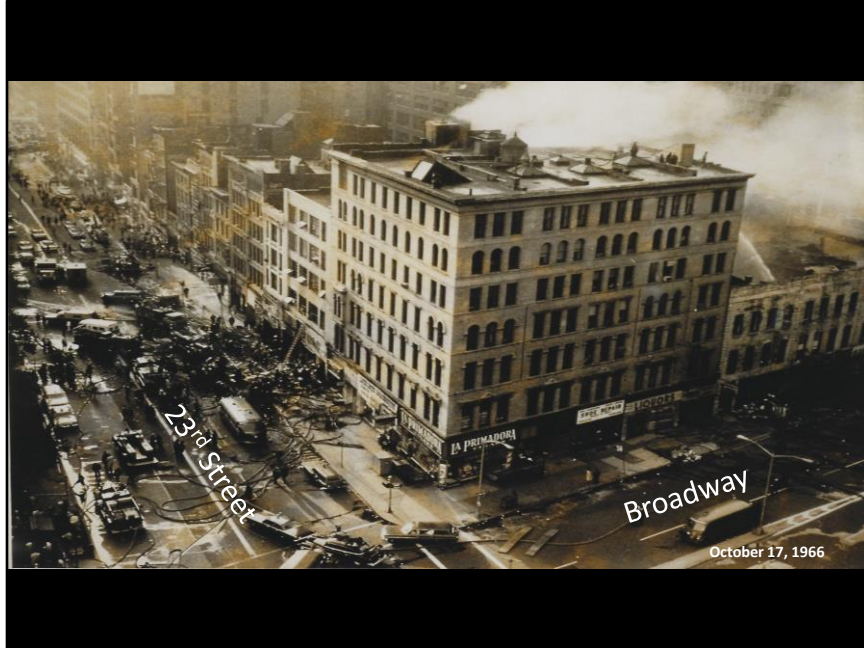
This is the intersection of 23rd Street and Broadway in NYC. You will note a portable ladder up to what is the building of the collapse at 6 East 23rd street. The fire had originated in the basement of a Brownstone type building on 22nd street and communicated into a section of the basement of 6 East 23rd Street. This would be below the occupancy of the Wonder Drug store.

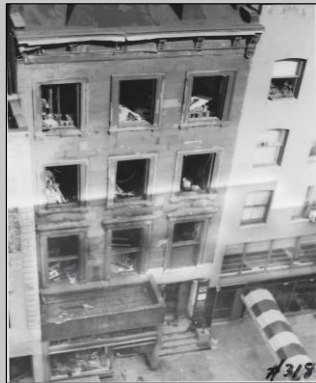
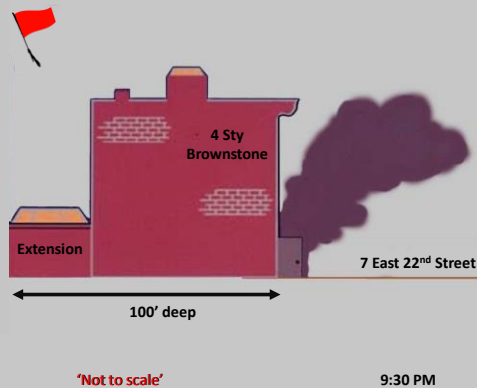
Fire on 22nd Street on Arrival

At 9:36 PM three Engines, two Ladder companies, one Battalion and one Deputy chief would be dispatched for a call to fire at the address 7 East 22nd Street. This was a 4 story Brownstone (Class 3, ordinary construction) type building with an art dealer studio occupying the basement, 1st, and 2nd floors. The 3rd floor was occupied by a Lamp company and the 4th floor was the residence of the Brown family. The fact that this family was home, and the wife alerted her husband of the smell of smoke this fire may have gone undetected for quite some time. The husband did not detect smoke in their apartment and proceeded down to the 3rd floor. Not sensing smoke, he exited onto the roof of a rear extension built onto the original Brownstone. Here he notice smoke issuing from a Skylight on the roof of this extension. Now he would return to alert the wife to call 911 and prepare the children with clothing to evacuate the building. The units dispatched to this initial call were Engines 14, 3, 16, and Ladders 3, 12, Battalion 6 including Division 3.

Upon arrival units would encounter extreme heat and thick smoke advancing a hand line (2 ½in/64mm) to the rear of the basement. An aerial ladder would be raised to the roof where members would accomplish vertical ventilation. The member(s) dispatched to the Roof assignment are expected to provide a visual survey of whatever exposures are presented to give a report. The fact that a rear extension two stories tall was constructed on the rear of this Brownstone is a significant detail to share with the Incident Commander and all Units Operating. This detail of information would be considered a **'Red Flag'** that everyone needs to consider in their 'size up', enhancement of situational awareness and evaluation of fire dynamics and spread.

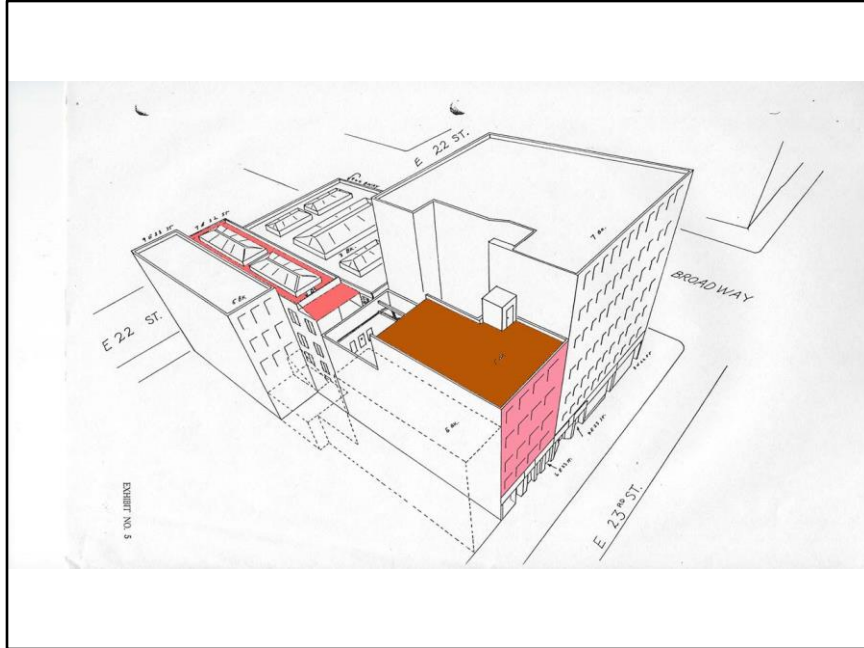
This viewpoint displays the original fire building on 22nd street with the 5-story commercial building 6 East 23rd Street in the foreground. As fire operations were progressing it was not known just how long the fire had been burning in the basement of the Art Dealer which the seat of the fire was in fact below the rear of the Wonder Drug store with numerous members present on the first floor and basement areas.

Those attack teams trying to advance onto the main body of fire from the 22nd street vantage point were not making progress to knock down a fire fueled with the heavy fuel base of wood used for framing, volatile paints, thinners, lacquers, and mineral spirits. The heat release rate and temperatures were extreme as was the smoke conditions.

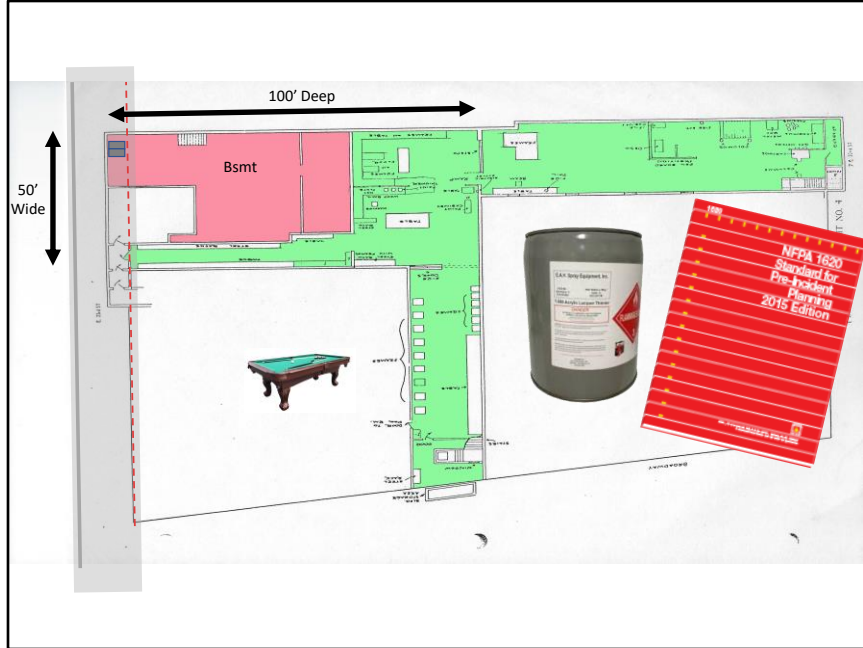
This illustration displays what was the entire basement workspace for the Art Dealer whose entrance was on 22nd with numerous alterations and extension into other buildings on 23rd street and a building fronting Broadway. The entire space is highlighted in Green. The basement altered (shortened) of the Drug store is highlighted in Red. This large (green) area with the fuel base mentioned can account for the volume of fire and conditions being encountered. These alterations and hazards had not been identified through fire department visits that would provide an alert upon a call to respond to this address. Years later Standards would be established by the NFPA (Standard 1620) to require visits to gather Building Intelligence for the preparation of Pre-Incident Planning.

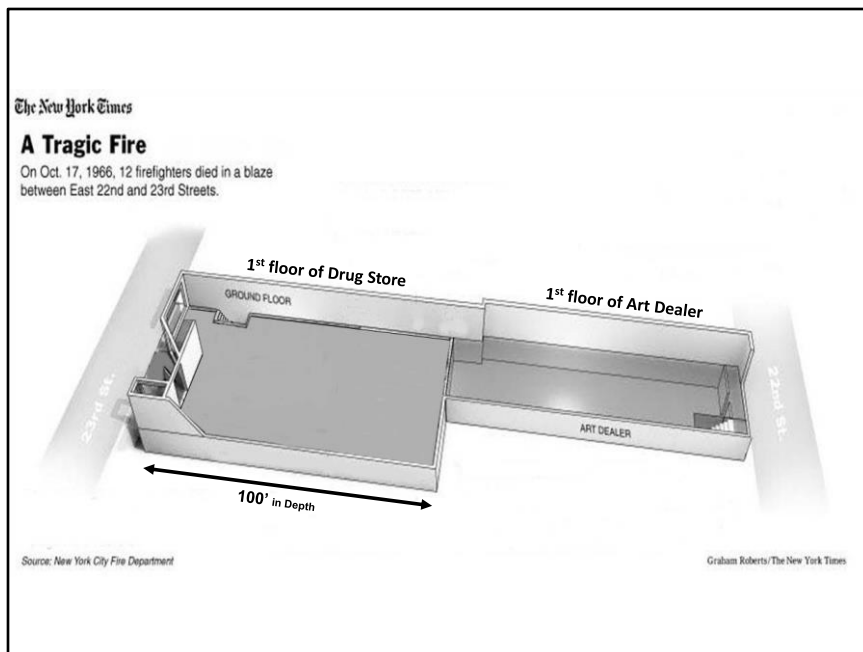
This is an artist depiction from the New York Times newspaper. It represents the first-floor layout of both buildings that would not give evidence of these buildings being interconnected.

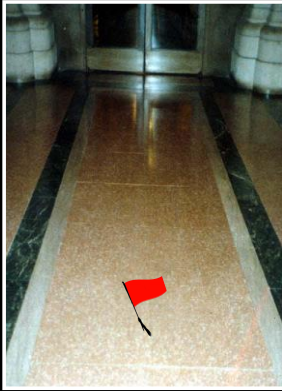
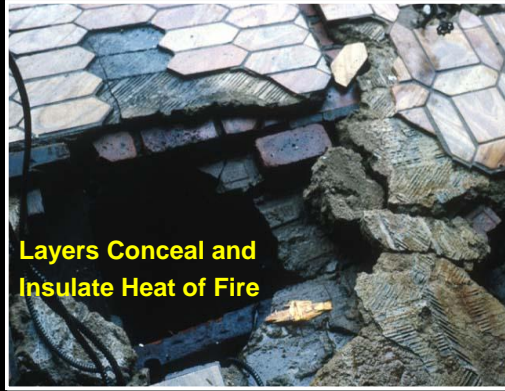
Terrazzo Floors

Those units entering the address 6 East 23rd Street should have noted the floor of the Wonder Drug store to be a poured in place Terrazzo flooring. This fact would also raise another **'Red Flag'** of pertinent information that creates a dangerous circumstance and question of structural stability in fire situations. This information should be communicated to the IC and all units operating in the building. This tragic event would reveal to the fire service that such a floor does not present evidence of heat from active fire below and depending upon a lack of compromise and openings the migration of smoke would also be hindered. This floor was installed in layers of planking supported by timber joists, with cement, tiles, and additional layer of Terrazzo above that. This would have added tremendous weight per square foot that would have exacerbated the time to failure as the timber joists were being degraded by heavy fire.

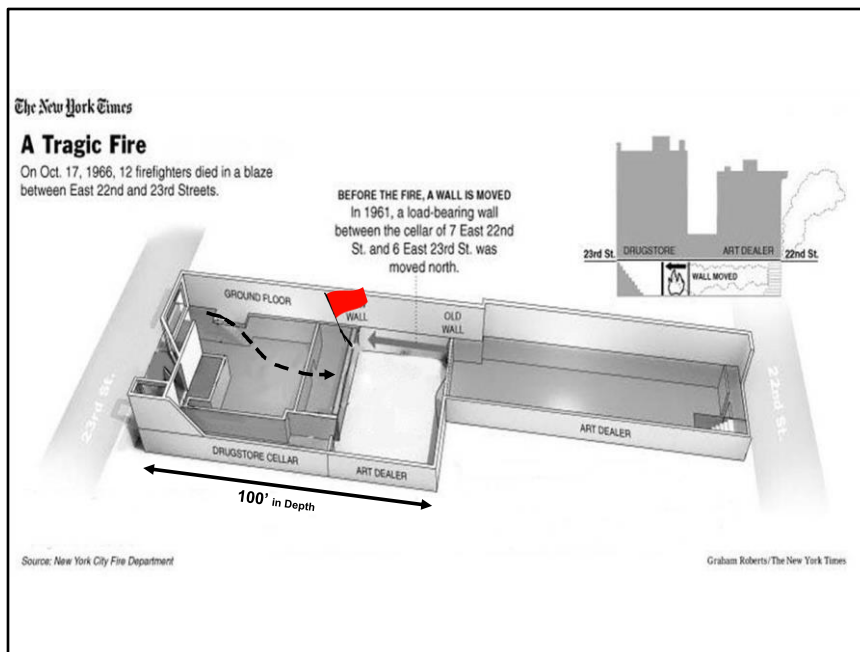
This illustration was also drawn by an artist of the New York Times shows the route that members of Ladder 3 and Engine 5 had taken to reach what was the rear wall of the basement of the Wonder Drug store. Because of the stored stock and limited width isles it obfuscated that fact that this space did not extend the full length (100ft/30m) of the building. Had these members been able to determine that fact would have been another **'Red Flag'** of critical information to share with the IC and units operating in the building.

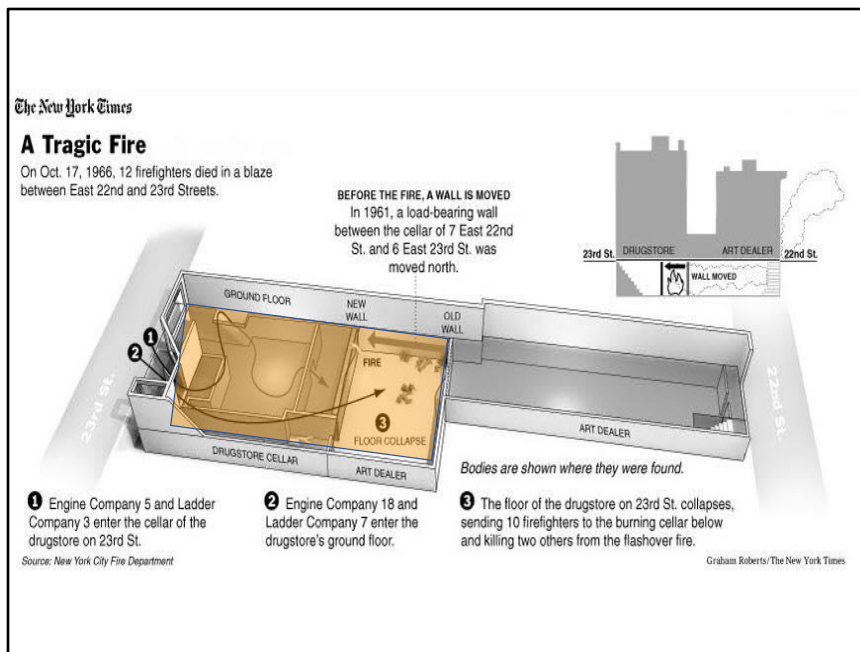
This illustration shows the position of Engine 18 with the members of Ladder 7 above the fire that had been raging below before the arrival of units on the initial alarm at 9:36 PM (21:36). The collapse occurred at approximately 10:39 PM (22:39), one hour and three minutes after the initial alarm. The supporting timber floor joists were of the dimensions measuring 3in by 14in spaced 16in on center. (76mm by 355 mm spaced 406 mm on center). Timber beams of this mass would withstand the direct exposure of fire for some time. Unlike the wood structural elements, the fire service encounters today with 2X4s used to construct truss work or what is referred to as 'Stick' construction.

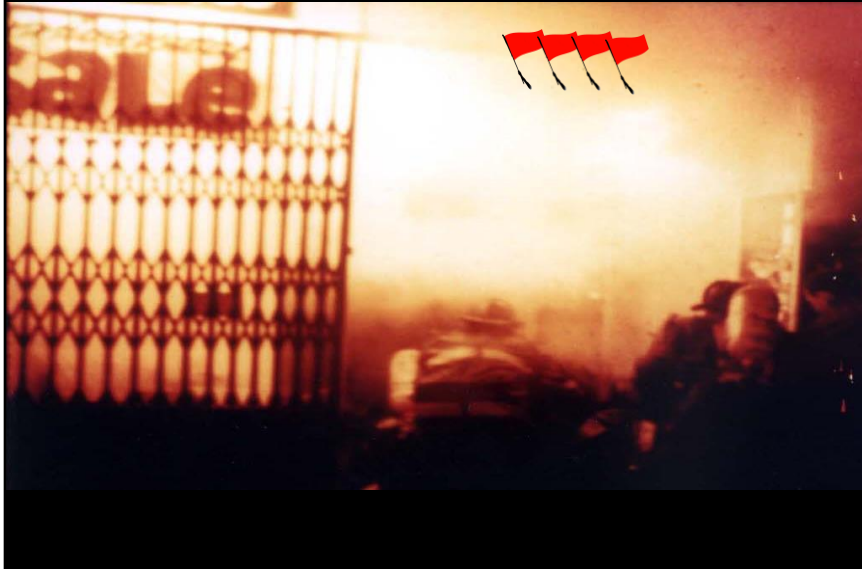
Just after the floor collapse and withdrawal of what members were still alive and able to escape the flames, other members made valiant attempts to re-enter the occupancy with hose lines. They would be thwarted by the volume of fire and heat venting from the entrance of the store. Thousands of firefighters, many off-duty would gather to assist in the search of rubble and burnt debris to remove our heroes with dignity. The fire commissioner at that time John T. O'Hagan would comment to the membership across the street in Madison Square Park "I know we all died a little in there".
