**Line of Duty Death**  
**Enhanced Report**  
**Oscar Armstrong III**  
**March 21, 2004**

**Independent Report by the  
Laidlaw Investigation Committee  
in cooperation with  
City of Cincinnati Fire Department  
And  
Cincinnati Fire Fighters - Local 48**

**ENHANCED REPORT  
OSCAR ARMSTRONG LINE OF DUTY DEATH  
1131 LAIDLAW AVENUE, CINCINNATI, OHIO  
MARCH 21, 2004**

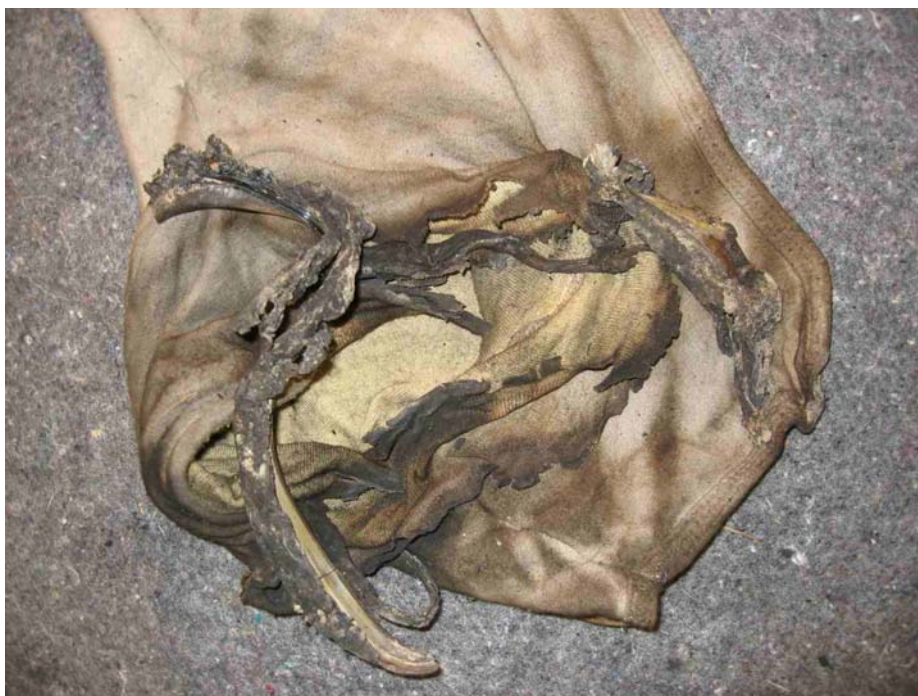
**HOOD**

b. Protective Hood: The protective hood worn received minimal damage in areas that were protected by overlapping personal protective equipment (coat and helmet). Those areas immediately exposed to the fire environment where the hood to mask seal is established and at the ears and chin were destroyed. The committee recommends the following actions with fire protective hoods in the future:

1. Replace all existing hoods with new style two-layer hood utilized in this incident.
2. All fire fighters should have 2 protective hoods.
3. New hoods should be color-coded differently to distinguish old style hoods from newly issued hoods.
4. Ensure all hoods are inspected every six months on the same rotation as the fire coat, pants, gloves, and helmet. As outlined in *NFPA 1500 Standard on Fire Department Occupational Safety and Health Program* and *NFPA 1971 Standard on Protective Ensemble for Structural Fire Fighting*.

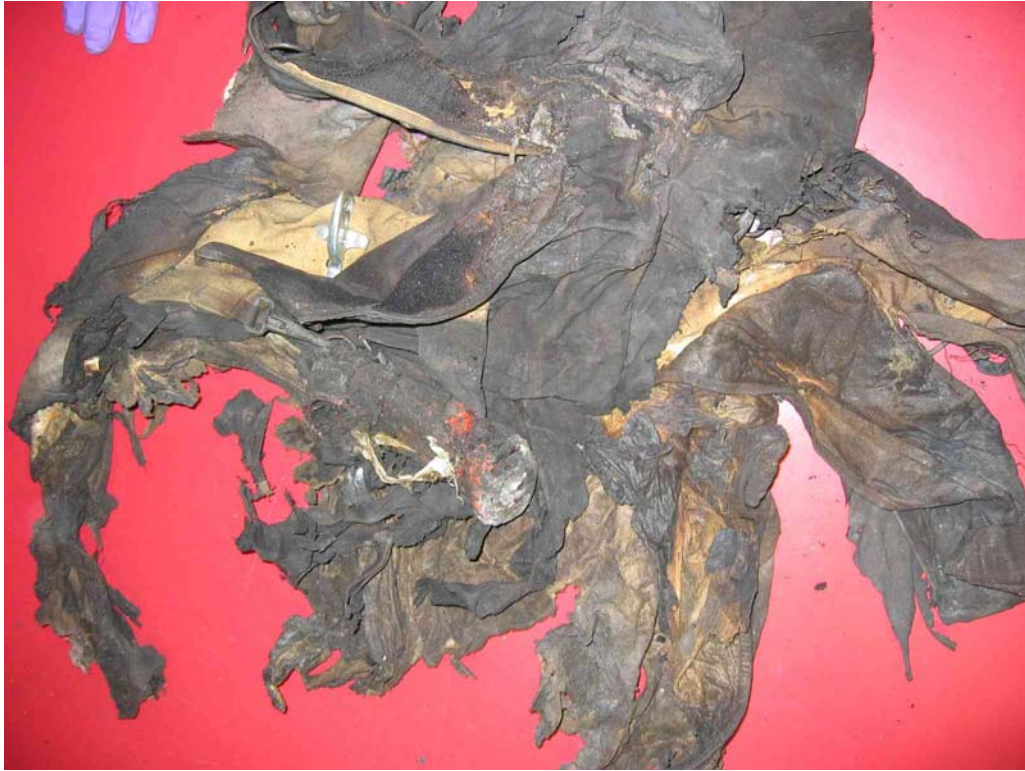
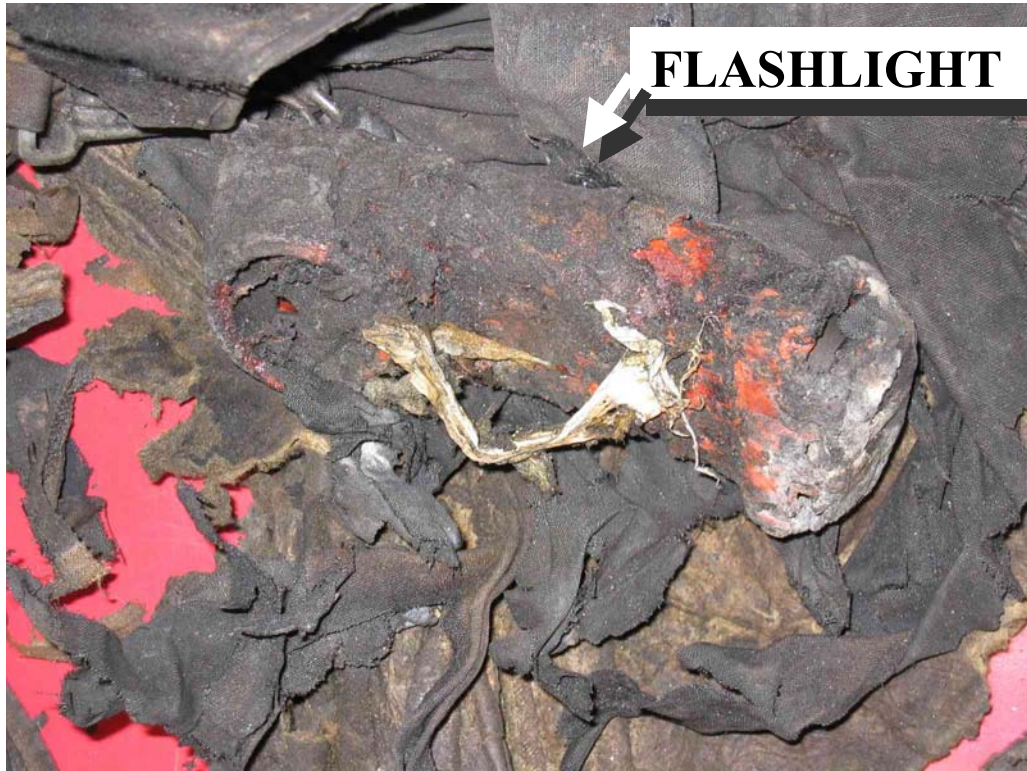
**COAT**

- c. Personal Protective Coat: The coat was almost completely destroyed with minimal remnants of the protective ensemble remaining. The committee recommends the following actions with the personal protective coat:

1. Ensure all current coats in the CFD meet or exceed the current *NFPA 1500 Standard on Fire Department Occupational Safety and Health Program and NFPA 1971 Standard on Protective Ensemble for Structural Fire Fighting*.

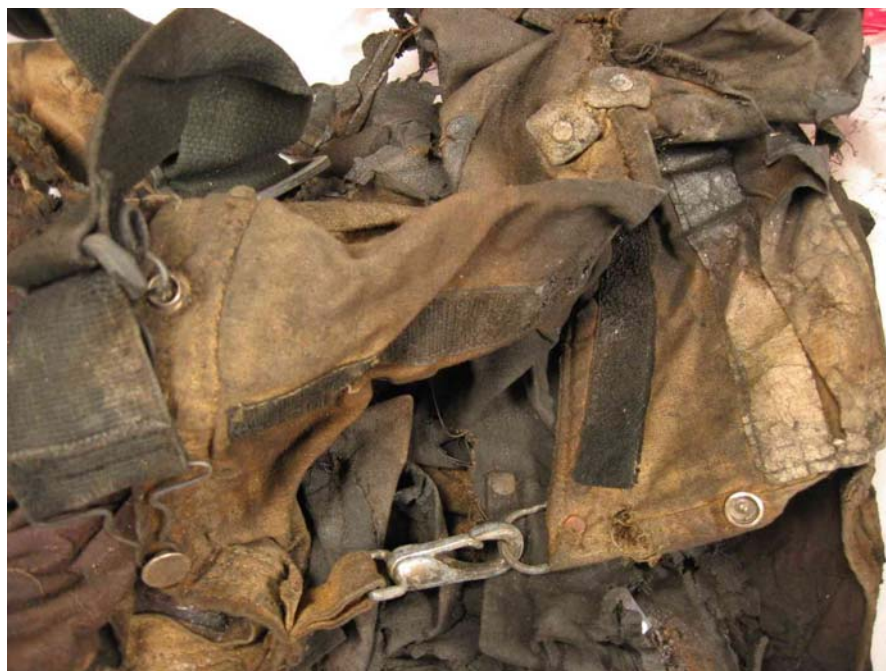
## PANTS

- d. Personal Protective Pants: The personal protective pants were completely destroyed with minimal remnants of the protective ensemble remaining. The committee recommends the following actions with the protective pants:

1. Ensure all current pants in the CFD meet or exceed the current *NFPA 1500 Standard on Fire Department Occupational Safety and Health Program and NFPA 1971 Standard on Protective Ensemble for Structural Fire Fighting*.

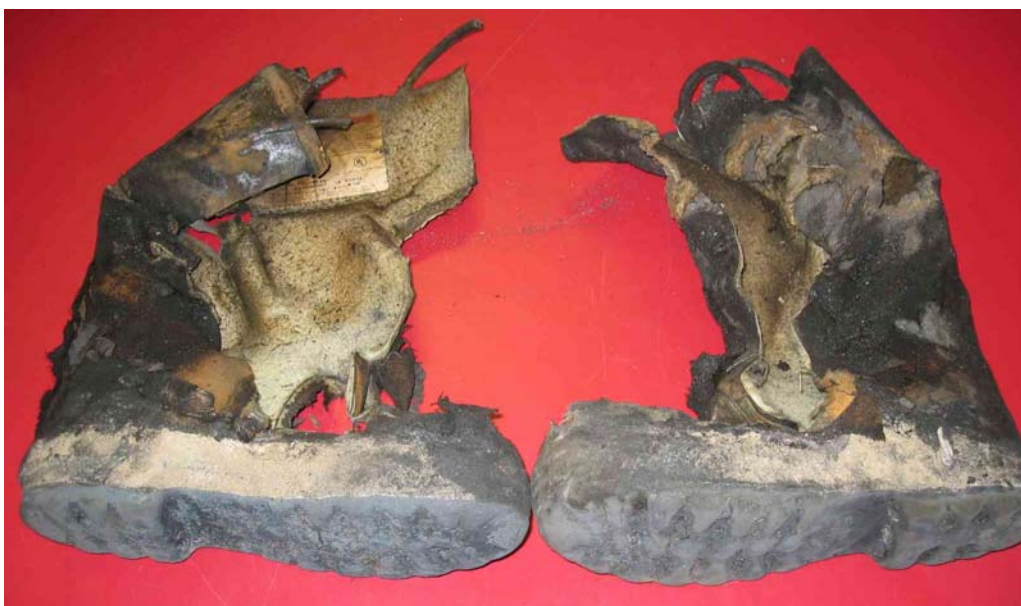
## BOOTS

- e. Boots: FF Armstrong's boots were of the rubber type and were completely destroyed by the fire environment. The committee recommends the following actions concerning the protective boots:

1. Ensure all current boots in the CFD meet or exceed the current *NFPA 1500 Standard on Fire Department Occupational Safety and Health Program and NFPA 1971 Standard on Protective Ensemble for Structural Fire Fighting*.

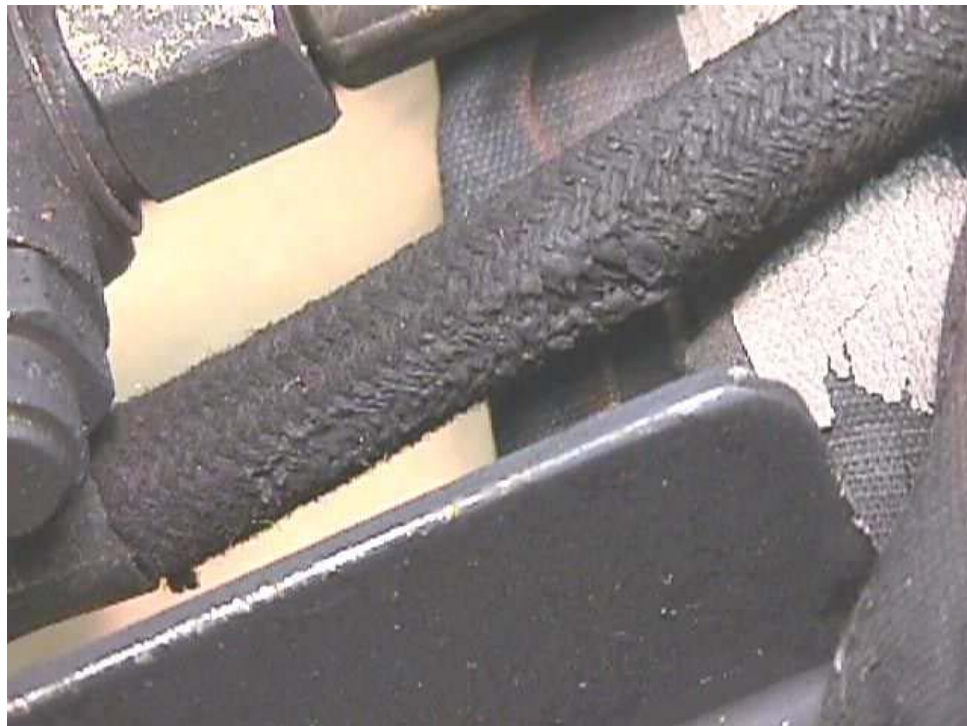
**Figure 12 – Charring of Gauge Hose Jacket**

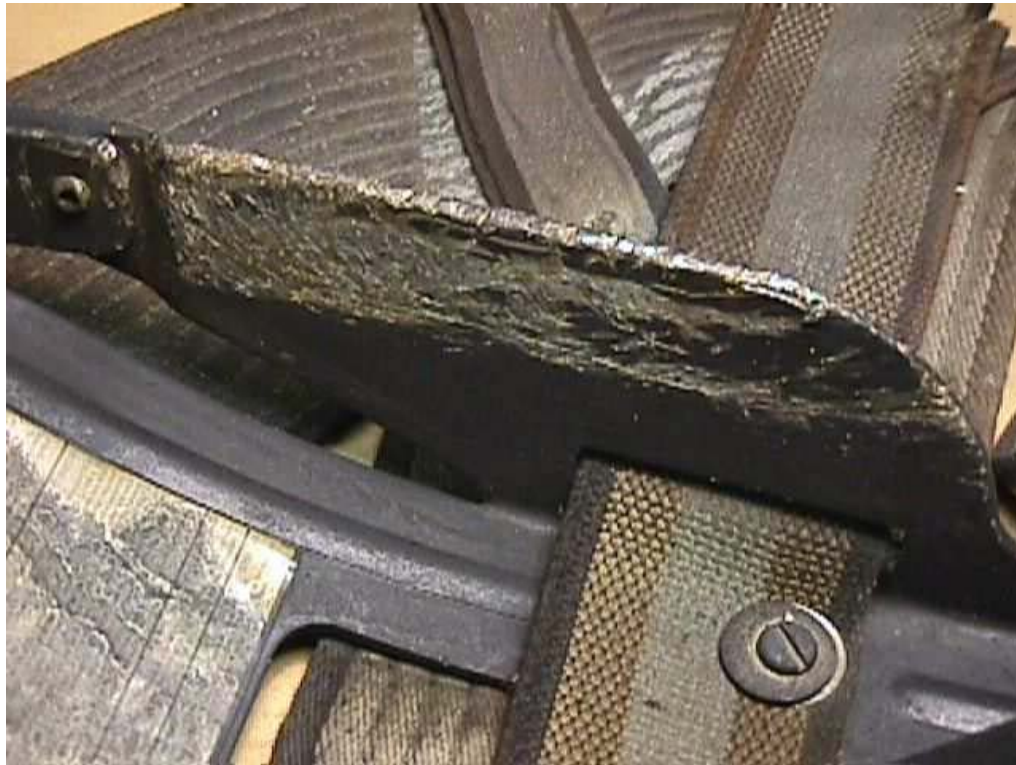
**Figure 15 – Damage to Carrier**

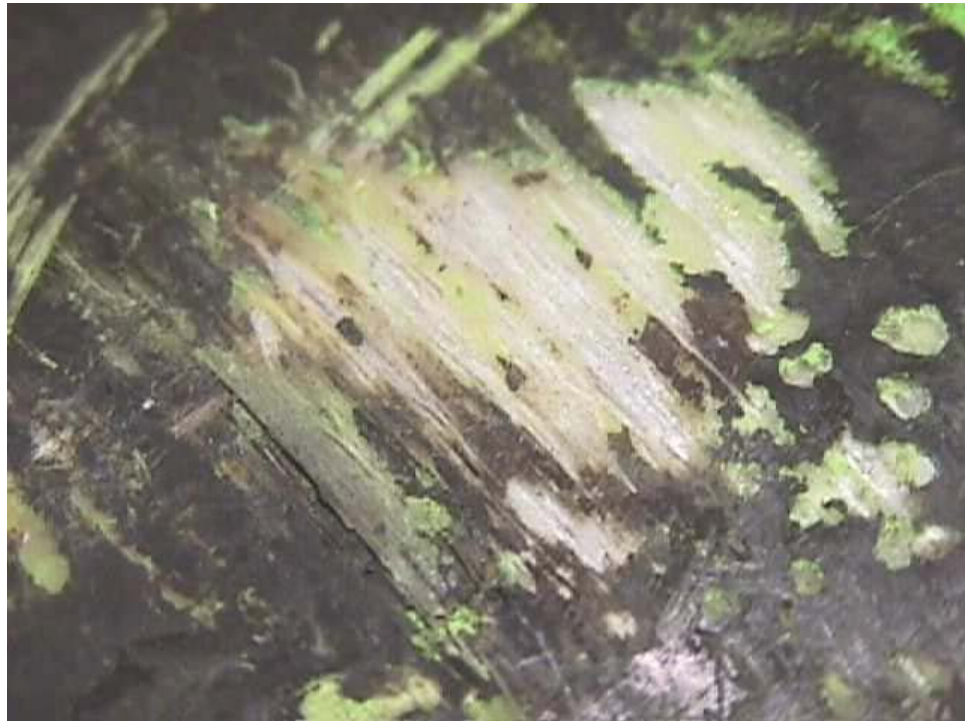
**Figure 25 – Damage to Cylinder Composite Layer**
