Captain Joshua Laird  
Line of Duty Death (LODD)

**AFTER ACTION REPORT AND  
IMPROVEMENT PLAN (AAR/IP)**

**August 2022**

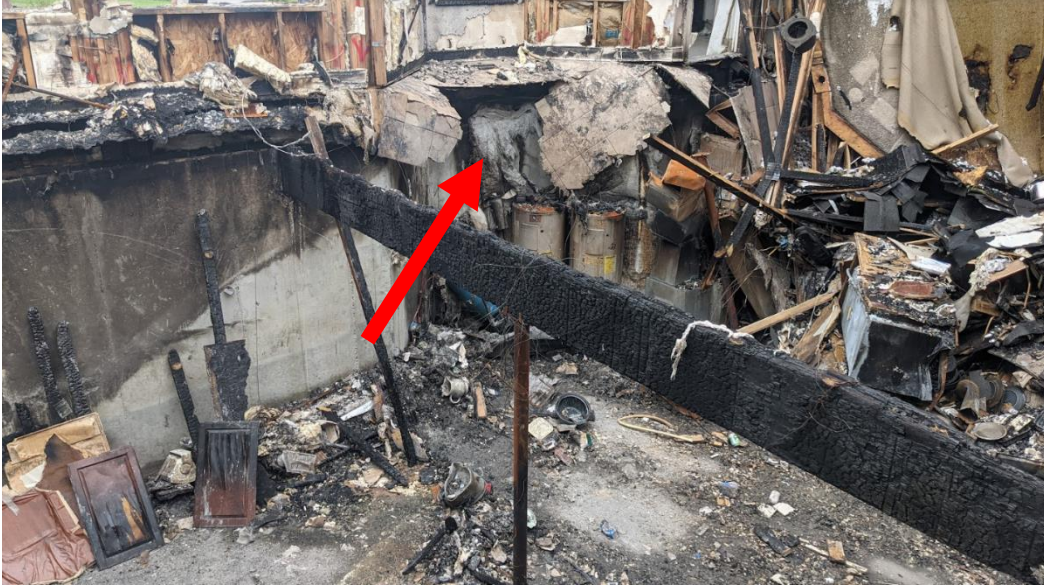
*Figure 16: View of basement from Side Bravo. The tile section with the arrow is the area where the collapse occurred sending Captain Laird into the basement.*

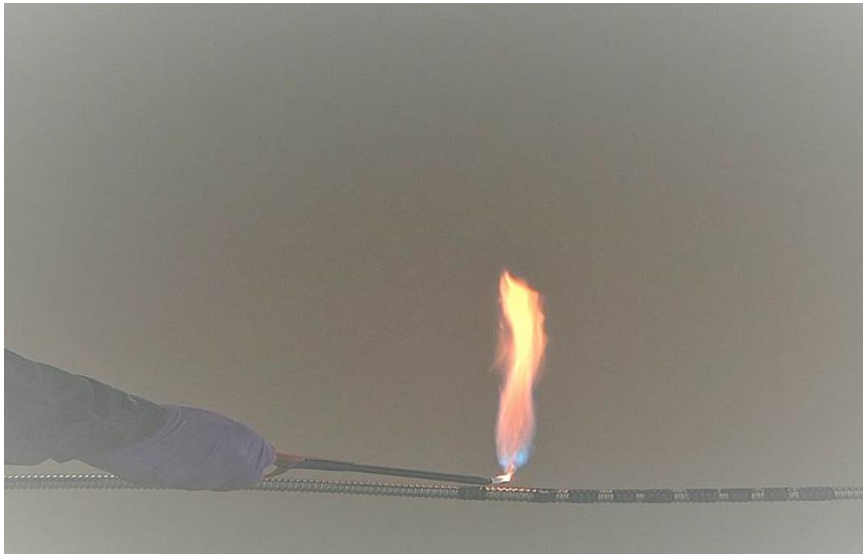
The classification of the fire was determined to be natural. Natural fire causes involve fires caused without direct human intervention or action, such as fires resulting from lightning, earthquake, wind, and flood. The collapse of the first-floor family room and corresponding fire damage was consistent with a fire originating in the basement and extending upwards. The fire was observed venting from the first-floor family room windows in the Bravo quadrant upon arrival.

Figure 17: Approximate flame that would have come from the CSST perforation.

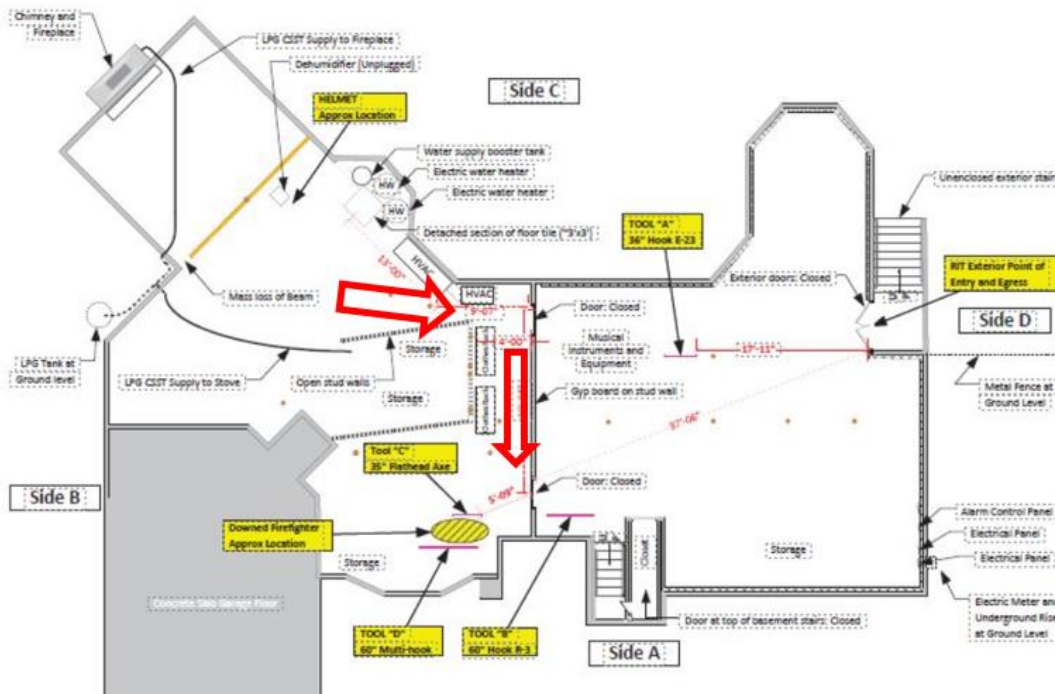
Figure 21: Believed to be the pathway that E251A took to escape the fire.

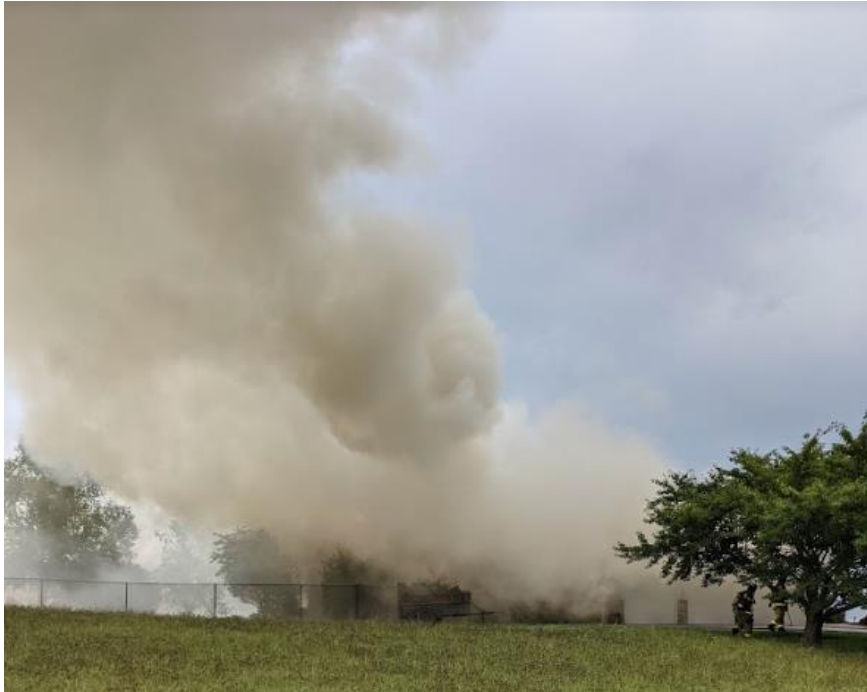
*Figure 33: View of smoke and fire conditions early into the incident. Due to the volume of fire and environmental conditions, smoke was banked down to the street level upon E251's arrival.*

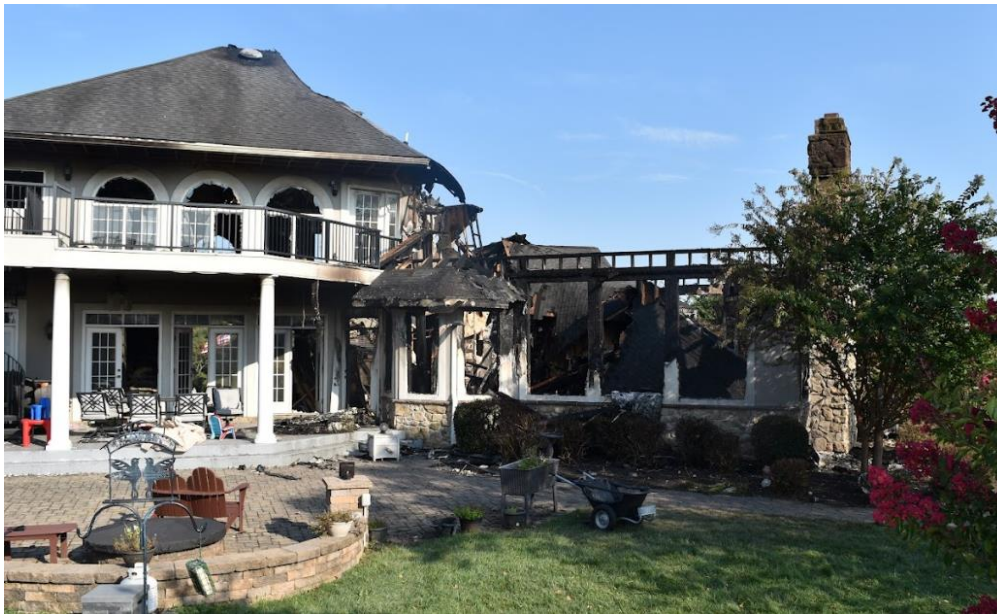
Figure 34: View of Side Charlie of the structure post fire.

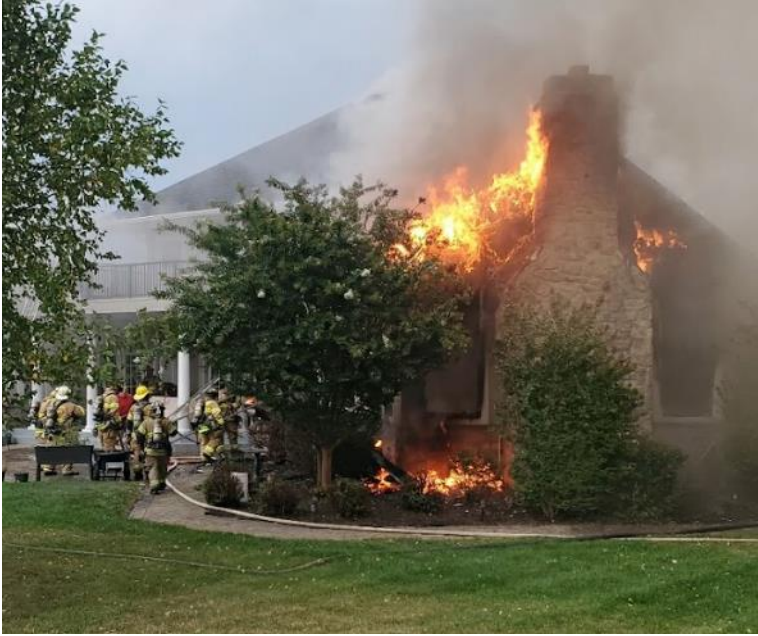
*Figure 36: Fire conditions on Side Charlie of the structure post Mayday transmission.*

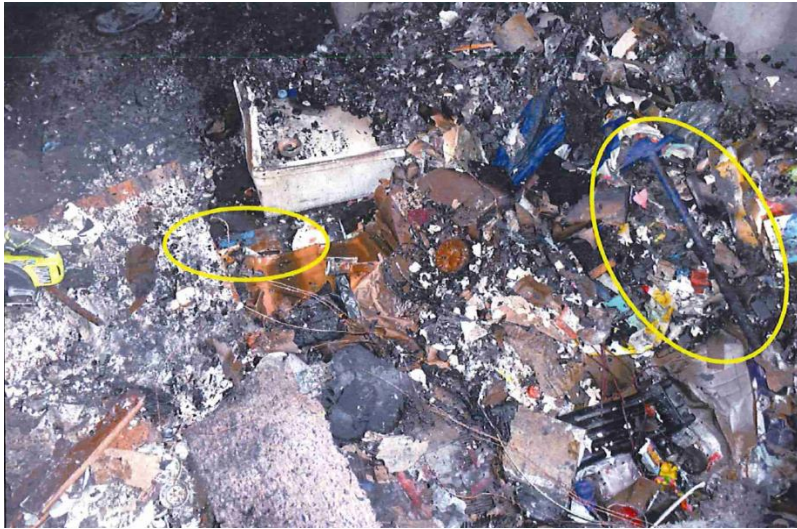
Figure 38: Location where Captain Laird was found. Tools left behind by RS3 are circled.

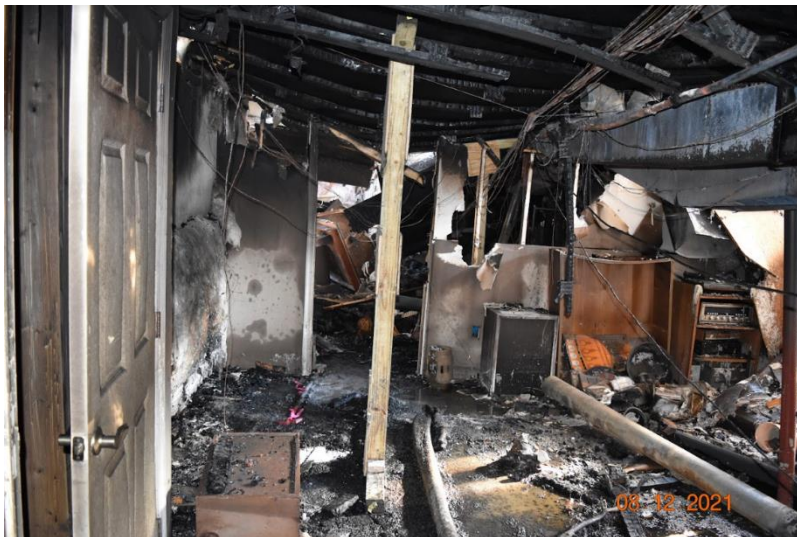
Figure 40: View of basement area, post collapse, where Captain Laird was located and the interior basement wall.
