U.S. Fire Administration/Technical Report Series

# Highrise Office Building Fire One Meridian Plaza

Philadelphia, Pennsylvania

USFA-TR-049/February 1991

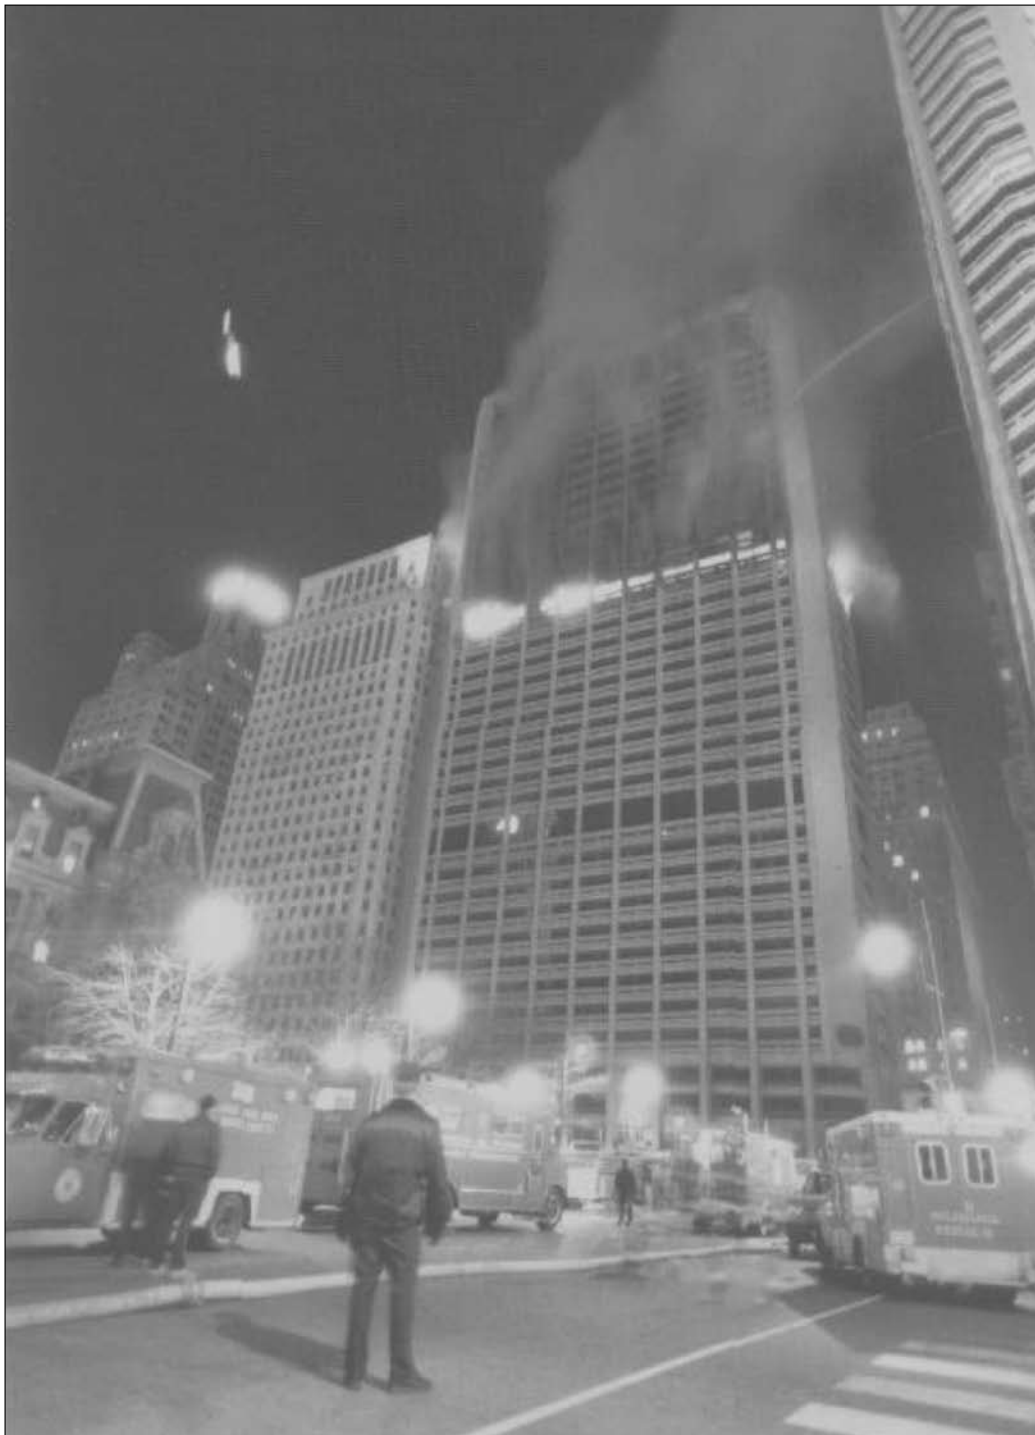
**Exterior view of One Meridian Plaza and fireground operations in the early morning hours of February 24, 1991. Fire involves the 22nd, 23rd, 24th, and part of the 25th floors. Note the heavy stream played on the exterior from an adjacent building.**

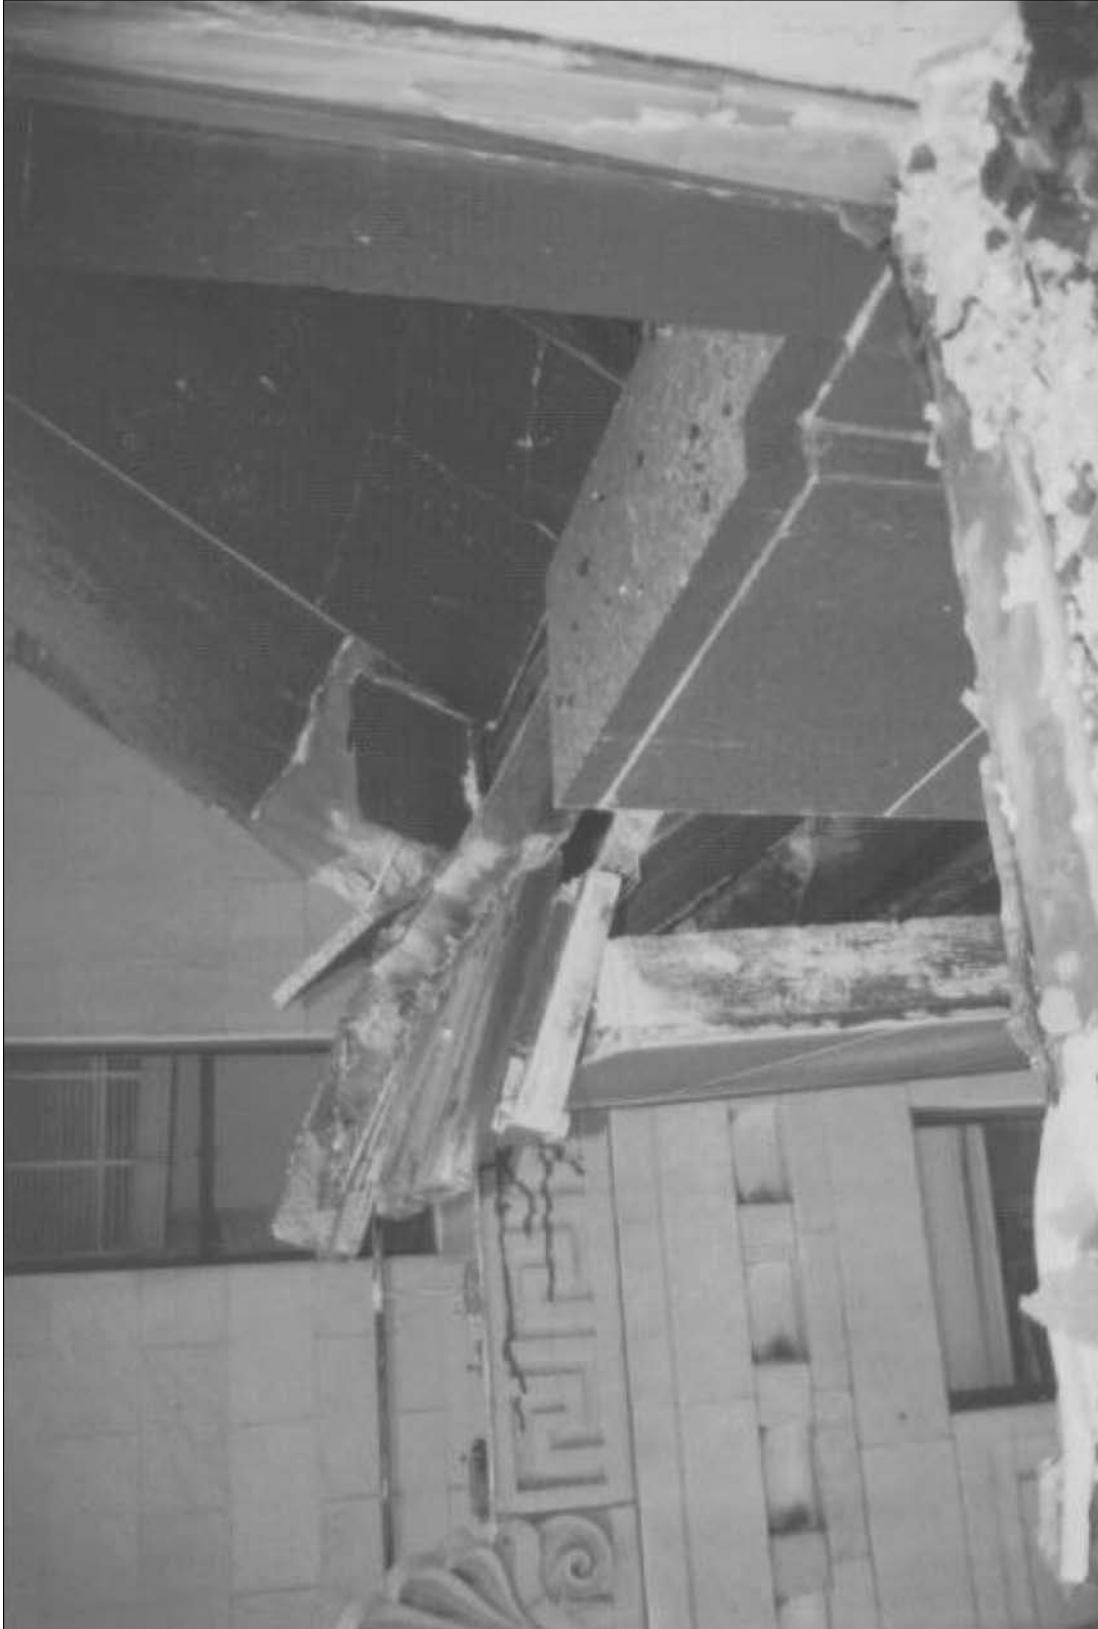
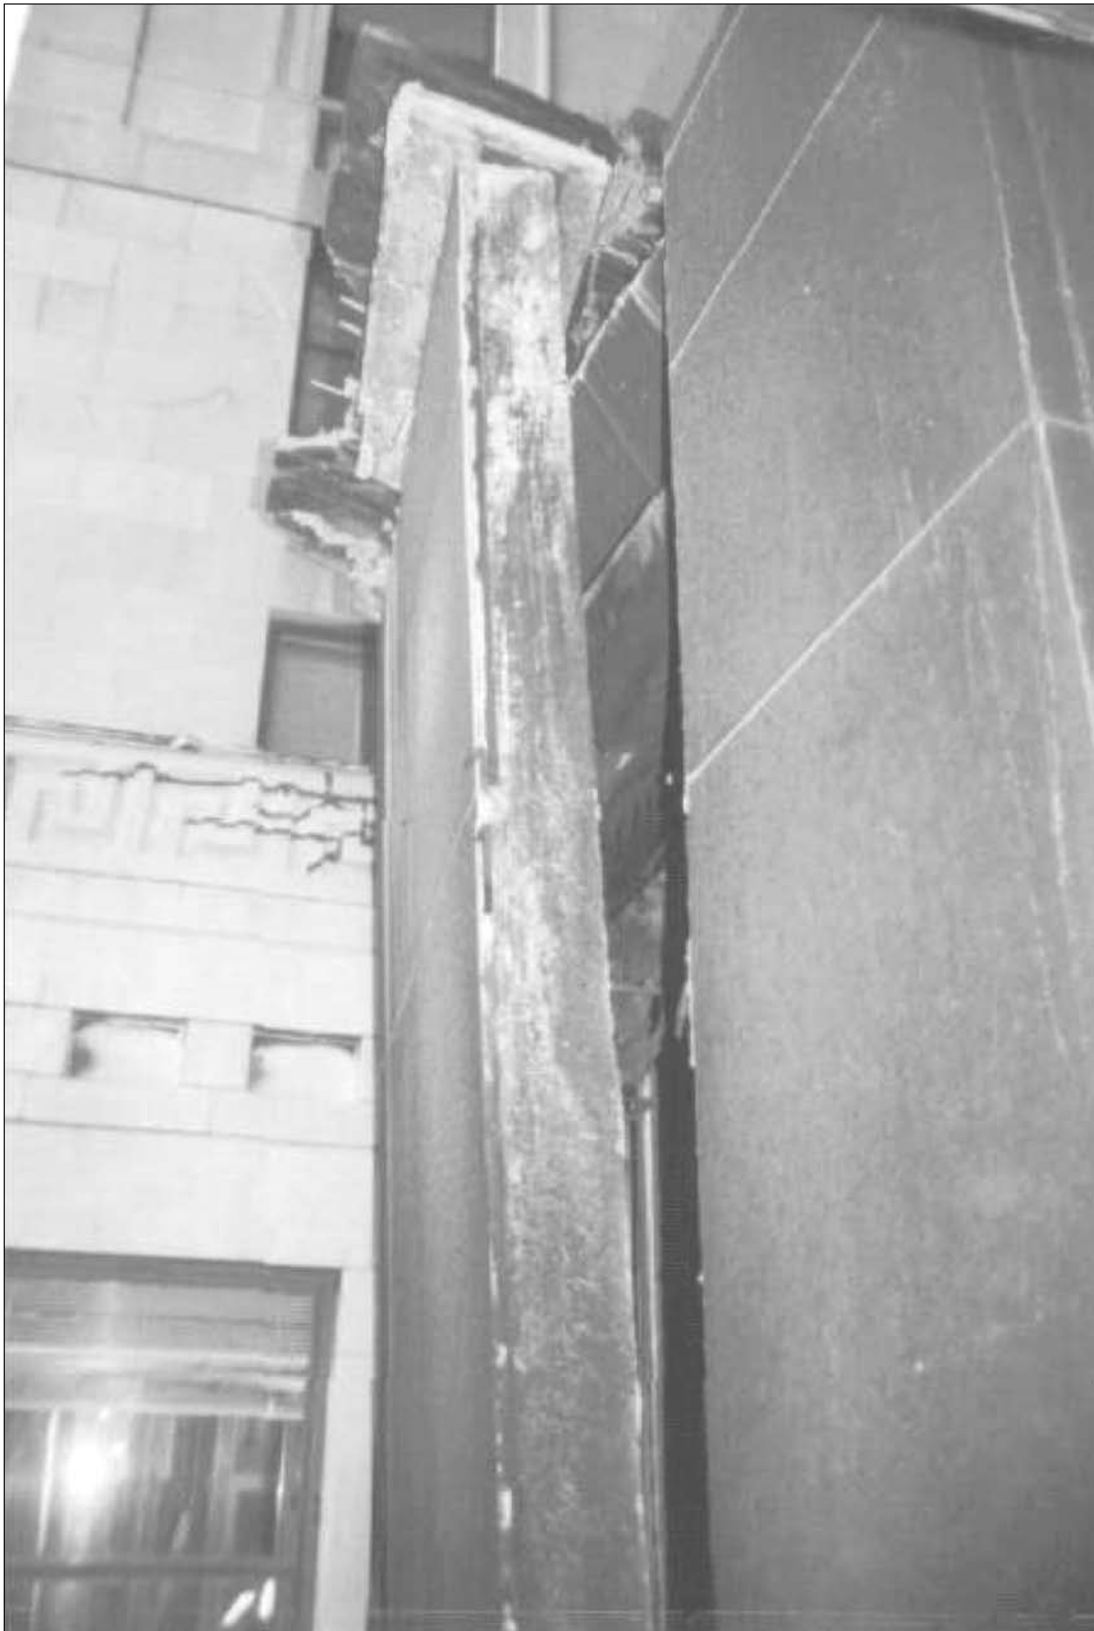
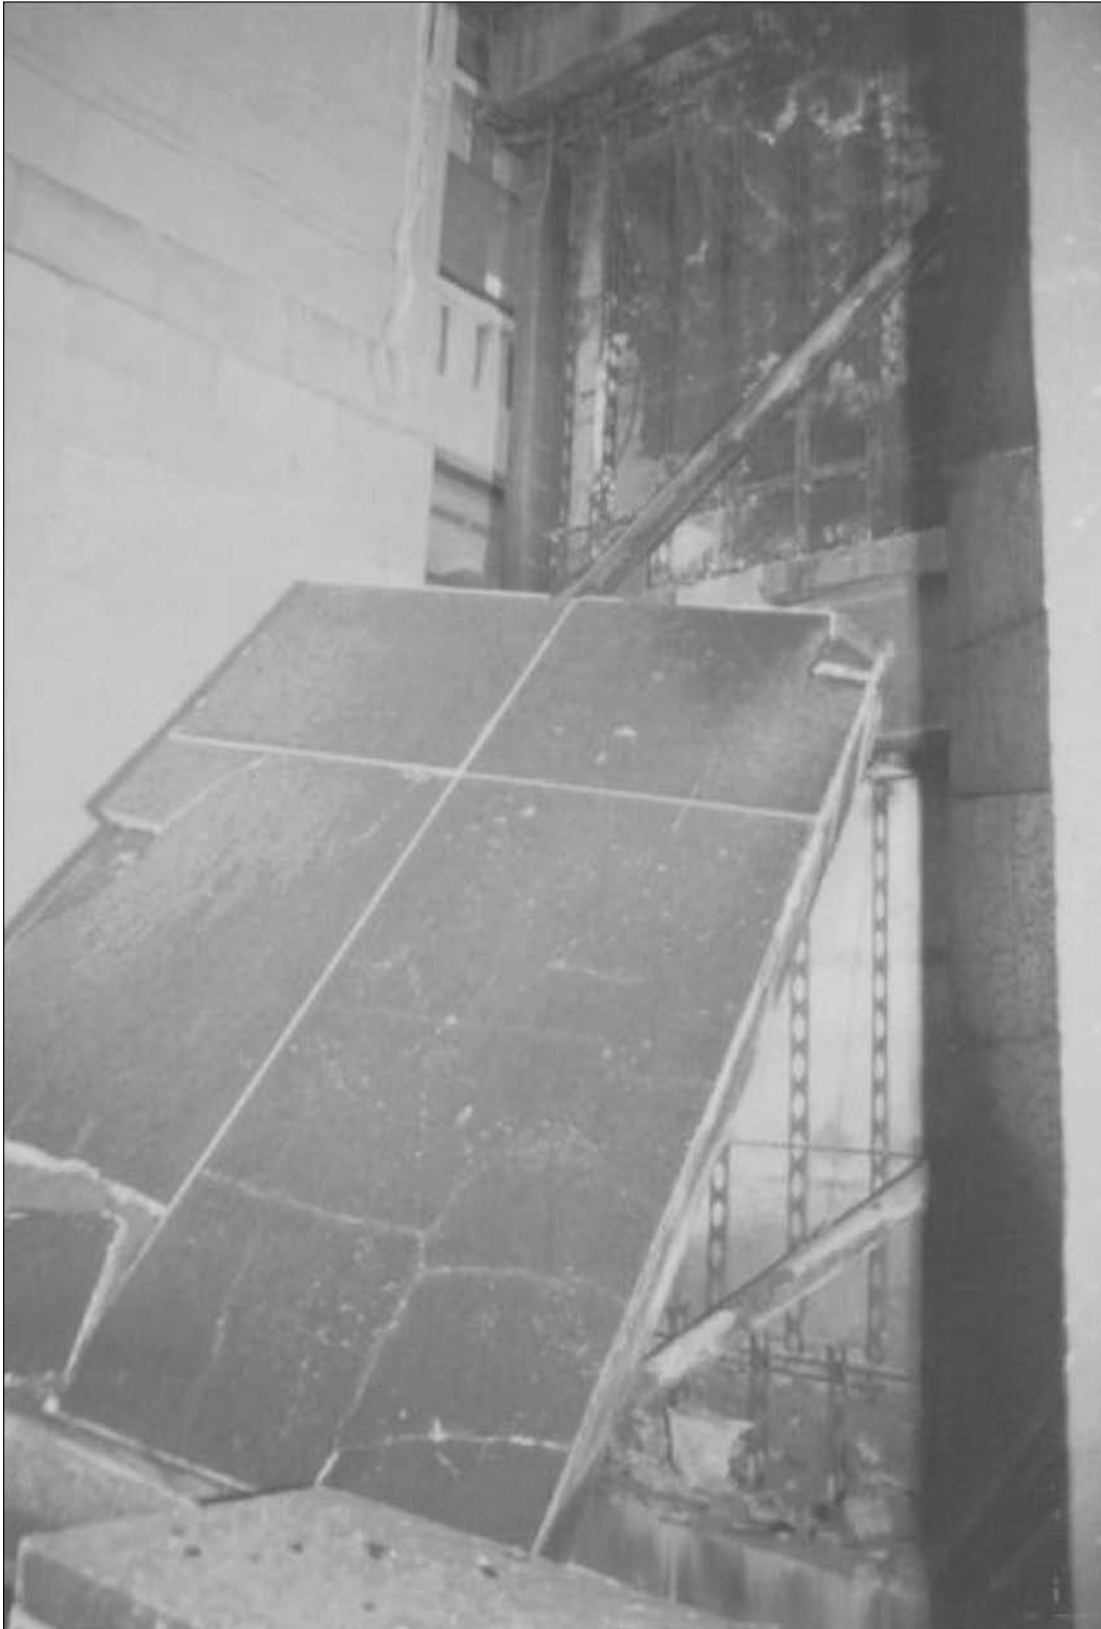
Prior to deciding to evacuate the building, firefighters noticed significant structural displacement occurring in the stair enclosures. A command officer indicated that cracks large enough to place a man's fist through developed at one point. One of the granite exterior wall panels on the east stair enclosure was dislodged by the thermal expansion of the steel framing behind it. After the fire, there was evident significant structural damage to horizontal steel members and floor sections on most of the fire damaged floors. Beams and girders sagged and twisted--some as much as three feet--under severe fire exposures, and fissures developed in the reinforced concrete floor assemblies in many places. Despite this extraordinary exposure, the columns continued to support their loads without obvious damage.

Here and in the next two photos exterior granite panels from the east stair tower were dislodged due to the thermal expansion of the steel frame of the building.

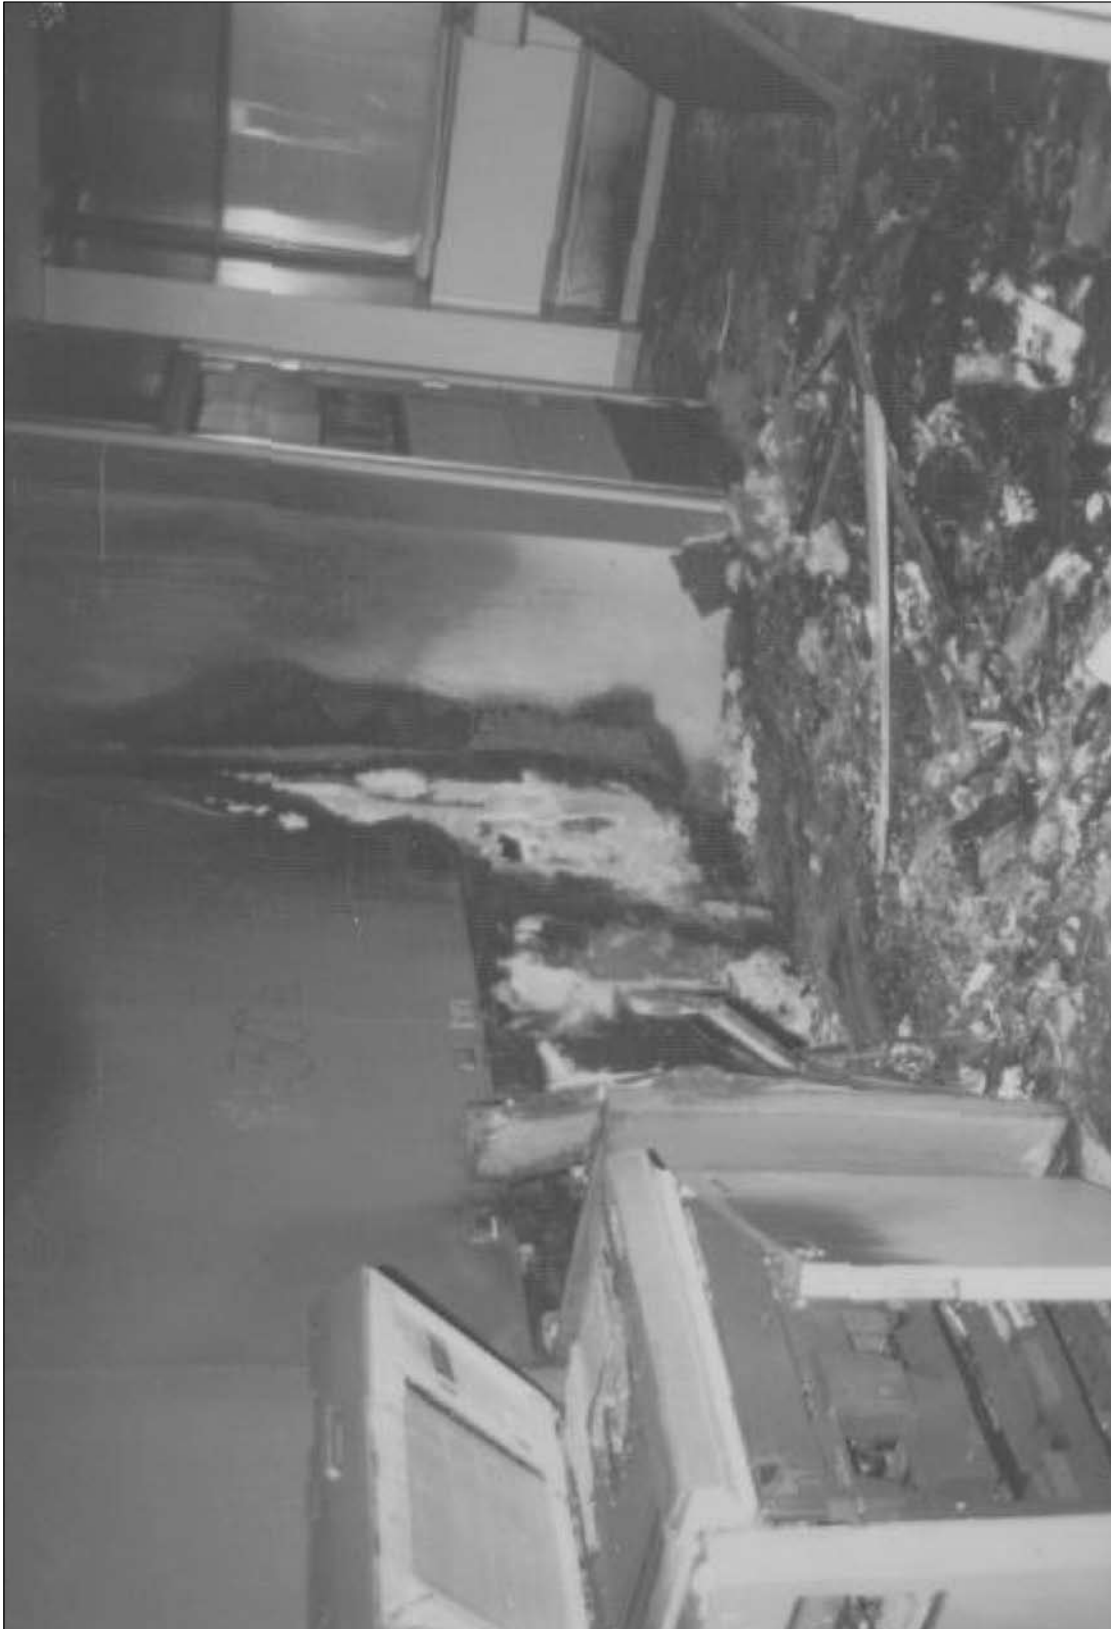
The fire was stopped when it reached the 30th floor, which was protected by automatic sprinklers. As the fire ignited in different points this floor level through the floor assembly and by autoexposure through the windows, 10 sprinkler heads activated and the fires were extinguished at each point of penetration. The vertical spread of the fire was stopped solely by the action of the automatic sprinkler system, which was being supplied by fire department pumpers. The 30th floor was not heavily damaged by fire, and most contents were salvageable. The fire was declared under control at 3:01 p.m., February 24, 1991.

**One of the areas of fire penetration on the 30th floor where a single sprinkler head activated to stop the upward extension of the fire.**

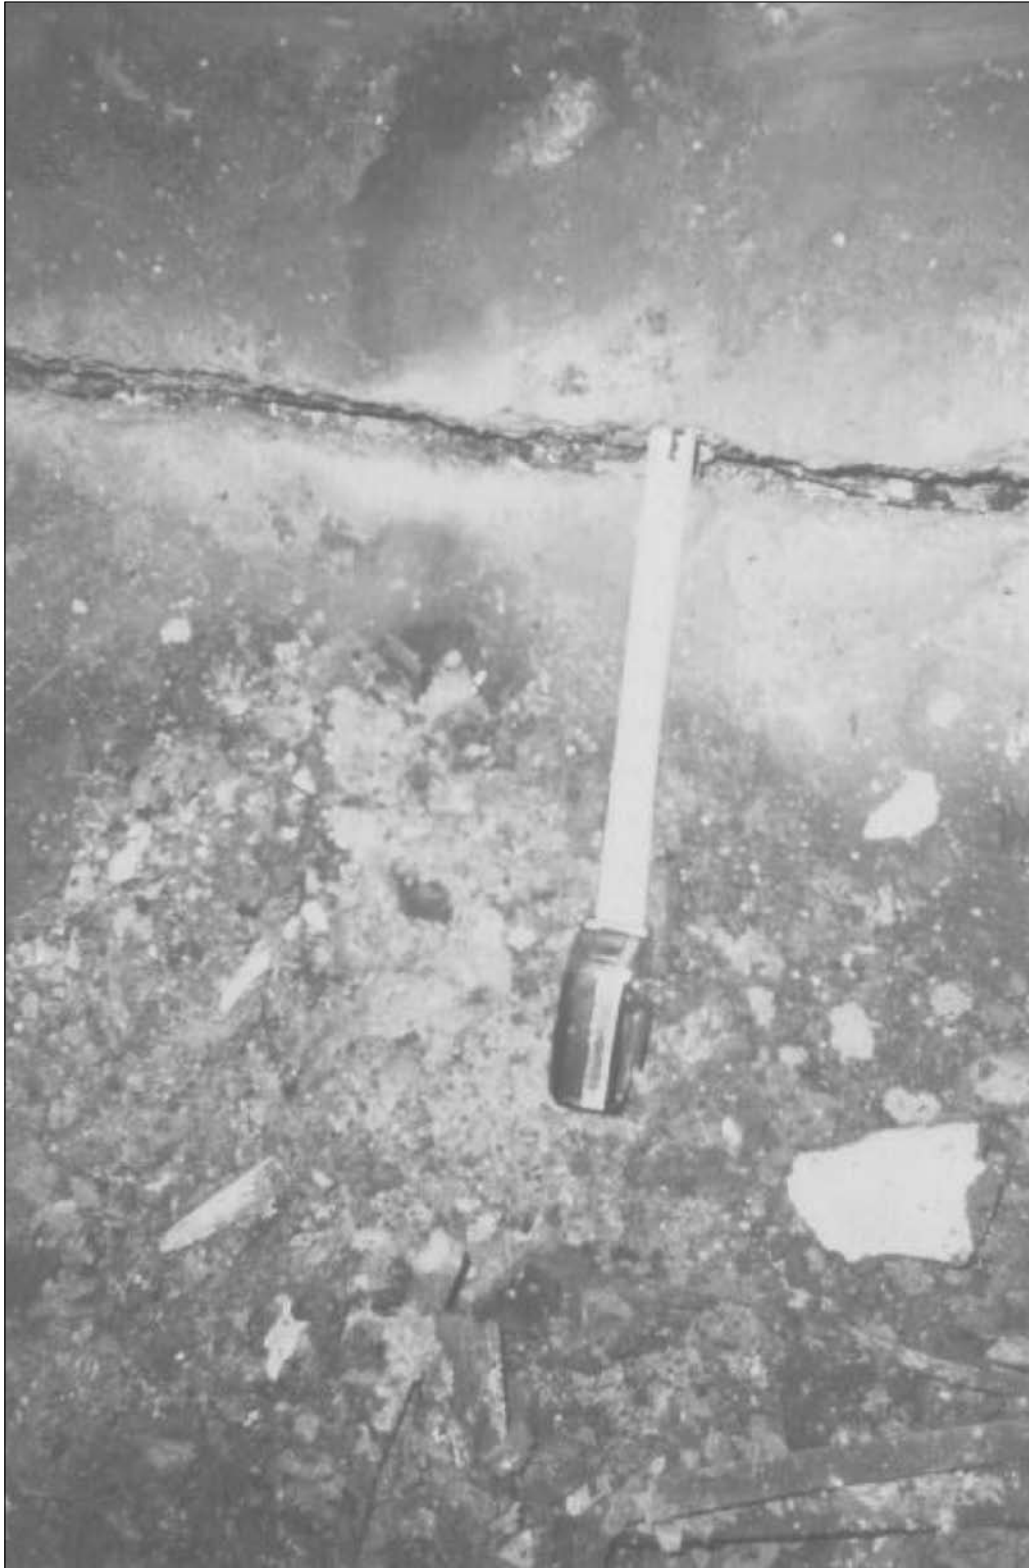
Close-up of crack in concrete floor, 28th floor.

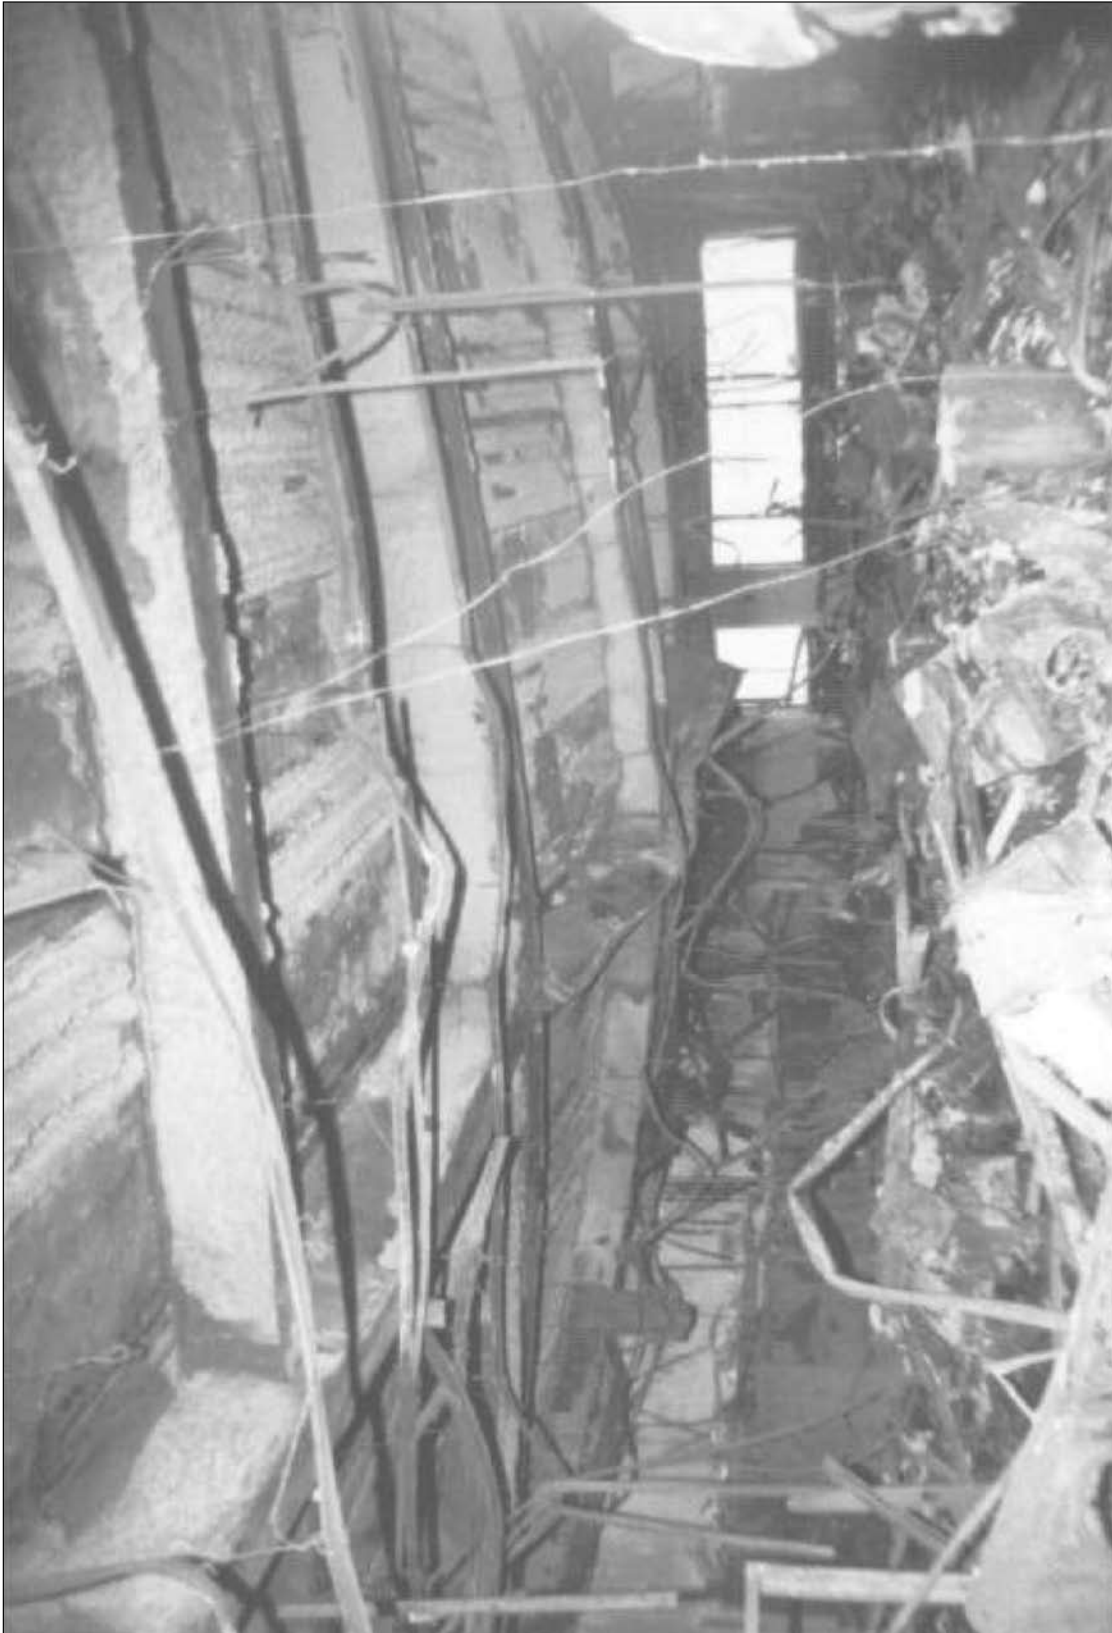
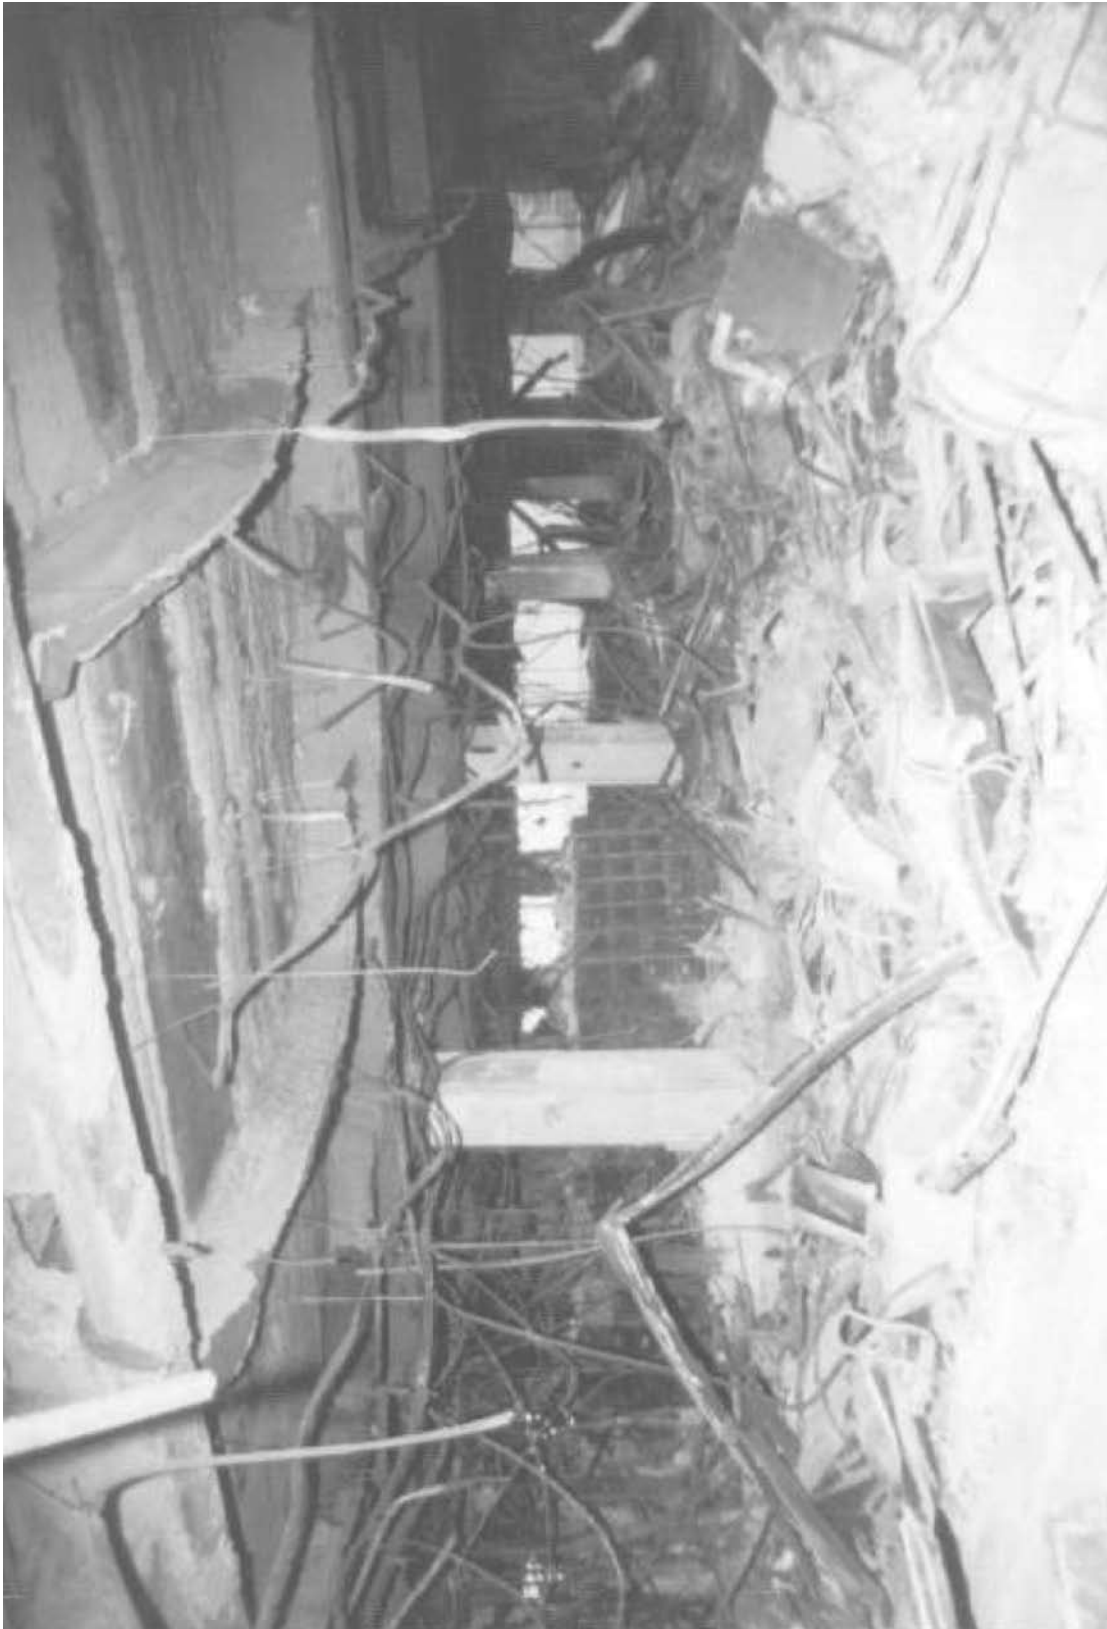
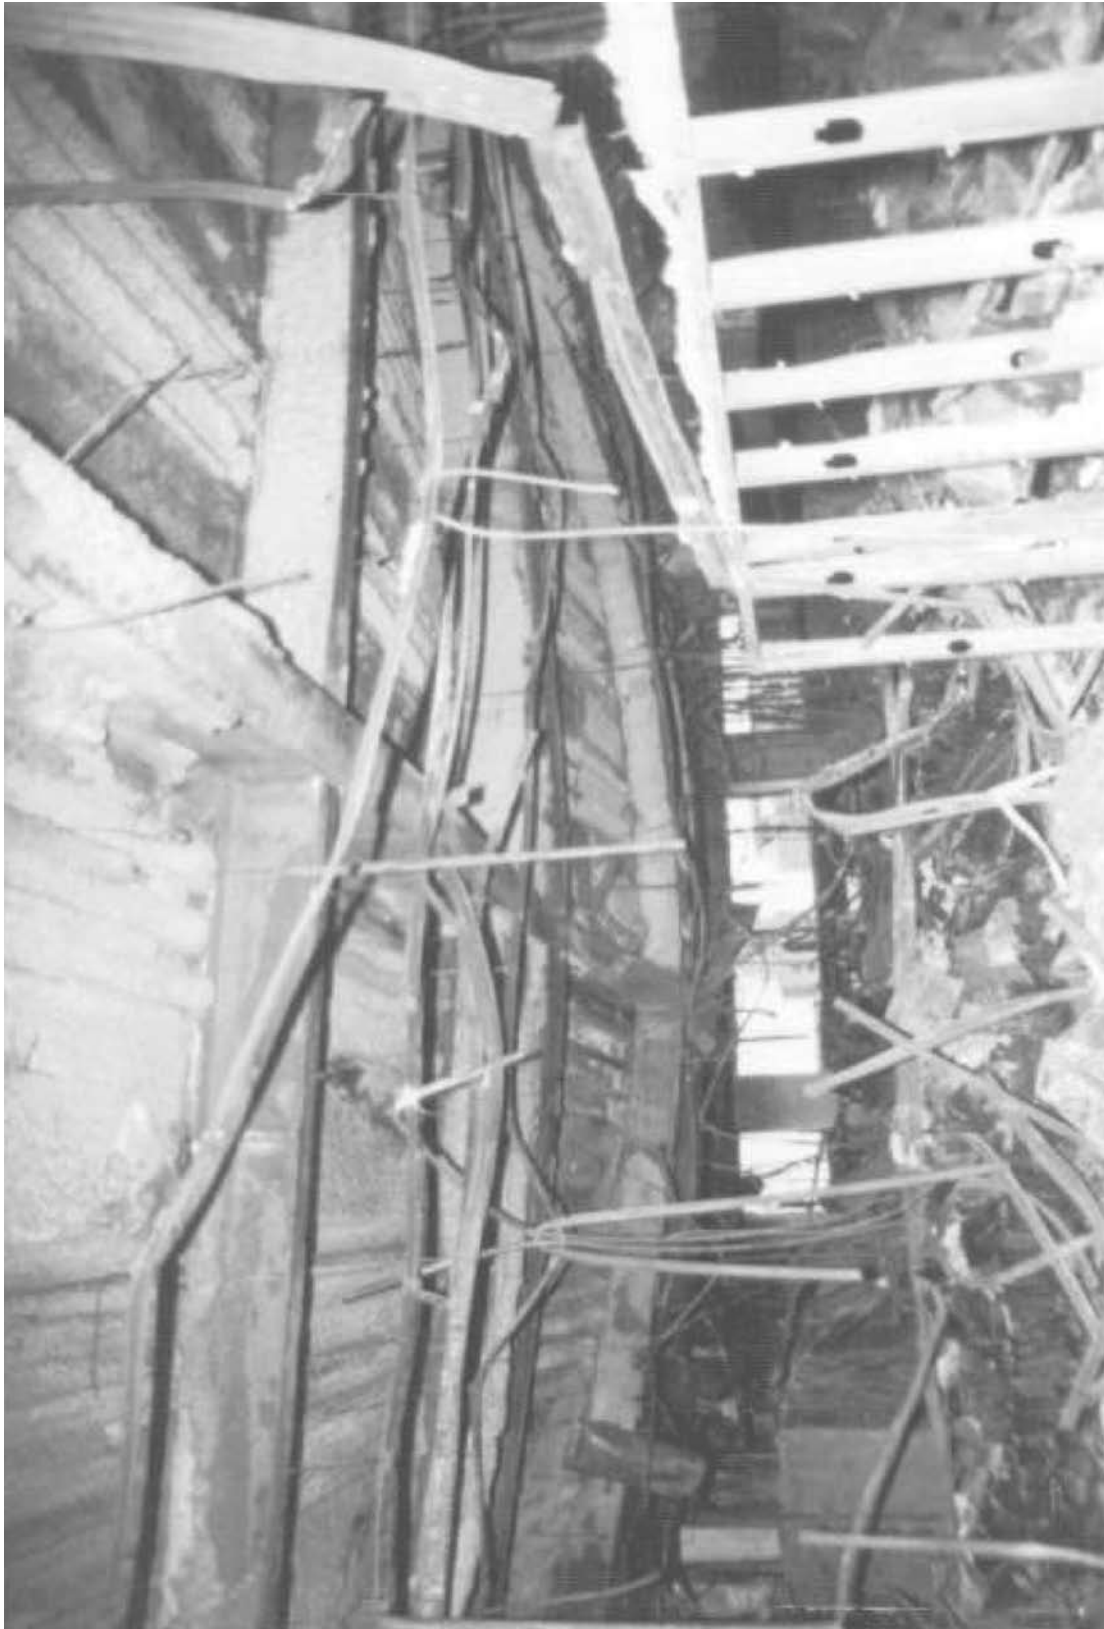
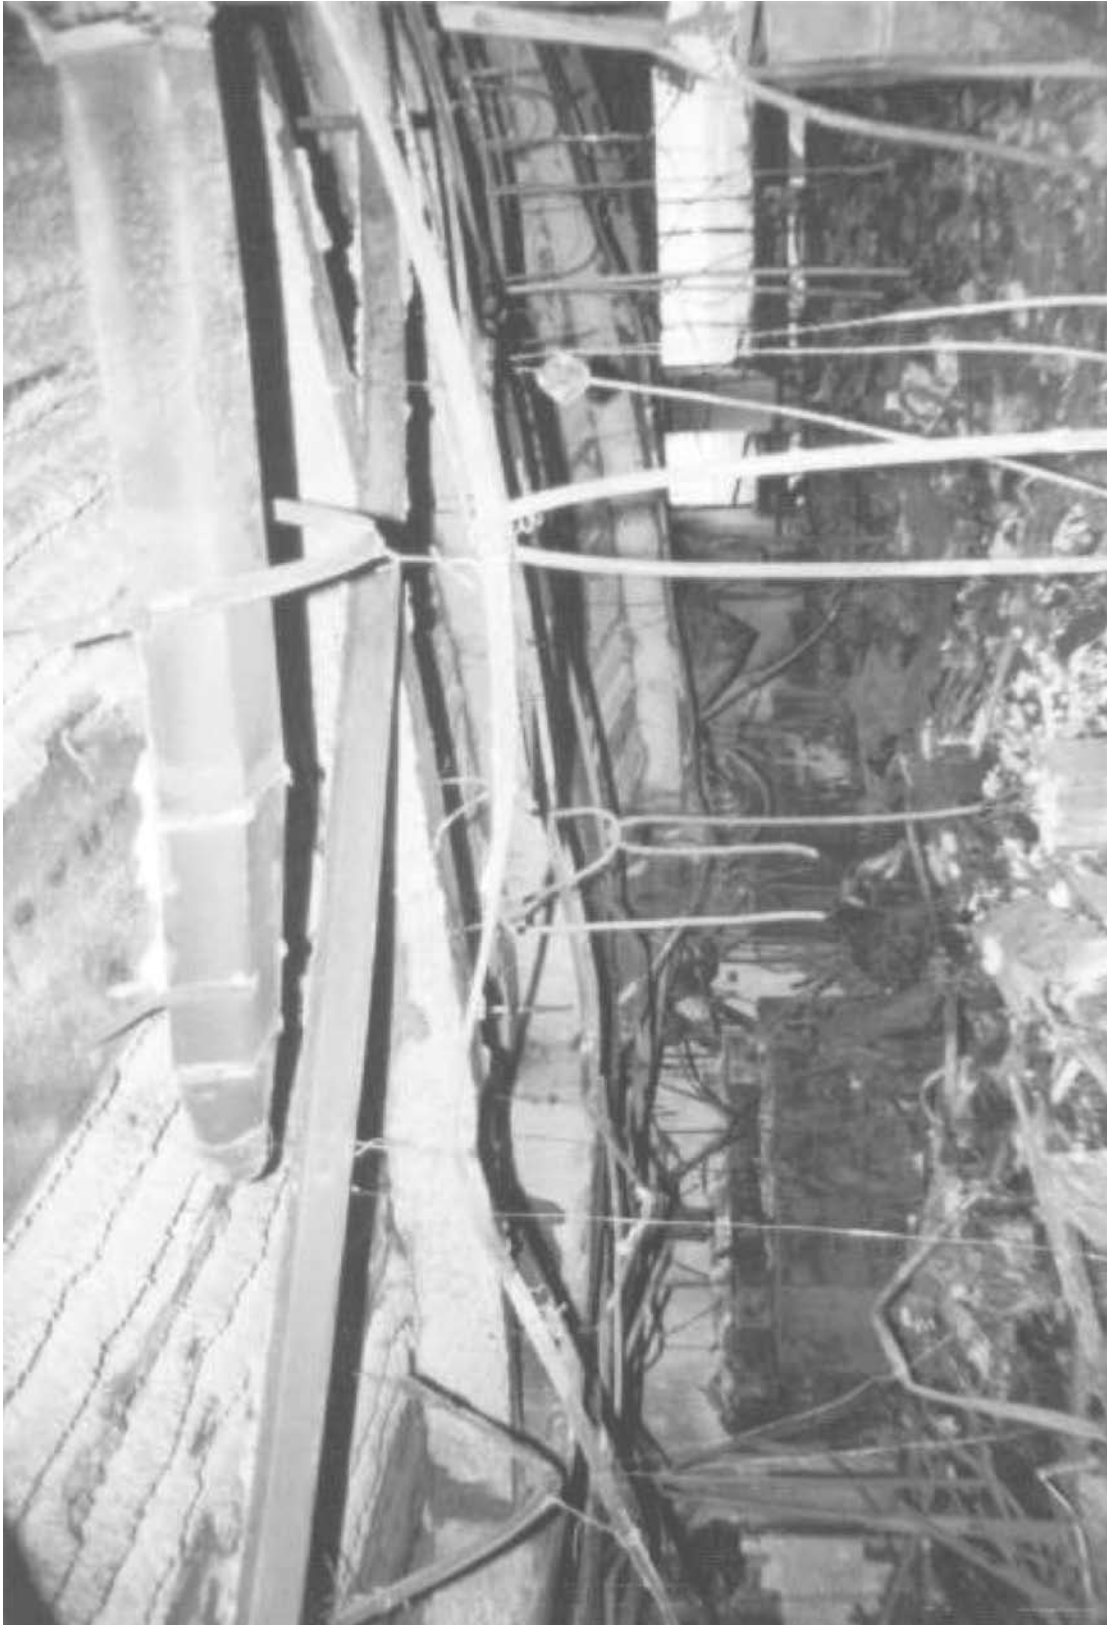
Here and in the next three photos are interior views of floor areas after the fire. Note the total consumption of the available fuel and sagging of the floor deck of up to three feet between columns.

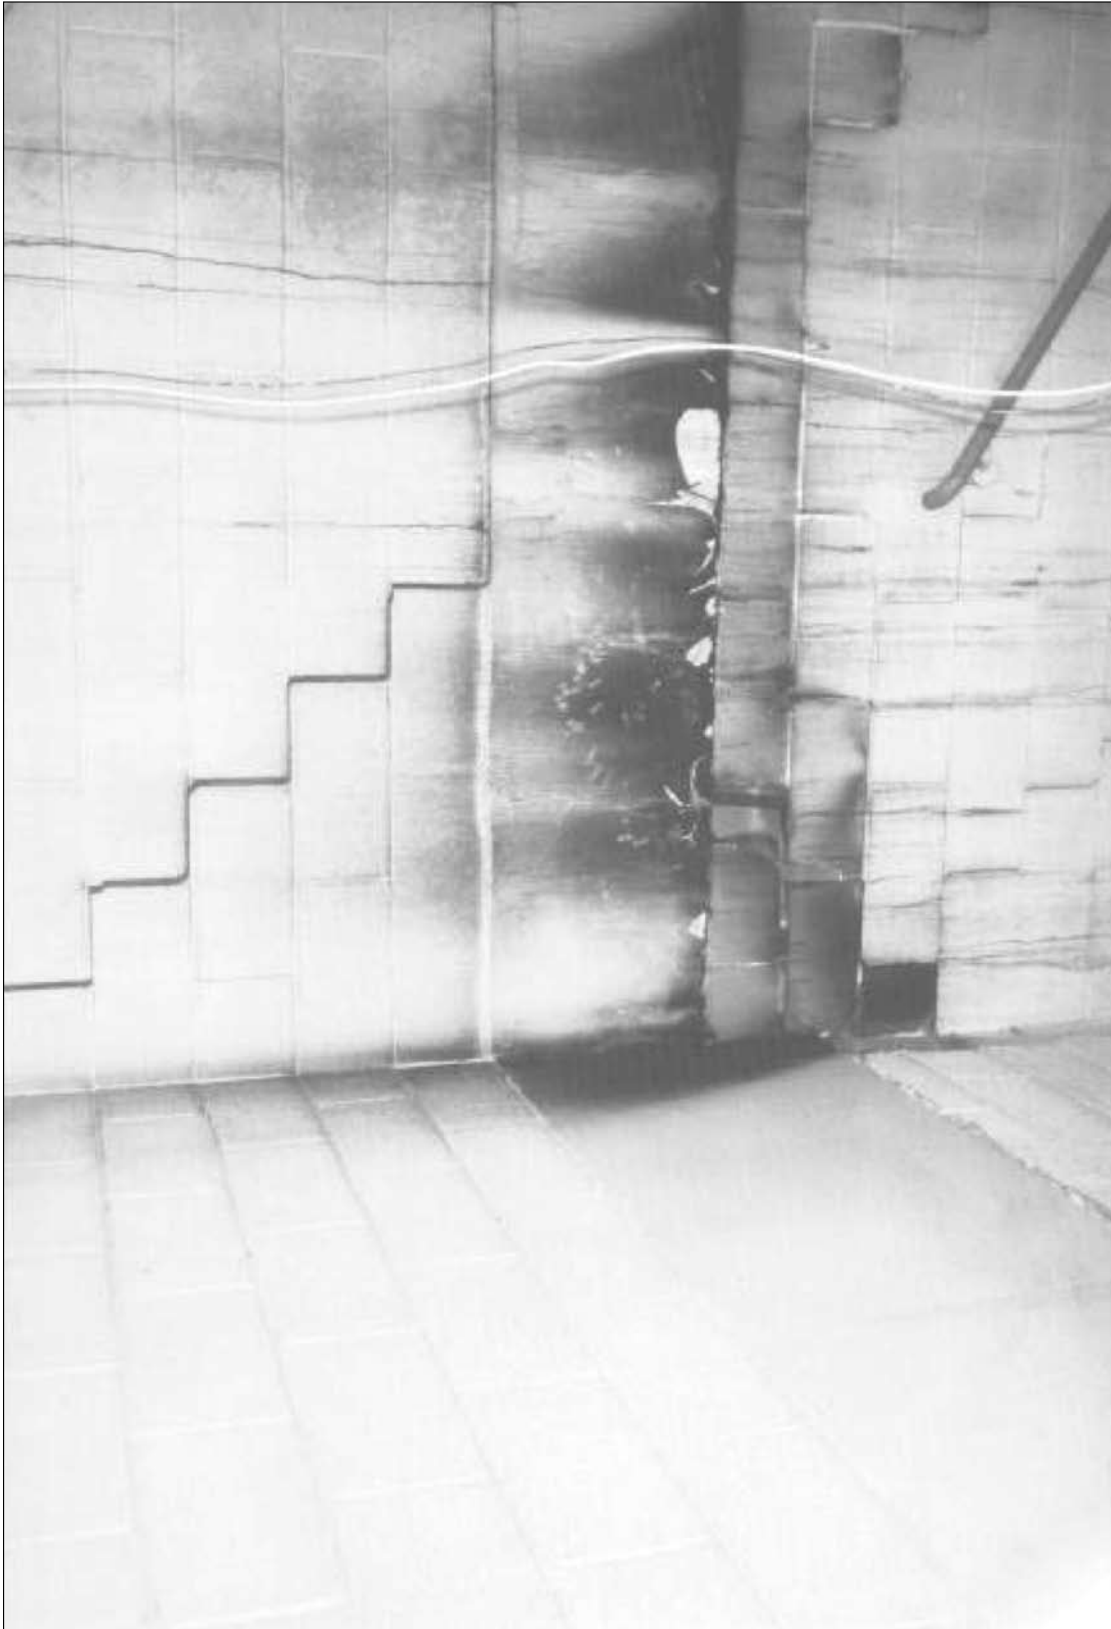
Fire tower between 25th and 26th floors. Note heavy fire and smoke damage.

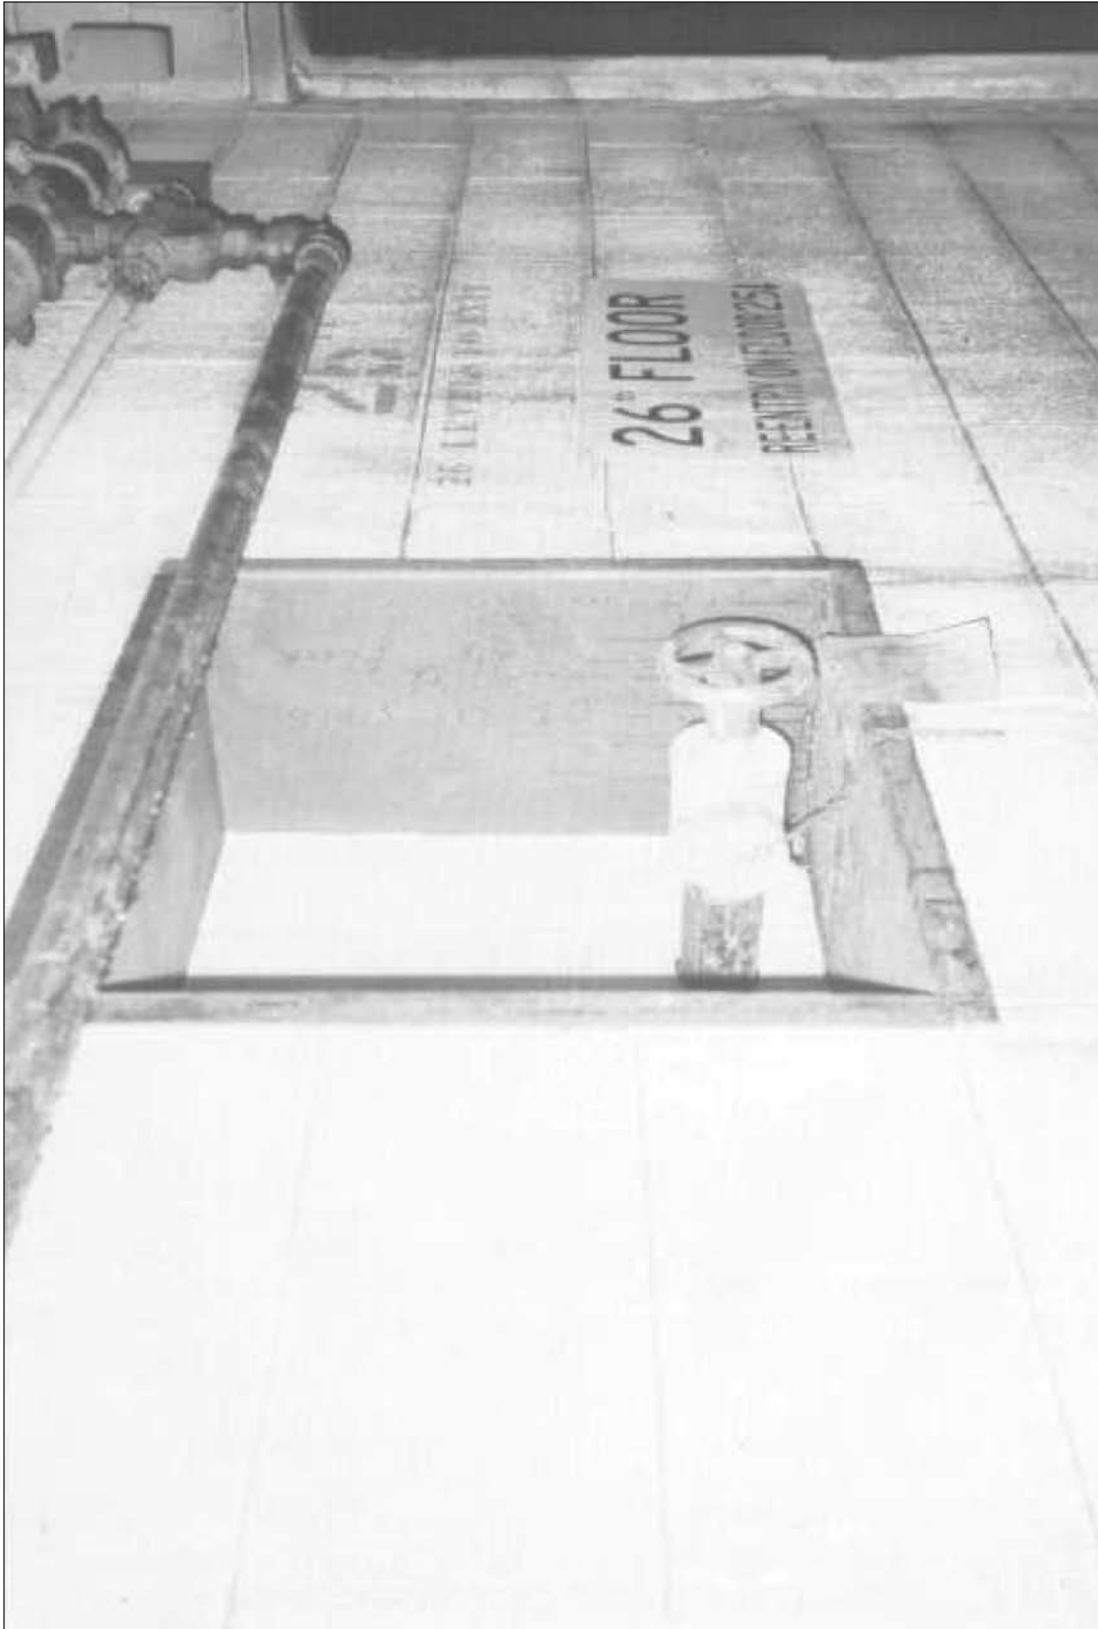
When the PRVs were originally installed, the pressure settings were improperly adjusted. Index values marked on the valves did not correspond directly to discharge pressures. To perform adjustments the factory and field personnel had to refer to tables in printed installation instructions to determine the proper setting for each floor level.<sup>4</sup> For more detailed information about PRVs see Appendices D and E.

The PRV equipped hose outlets on the 22nd floor of One Meridian Plaza, adjusted as reported at the time of the fire, would have produced nozzle pressures of approximately 40 psi. This is insufficient for a straight stream device and dangerously inadequate for a fog nozzle.

Standpipe hose outlet with pressure reducing valve (PRV), 26th floor.
