U.S. Fire Administration/Technical Report Series

# Highrise Office Building Fire One Meridian Plaza

Philadelphia, Pennsylvania

USFA-TR-049/February 1991

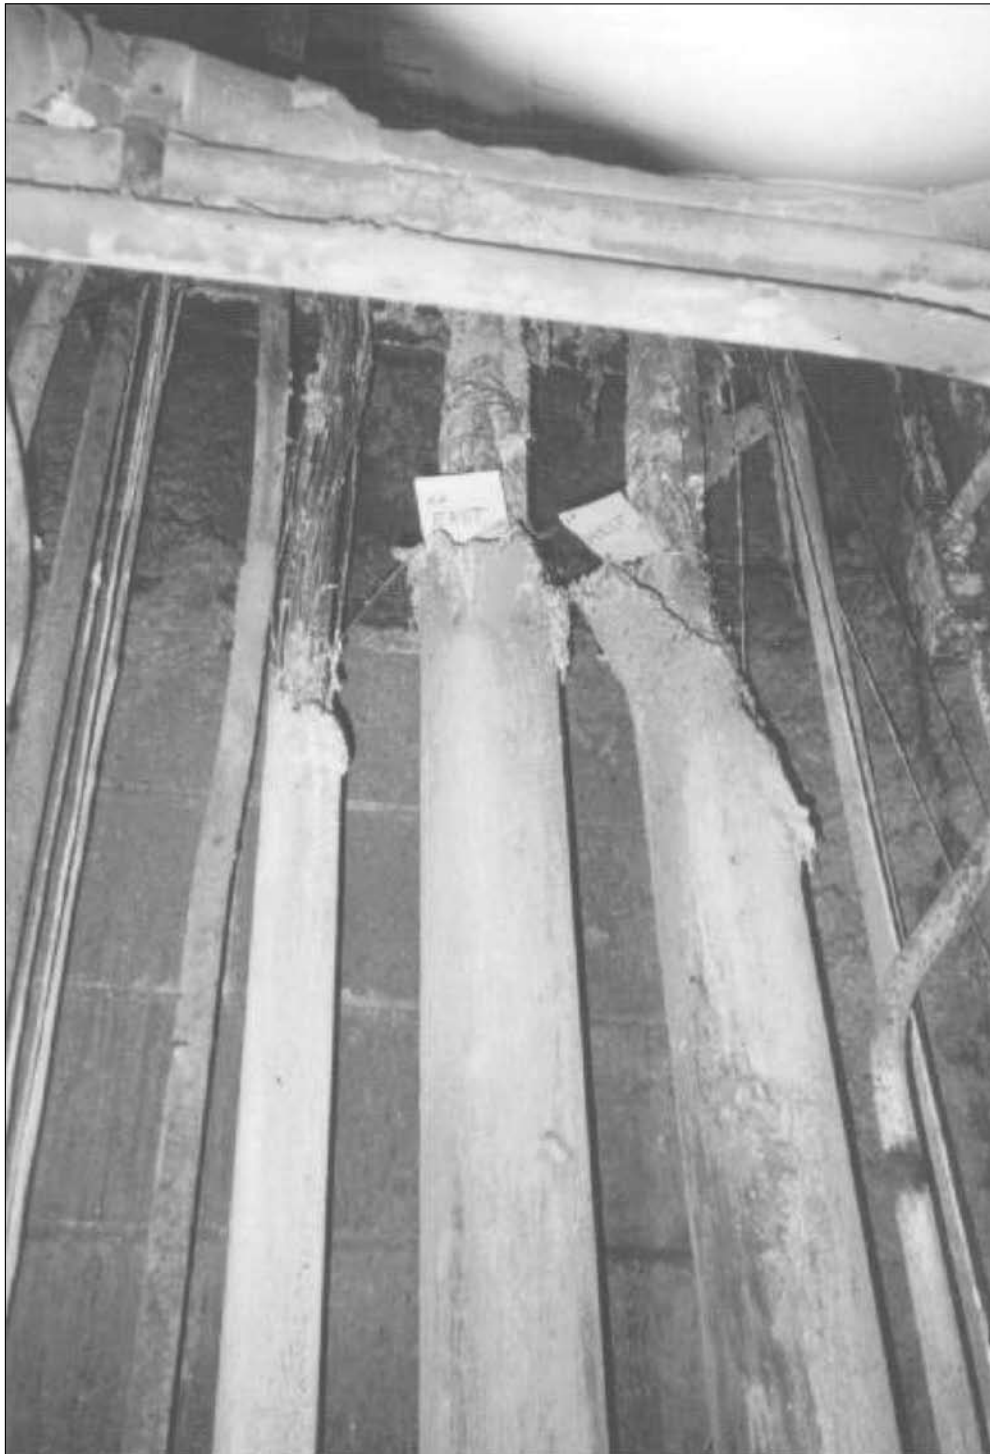
| Issues | Comments |
|--|---|
| Electrical Systems | Installation of the primary and secondary electrical power risers in a common unprotected enclosure resulted in a complete power failure when the fire damaged conductors shorted to ground. The natural gas powered emergency generator also failed. |

Shortly after the battalion chief and the attack team reached the 11th floor there was a total loss of electrical power in the building. This resulted when intense heat from the fire floor penetrated the electrical room enclosure. The heat caused the cable insulation to melt resulting in a dead short between the conductor and the conduit in both the primary and secondary power feeds, and the loss of both commercial power sources. The emergency generator should have activated automatically, but it failed to produce electric power. These events left the entire building without electricity for the duration of the incident in spite of several efforts to restore commercial power and to obtain power from the generator.

**Electrical shaft enclosure on the 30th floor, showing side-by-side risers for the two power supplies, both damaged by fire penetration at the plenum level of the adjoining office space.**

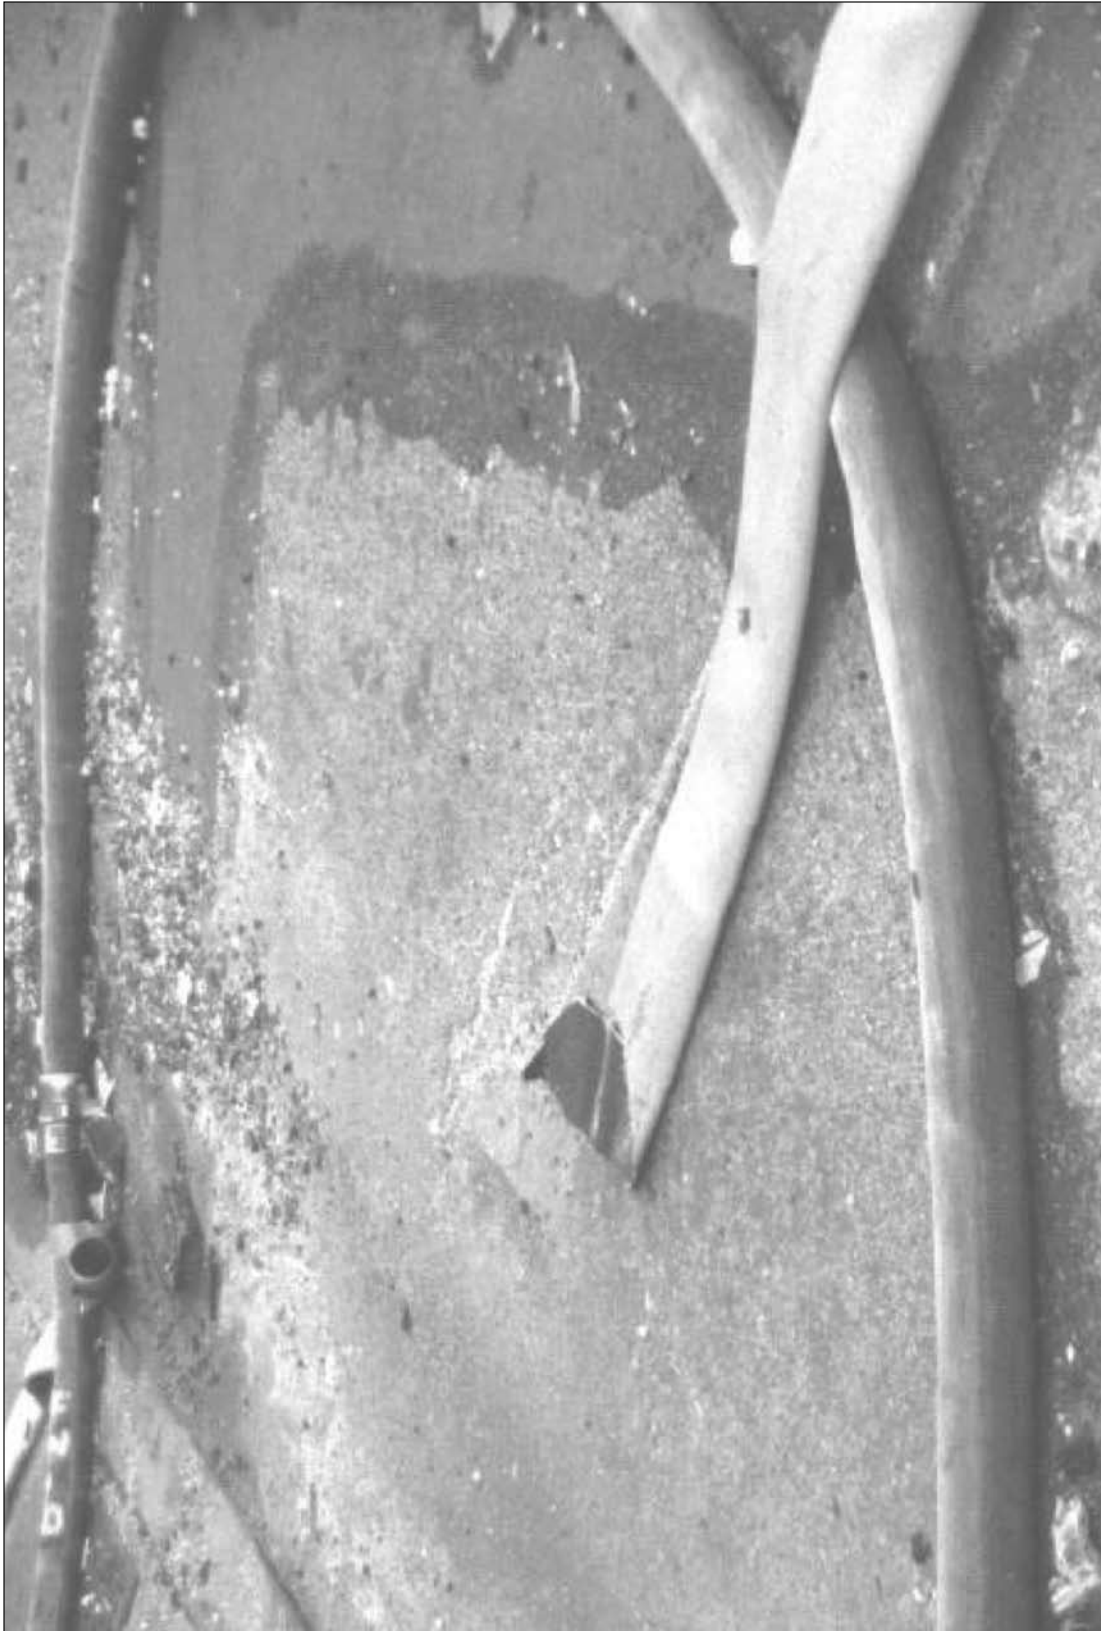
Section of 5-inch hose that was ruptured by falling debris outside the building. Hose lines feeding the standpipes and entering the stairways were damaged several times and had to be replaced at great risk to firefighters. (Shoring boards were later used to protect the hose lines.)

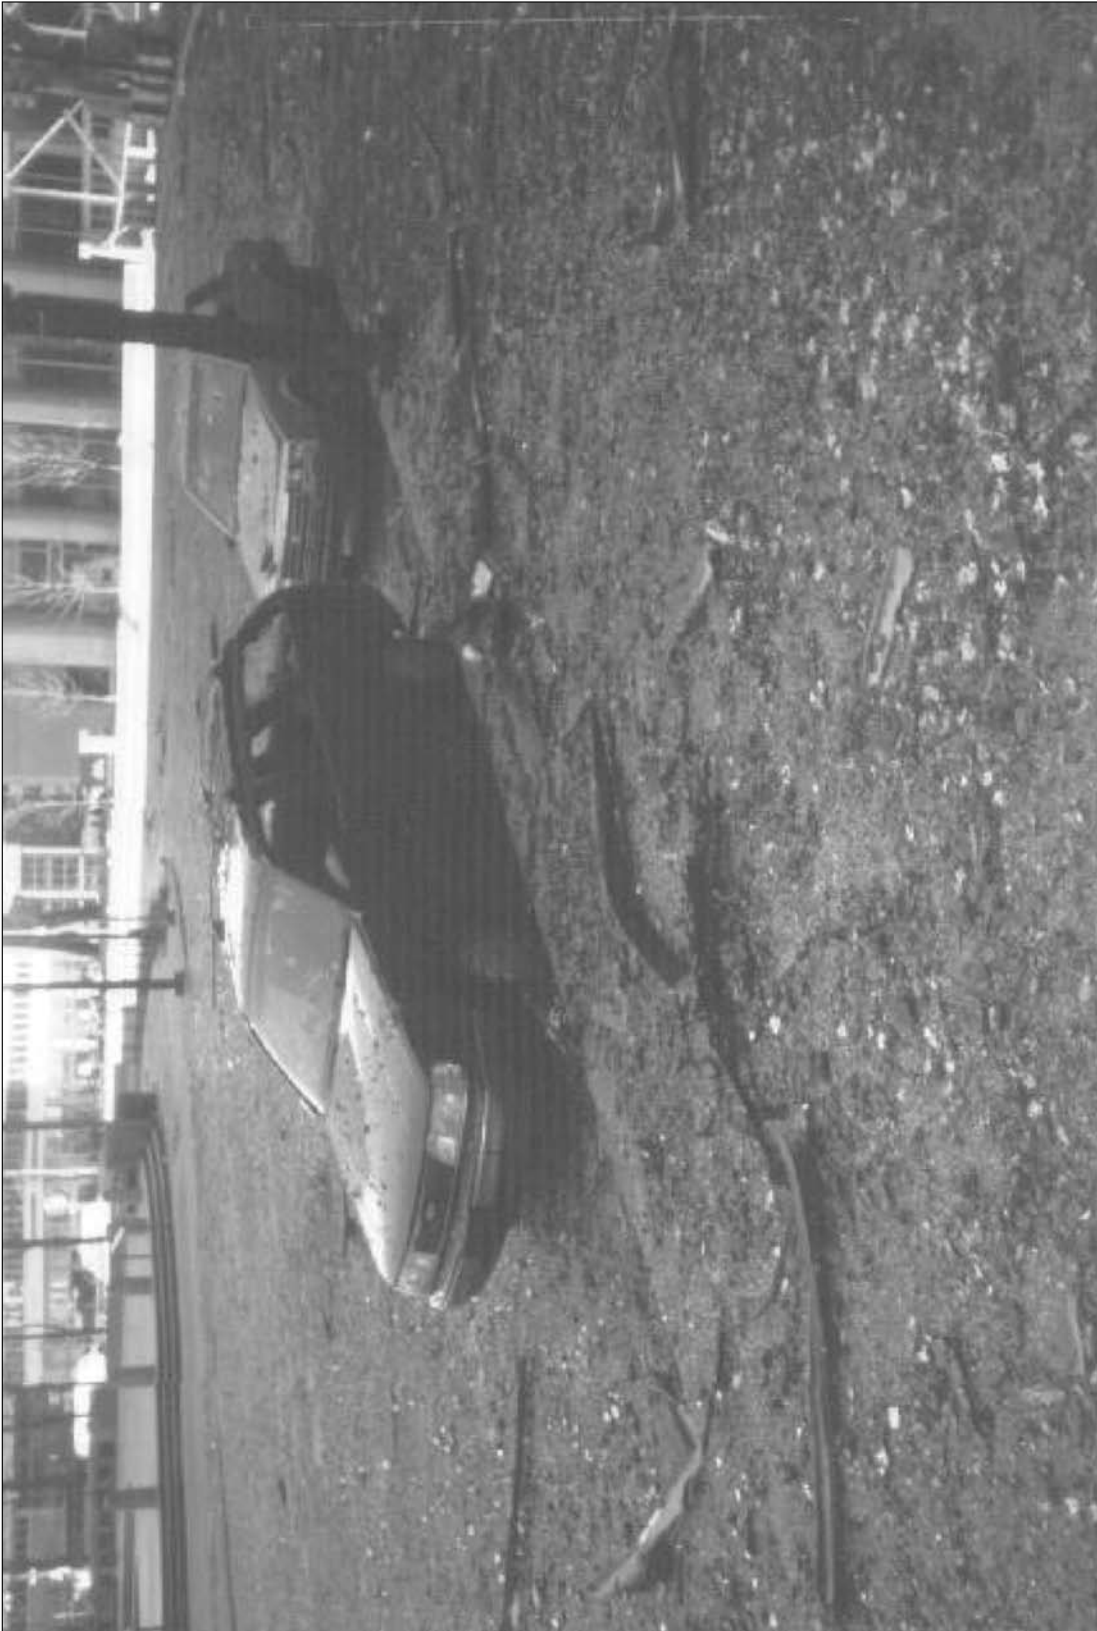
On the street below pedestrians were cleared from the area because of falling glass and debris as more and more windows were broken out by the fire. Additional hoselines were connected to the standpipe connections, attempting to boost the water pressure in the system. However, the design of the PRVs did not allow the higher pressures to reach the interior hose streams. Additional alarms were requested to bring a five-alarm assignment to the scene.

Street in front of the building from front steps showing stranded autos and debris in street.
