Bomber Hits Empire State Building; New York Gets Its Highest Fire

**Four Alarm Assignment Subdues New York's
Loftiest Blaze Following Fatal Bomber Crash**

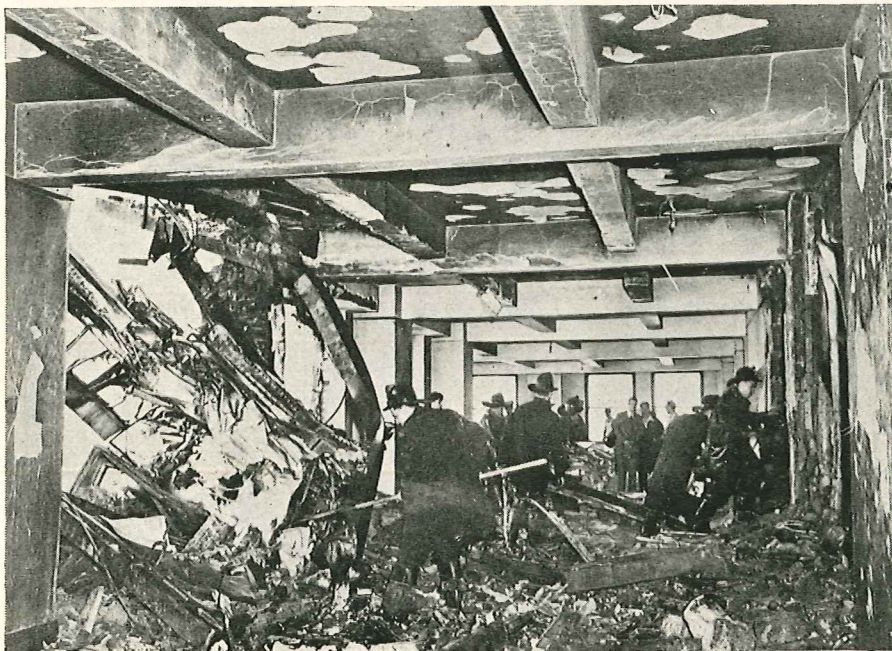
feet below. A steel girder at the seventy-ninth floor was bent inward eighteen inches by the shock.

Wreckage on 78th Floor After Crash. Remains of Bomber Shown at Left

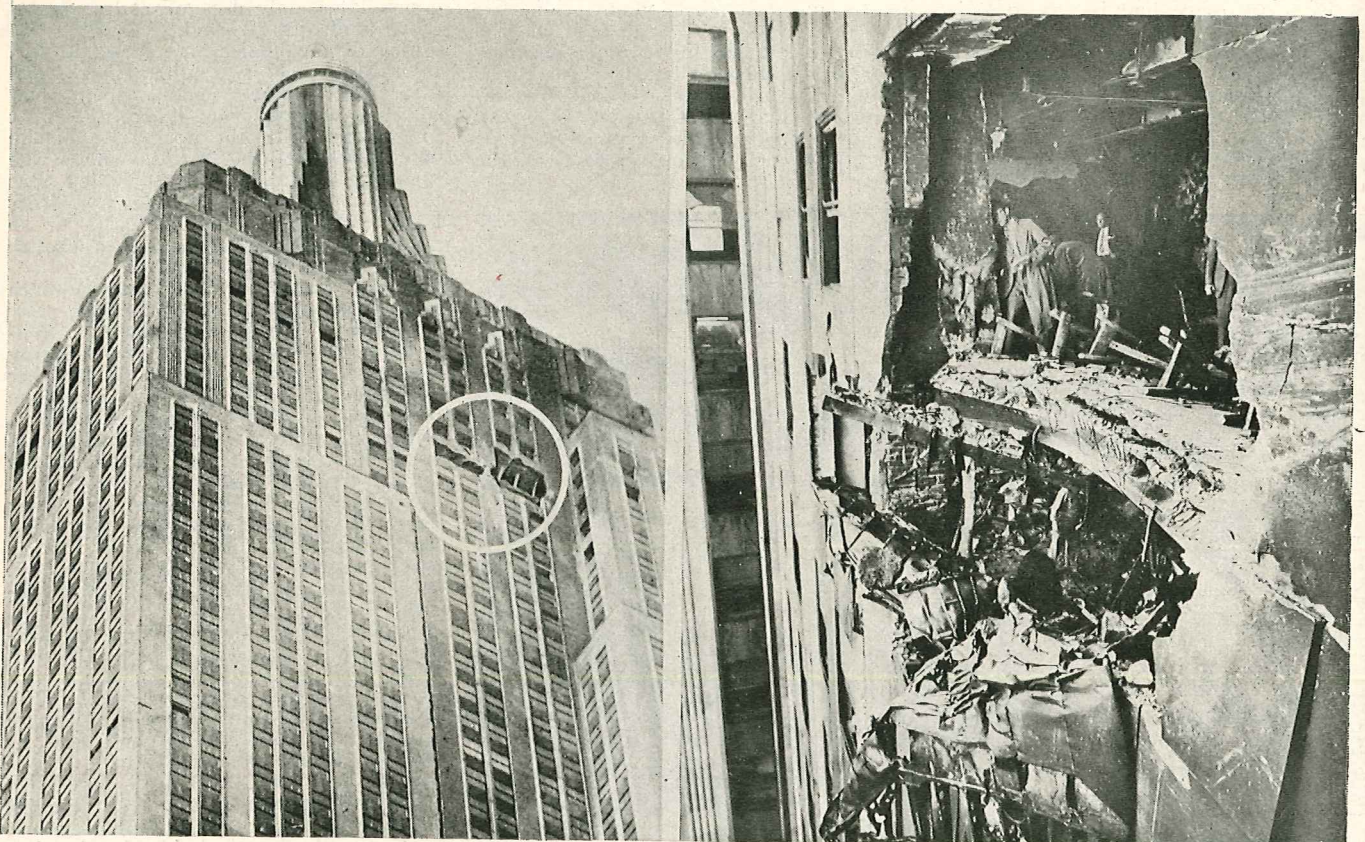
The eight ton, twin-engine plane, striking the north side of the 102-story, 1,250-foot structure, smashed through seven walls and partitions and then hurled parts of its wreckage out the south side, where one of the motors crashed atop a twelve story building across 33rd street. Other parts of the plane, together with pieces of the structure itself, were thrown in every direction, fragments being found half a mile distant. The plane, said to have been traveling faster than 300 miles per hour, struck with terrific force; its wings were sheared off but the motors and fusilage ripped a hole eighteen feet wide and twenty feet high in the outer wall of the seventy-eighth and seventy-ninth floors, on the 34th street side of the structure.

Right: Where Bomber Struck. Two Floors Were Involved as Indicated. Left: The Gaping Holes (Circled) at the 78th and 79th Floors of the Empire State Building Marks the Place Where the B-25 Army Bomber Crashed Into the Structure

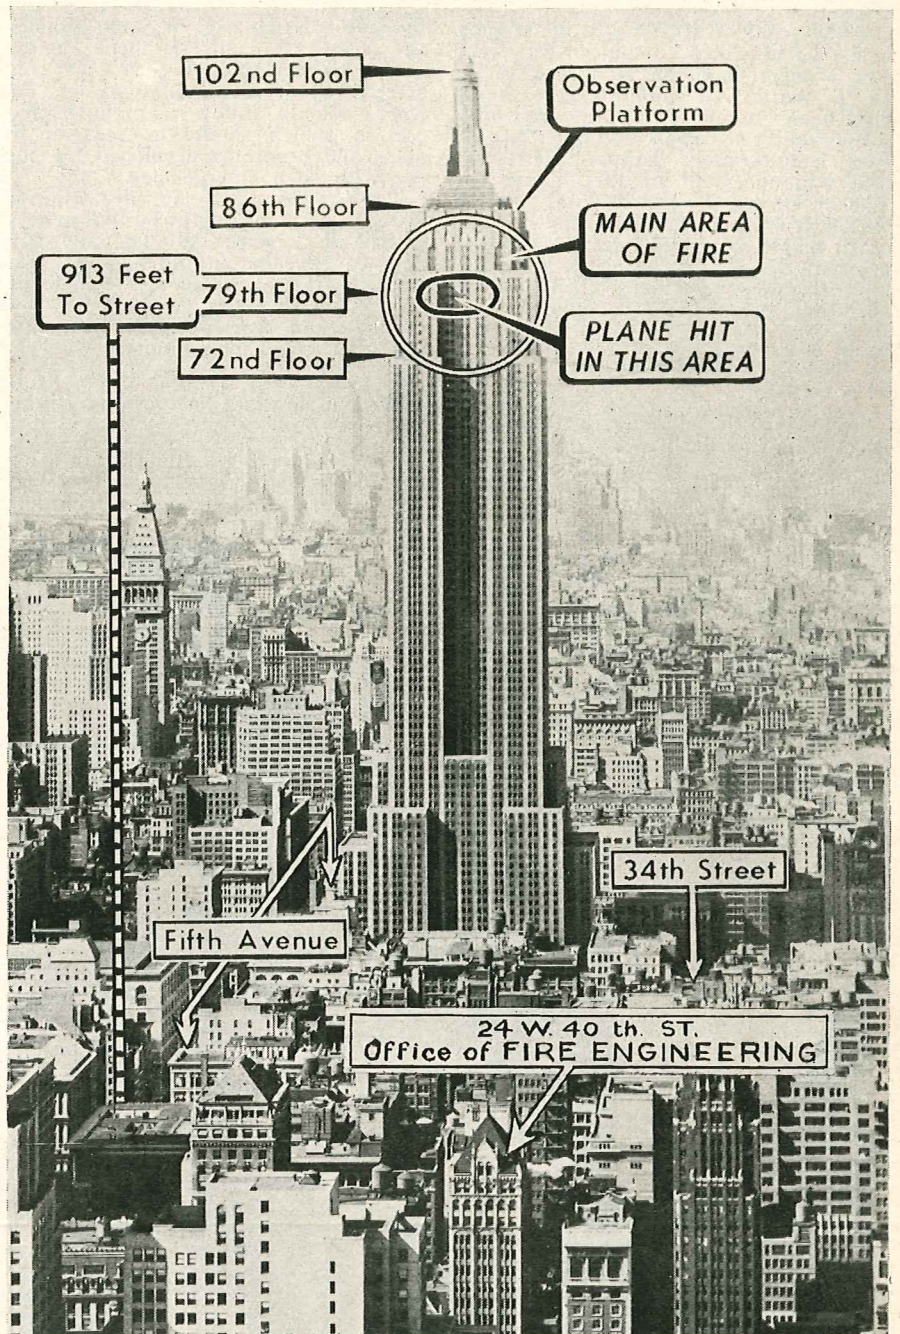
Key Areas Involved in Bomber Crash Into the 79th Floor of the Empire State Building Are Located in This View Looking South, with North Side of the Structure Shown. This Picture Was Made Prior to July 28th Unparalleled Accident. Fog Shrouded the Top of the Building on the Day the Plane Crashed Into the Building, Making General Views of Crash Area Impossible

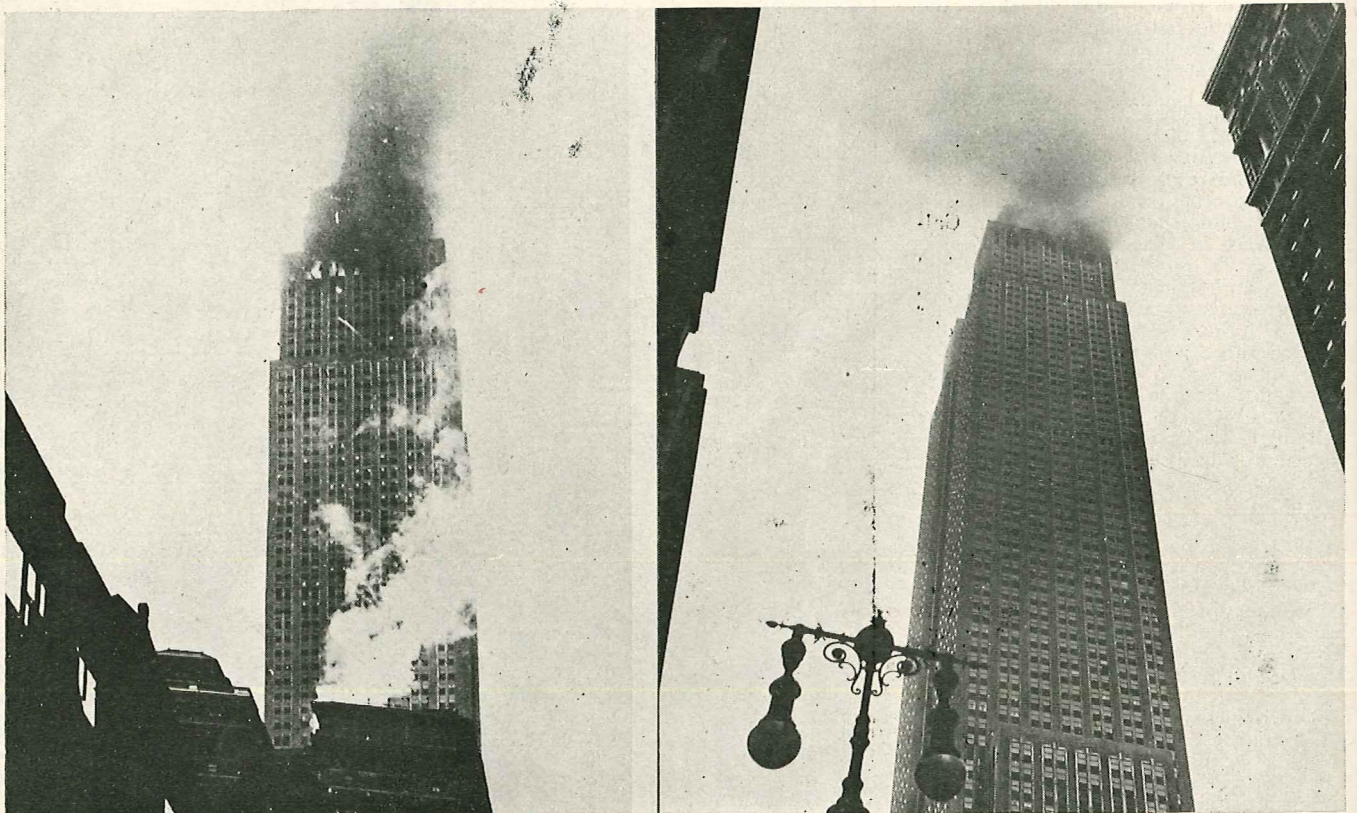
Cascading torrents of flaming gasoline poured through the seventy-eighth and seventy-ninth floors, setting fire to everything that was combustible. Burning fuel ran down stair wells into hallways as far as the seventy-fifth floor, as well as down the face of the building. Choking fumes and smoke rose upward to the conservatory, 1,050 feet above the street. Roofs of adjacent buildings sprouted fire and smoke.

Two Views of the Empire State Building Fire. Left: Shortly After the Bomber Crashed. Smoke at Bottom Is from Neighboring Building Where Fire Was Started by Falling Debris. Right: As the Fire Was About Under Control.

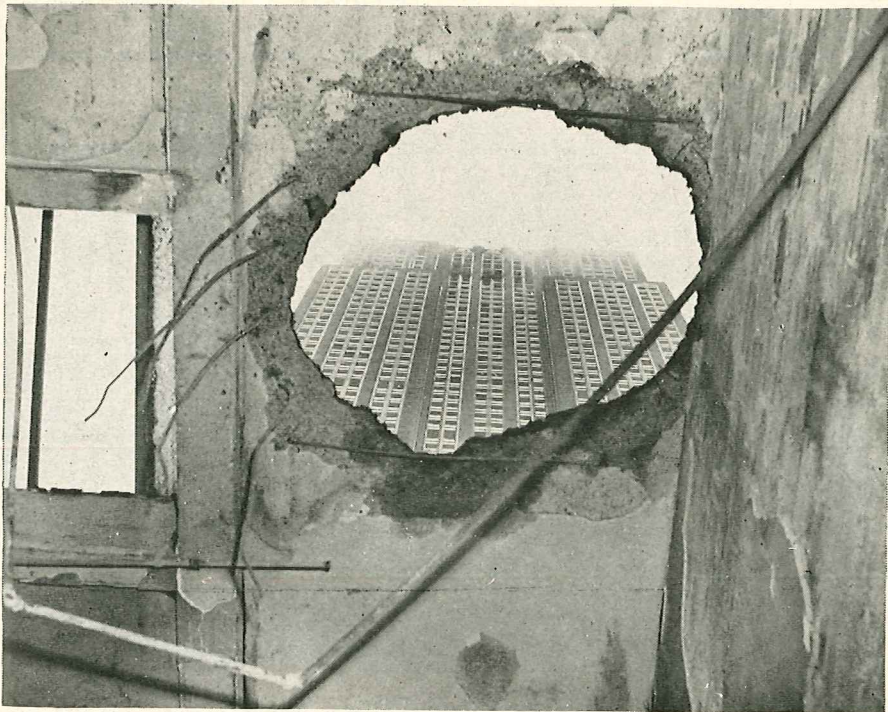
One motor, which tore clear through the seventy-eighth floor to fall on the twelve story office building at 10 West Thirty-third street, started a fire which demolished the penthouse of Henry Hering, noted sculptor, with resulting damage estimated at \$75,000. The other motor and part of the landing gear crashed into one of the elevator shafts, where they fell to the sub-cellar, 1,000

This Odd View Was Taken Through Hole in Roof of Penthouse on 33rd Street, Across the Street from the Empire State Building. Part of the Crashed Plane Landed Here and Set Penthouse Afire
