**Oakland Fire Department
Origin and Cause Report**

Incident # 2016-085231

December 2, 2016

1315 31st Avenue

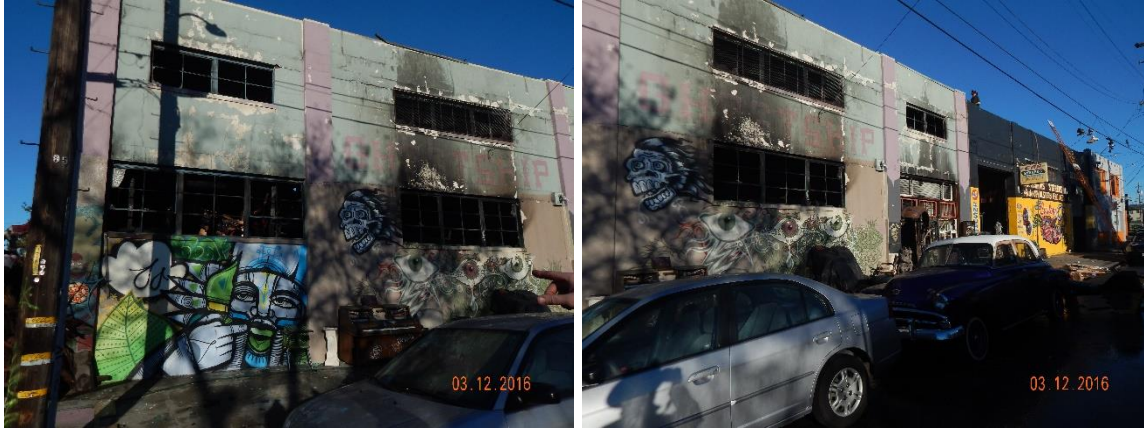
The front of the structure faced 31st Avenue. The exterior wall of 1315 31st Avenue was partitioned into 3 vertical sections, running from top to bottom. Windows were present in each section, on the first and second floors, with the exception of the east section that contained a metal roll-up door, with windows above. The roll-up door contained a man-door. No intact glass was present on either level. There was smoke staining above the windows in the middle section on the first and second floors as well as above the roll-up door. There was minimal smoke

staining above the windows in the east section on the second floor. Minor smoke staining was noted above the windows in the west section of the wall. (See photos below for the layout and location of the openings in the south wall of the structure.)

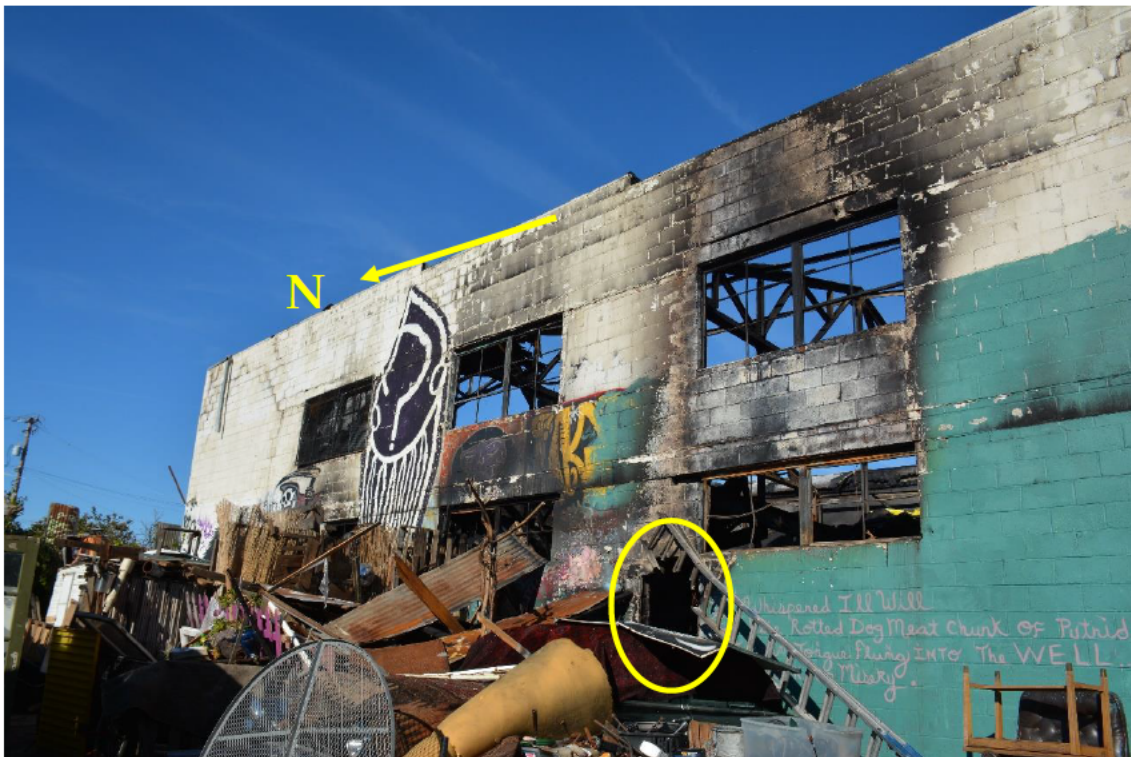
A single door-opening (created by removing concrete blocks from the wall) was present along the ground floor, at approximately the midway point (see below-circled). Fire and smoke damage was heaviest above the middle windows on the 1st and 2nd floors. (see photo below)

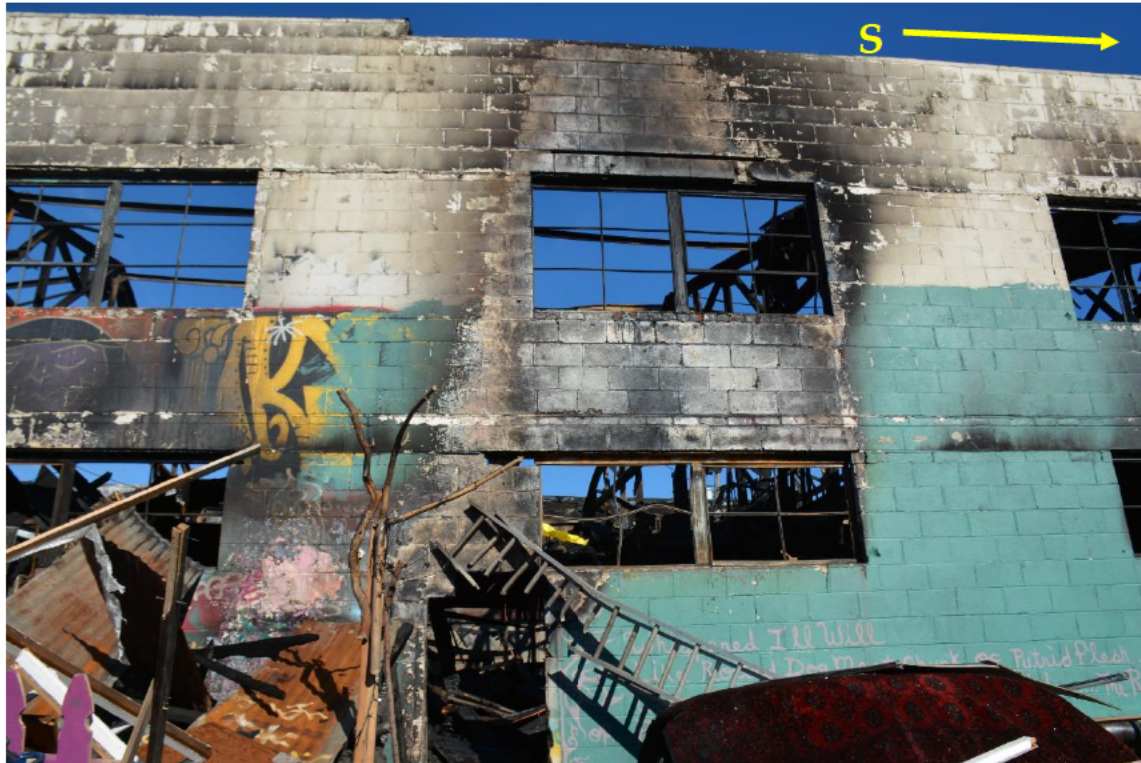
Additionally, the fire pattern above the single man-door intersected with fire patterns around the windows above and slightly to the right of the doorway.
(see photo below)

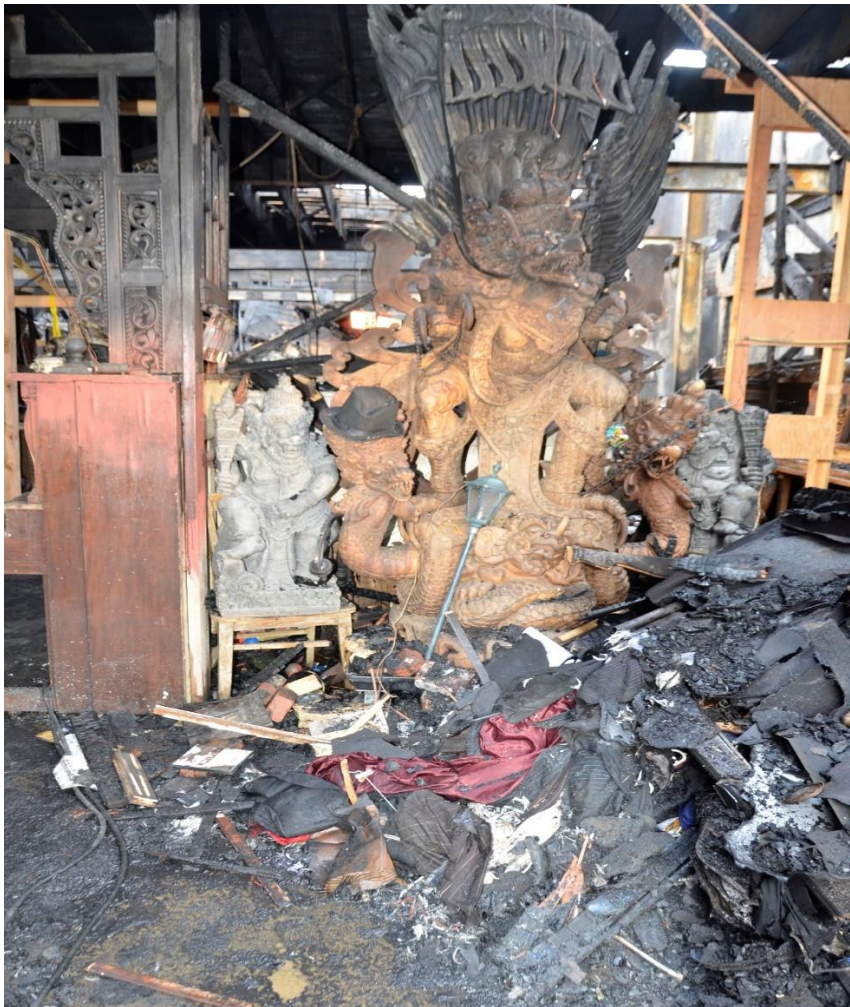
On December 3, 2016, entry was made into the 31st Avenue door opening. Directly inside was a large wooden bird-like statue (see photo below.) The statue was intact but sustained heat damage at its top. This statue created an impedance to movement and directed entering occupants to the left. To the left (west) was the room the tenants describe as the kitchen area. This room sustained some heat, soot and water damage but was in relatively good condition. To the west of the kitchen were living spaces.

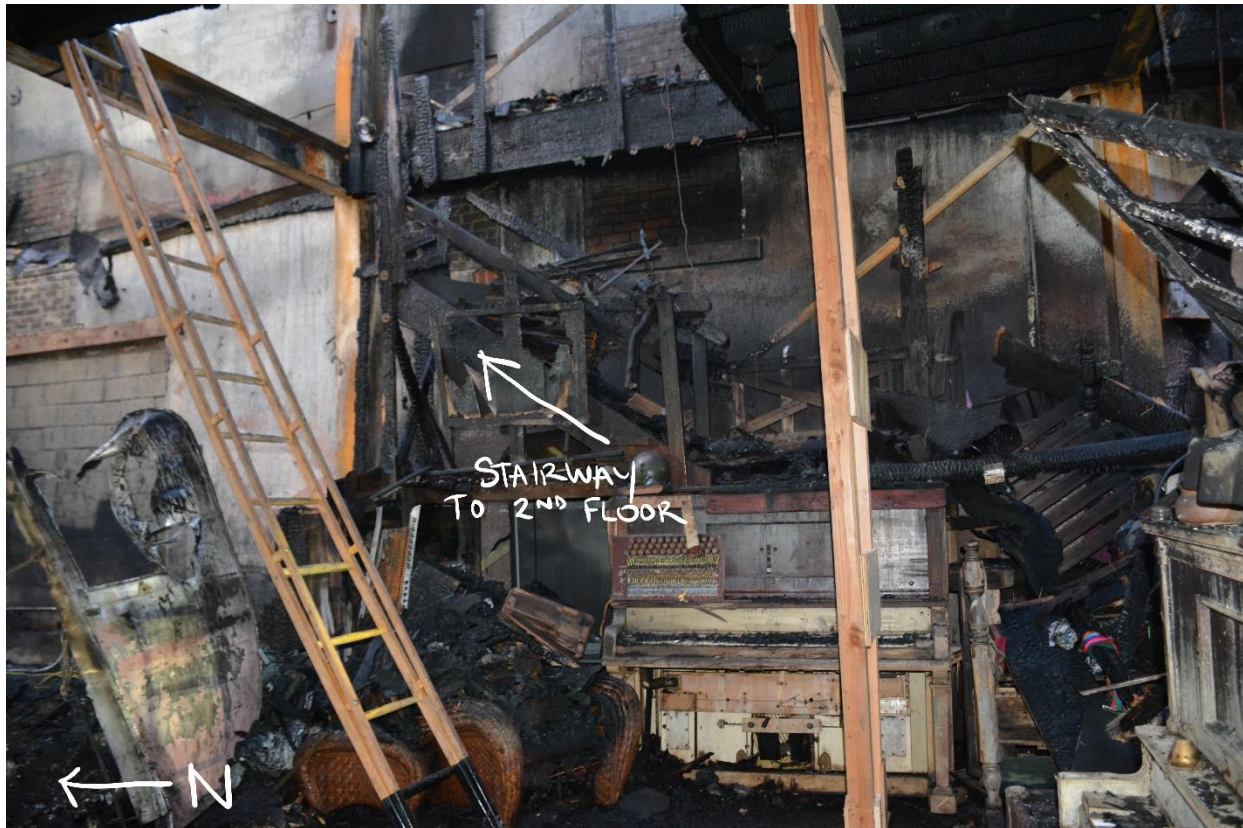
To the north of the door opening, left of the statue, was a passageway lined with pianos and other items. These items exhibited some heat damage to upper portions of the contents but the lower level items (pianos, wooden benches, chairs) were intact. To the east was location of the front (south) staircase to the second floor. The bottom steps to the mid -section of the staircase were intact. The upper section of the staircase and the second floor surrounding the staircase had collapsed onto the first floor. (see photo below)

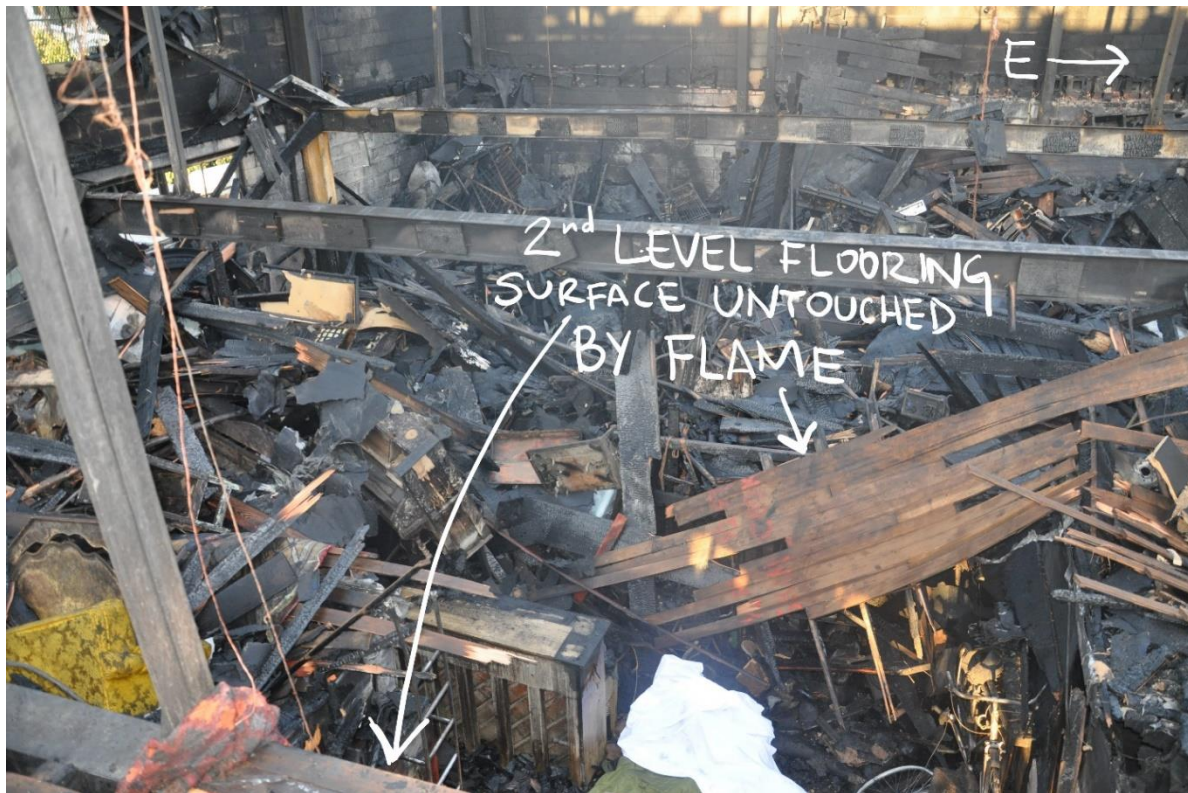
The motorhome on the east wall was also beneath the collapsed 2nd floor and its contents. The 2nd floor surface of the wood flooring was unburned. However, the sub-surface (ceiling of 1st floor), exposed to the ground floor, was charred. (see photo below) The motorhome aluminum sides were intact with paint present. The rear of the motorhome had the most damage due to collapse of the 2nd floor. The front of the motorhome, which faced the west wall, had a wooden pallet vertically mounted to it and a bike mounted to the pallet. The top of the pallet was charred approximately a third of the way down. The bicycle seat was consumed and there was melting to the top exposed rubber of the tire but the rest of the tire was in good condition. Another bicycle was leaned up against the motorhome; this bicycle was in good condition.

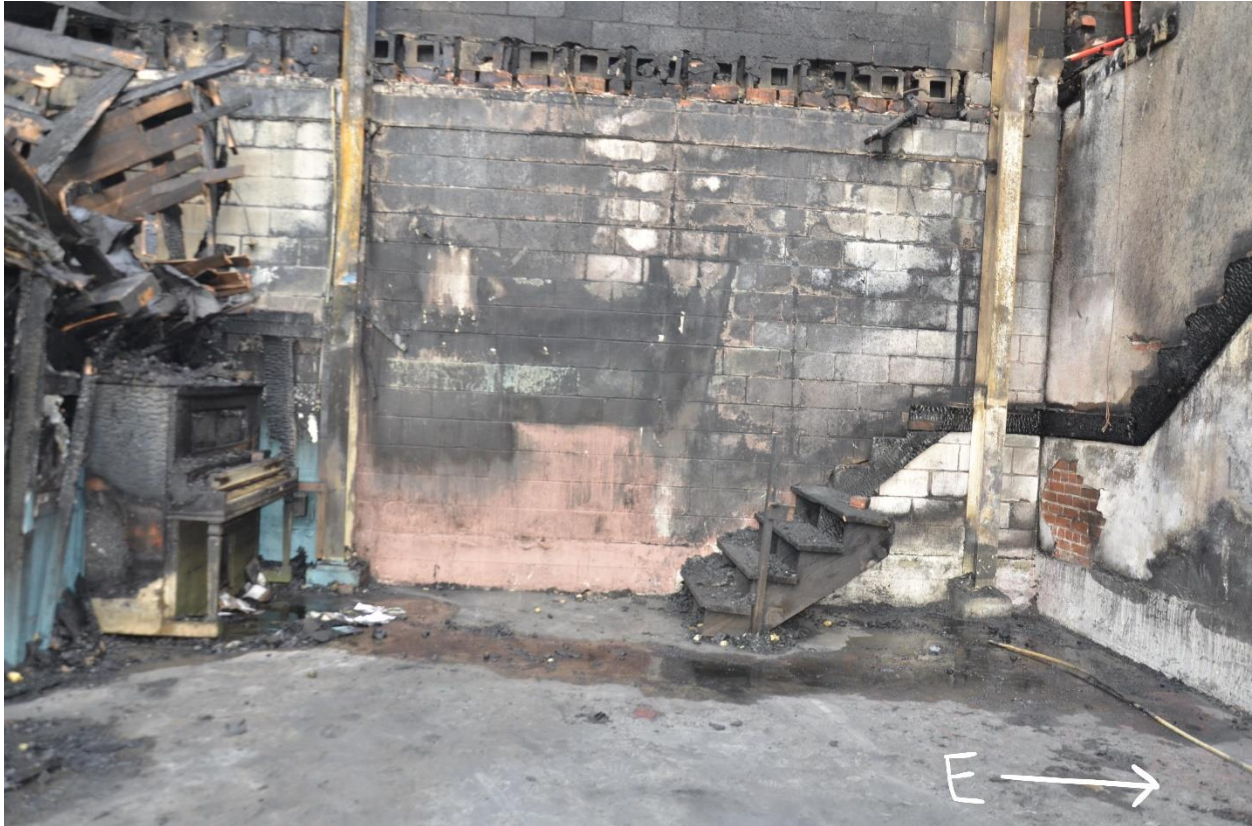
Investigators began to clear the area to the east of the platform making their way to the rear staircase. This area sustained extensive damage. The roof and second floor had collapsed into the area resulting in charring to wood members and furnishings. It was noted that during suppression efforts, this portion of the building was most difficult to access. Investigators cleared the area leading to the rear (north) steps finding the first four steps intact and in good condition. The remaining steps were consumed. (see photo next page)

Along the north wall, to the west of the steps, investigators examined a leather booth and a piano. The top leather of the booth sustained heat damage exposing the cushion material. The seat of the booth sustained some heat damage and was less damaged than the back and top of the booth. The rear of the piano rested against the travel trailer that was perpendicular to the north wall. The piano sustained heat damage with considerably heavier damage to the top than the bottom. (see photo next page)

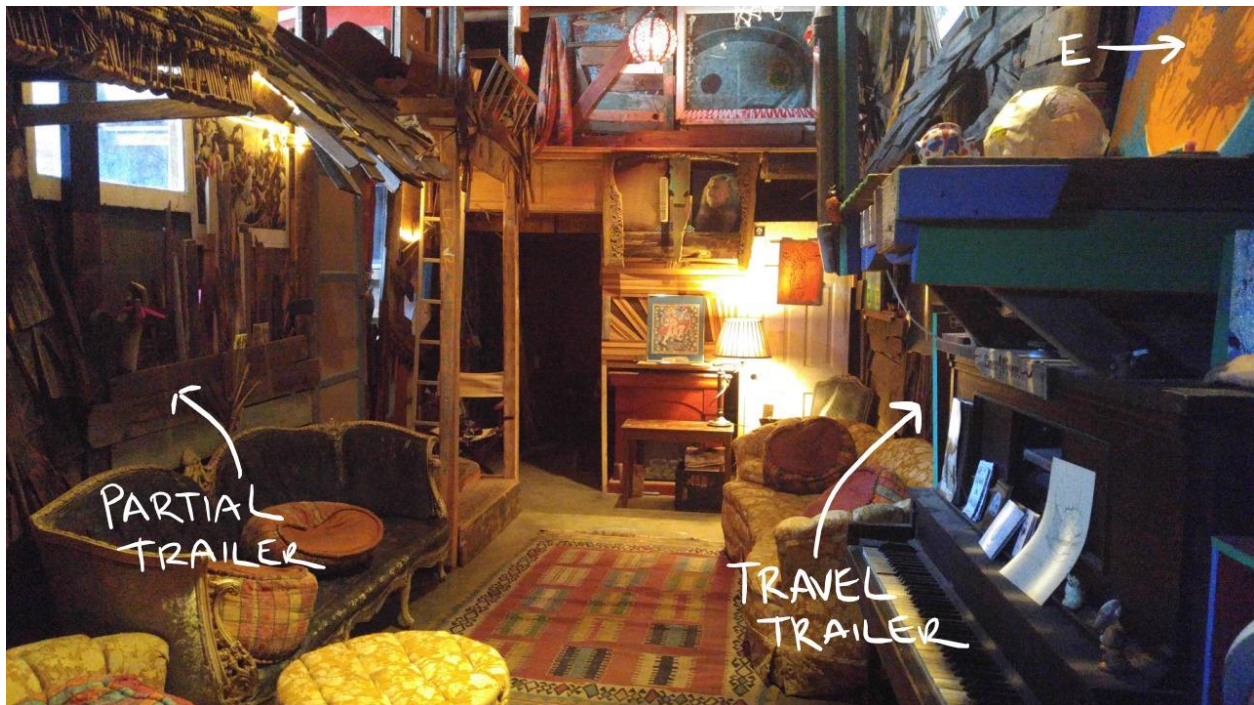
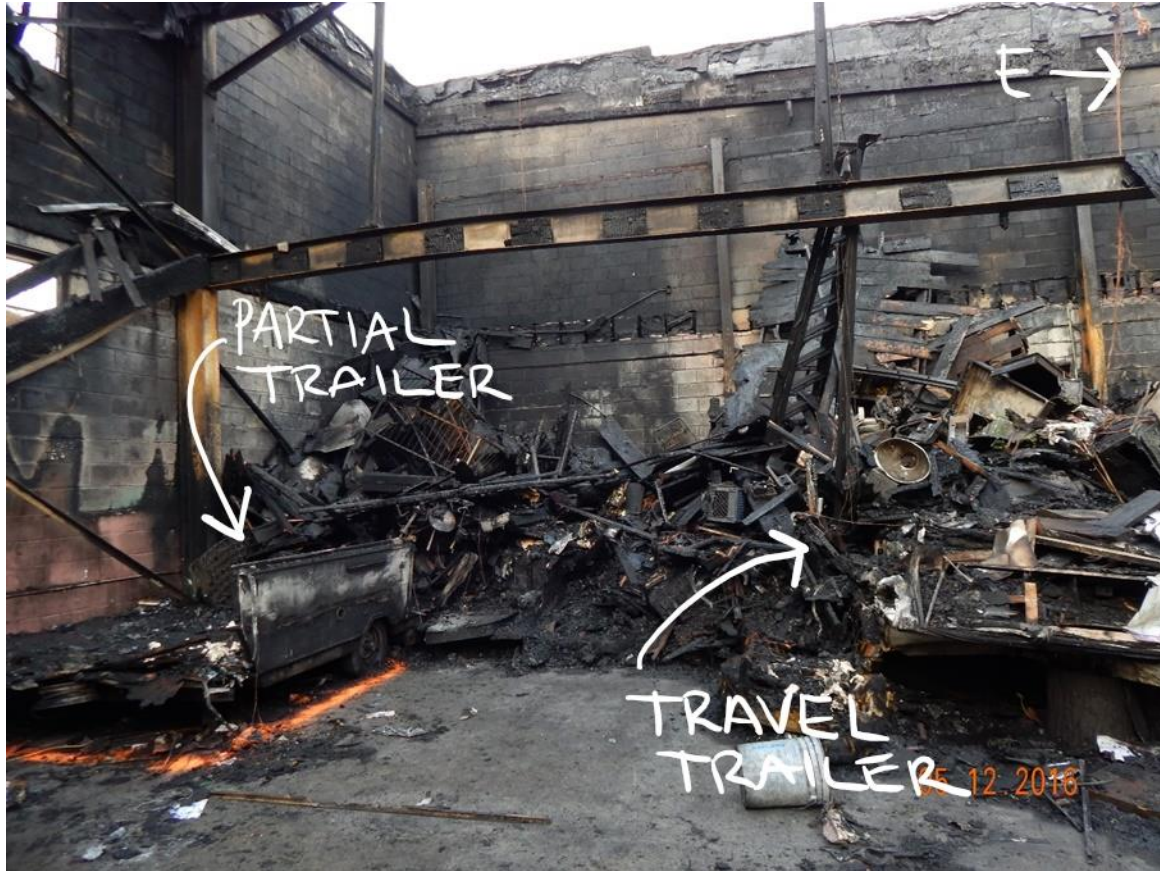
Next to this living space was a partial travel trailer, altered by previous tenants to customize the layout of the space. Reportedly, the south wall of the trailer was removed and replaced with a wooden wall that extended to the ceiling of the first story. The partial travel trailer sustained extensive fire damage. In addition, the roof and 2nd floor had collapsed onto it. Investigators identified and processed the space between the partial trailer on the west wall and the travel trailer against the north wall. Previous information from interviews indicated this was a lounge area. Witnesses had reported seeing flames in this area during the early stages of the fire. This space sustained extensive fire damage. Couches found in this area were more heavily damaged on their upper portions compared to lower portions. (see comparative photos below and next page)

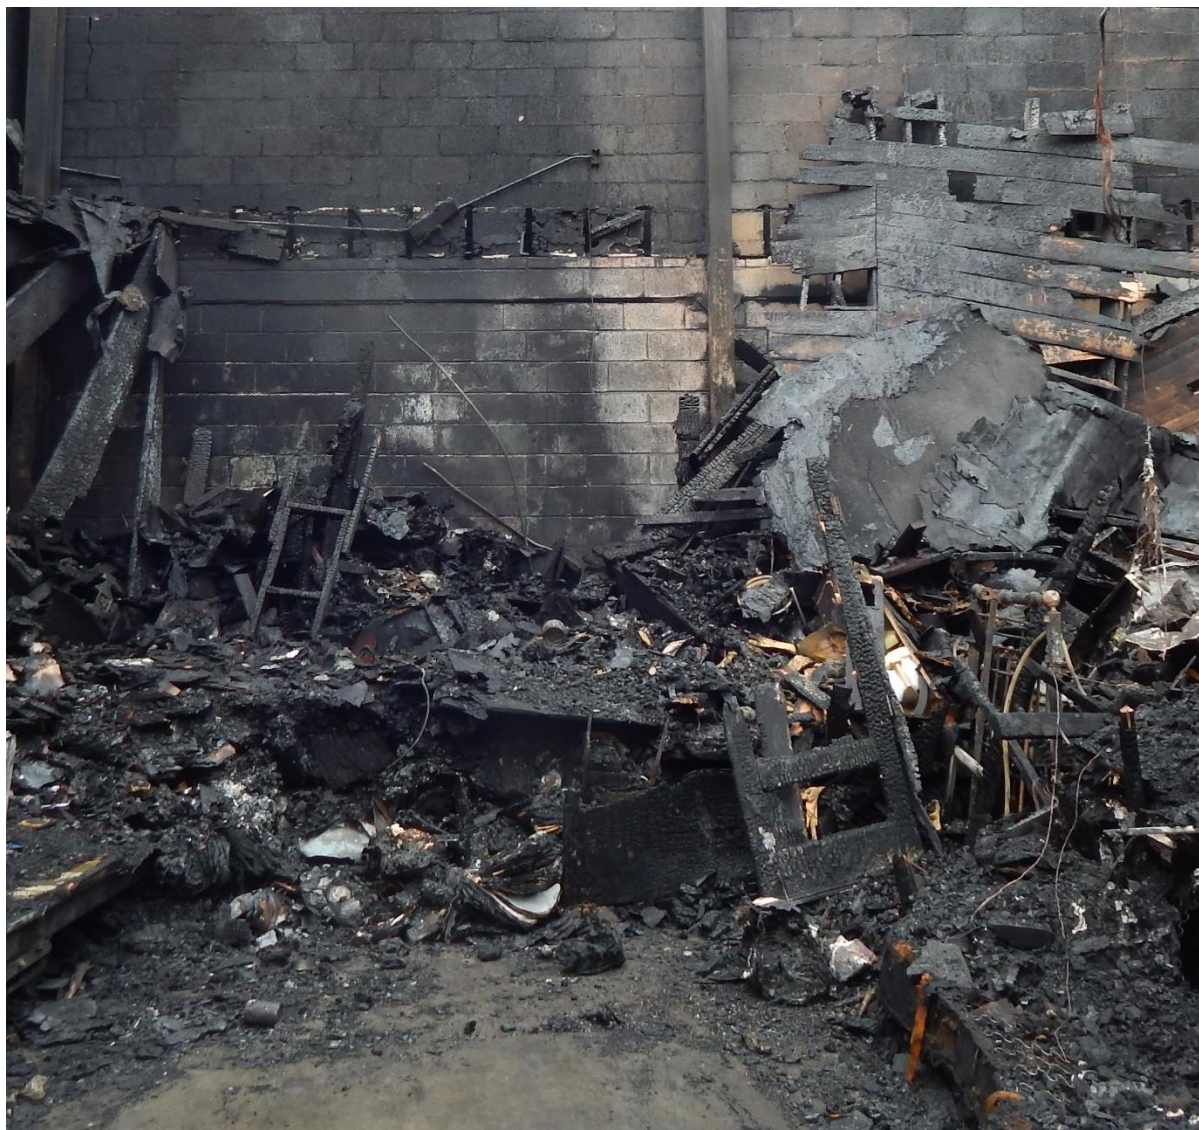
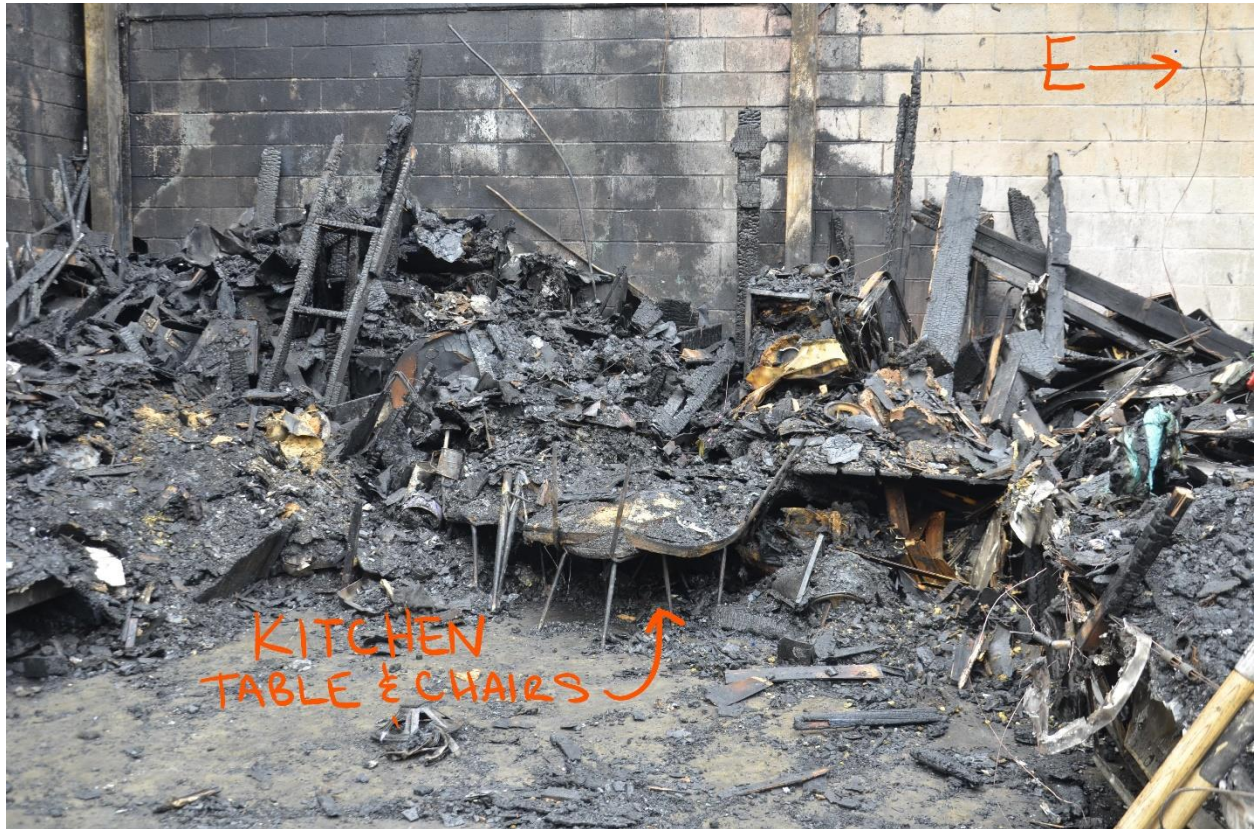
A makeshift wall that reportedly separated the lounge area from a living space located against the north wall of the building was consumed. A section of the door that accessed the living space was located in the debris. The door was heavily charred. (see photo below)

Directly inside the living space along the north wall, investigators removed debris, layer by layer, to uncover a kitchen table and chairs. The table had collapsed onto the metal chairs. The backrests for the chairs were consumed. Wood beneath the chairs' cushions was present but the majority of the cushion material was consumed. (see photo next page)

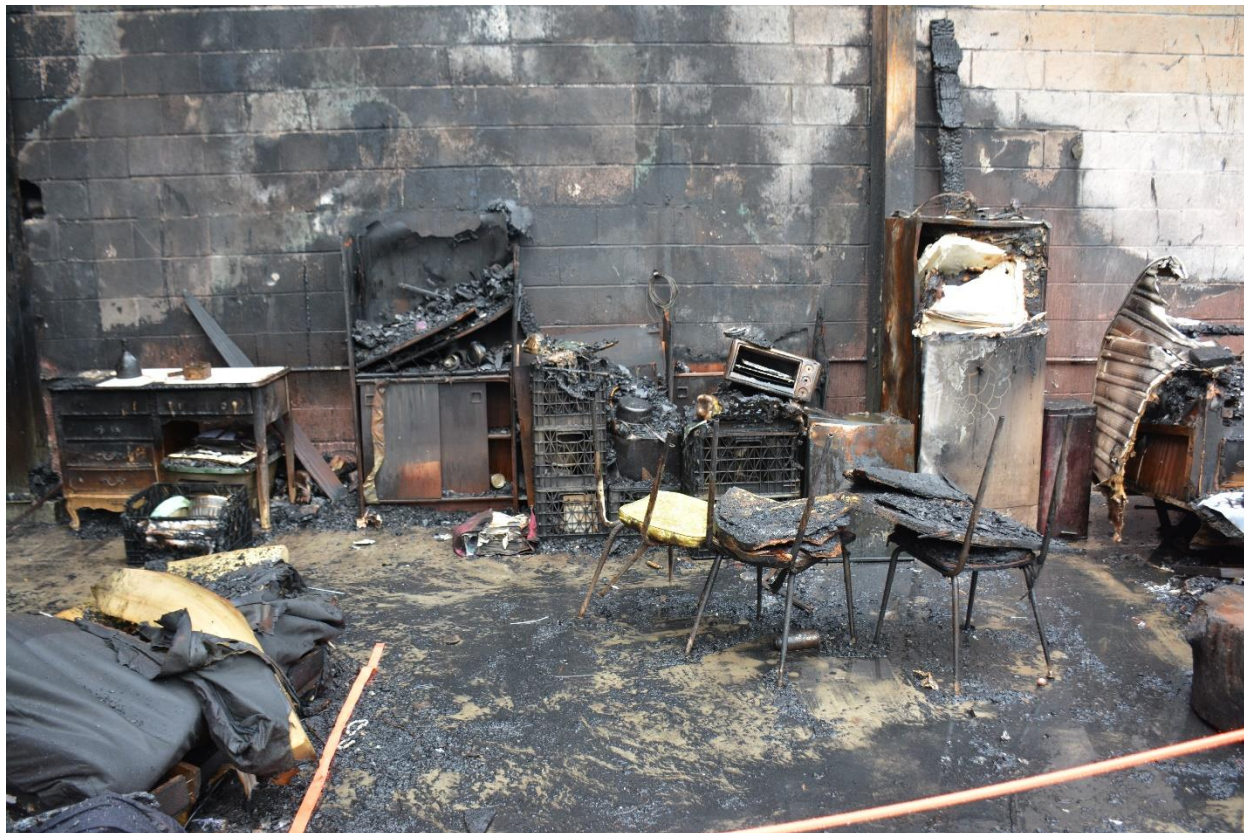
To the left of the refrigerators were several milk crates containing kitchen items. The milk crates were mostly intact. Behind the crates were two wooden storage cabinets placed against the north wall. The tops of the storage cabinets exhibited fire damage that diminished with proximity to the floor. (see photo next page)

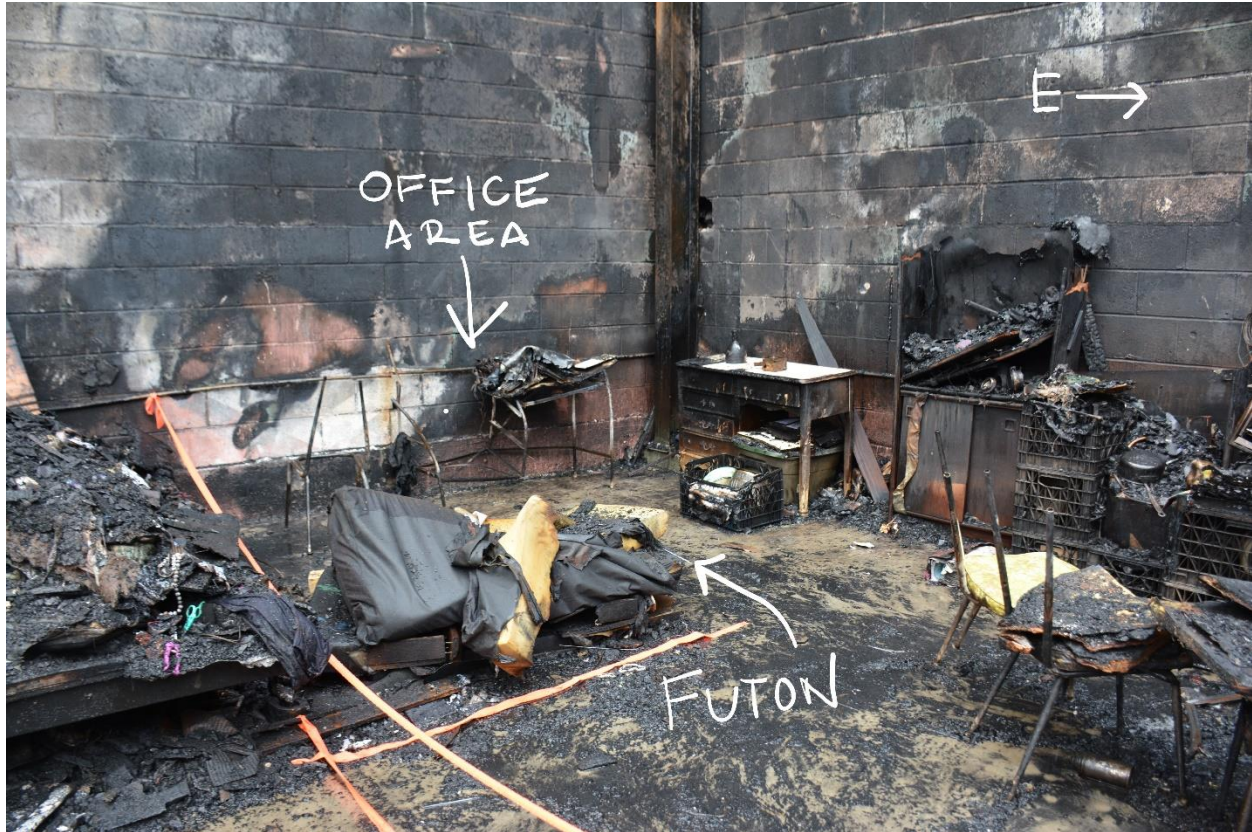
Scene examination resumed in the area west of the kitchen. The tenants referred to this area as an office. The building's second floor and roof had collapsed into this area. The area was examined layer by layer. Investigators found the remains of a makeshift wall, which separated the kitchen area from the office area. In the debris in front of the kitchen side of the wall, a metal duplex receptacle was found. The receptacle box had sustained extensive fire damage leaving only the metal components remaining. The occupants stated that electronics from the office were supplied by this receptacle. On the office side of the wall was a small futon couch. The couch was in good condition with the cloth and cushion present. (see photo below)

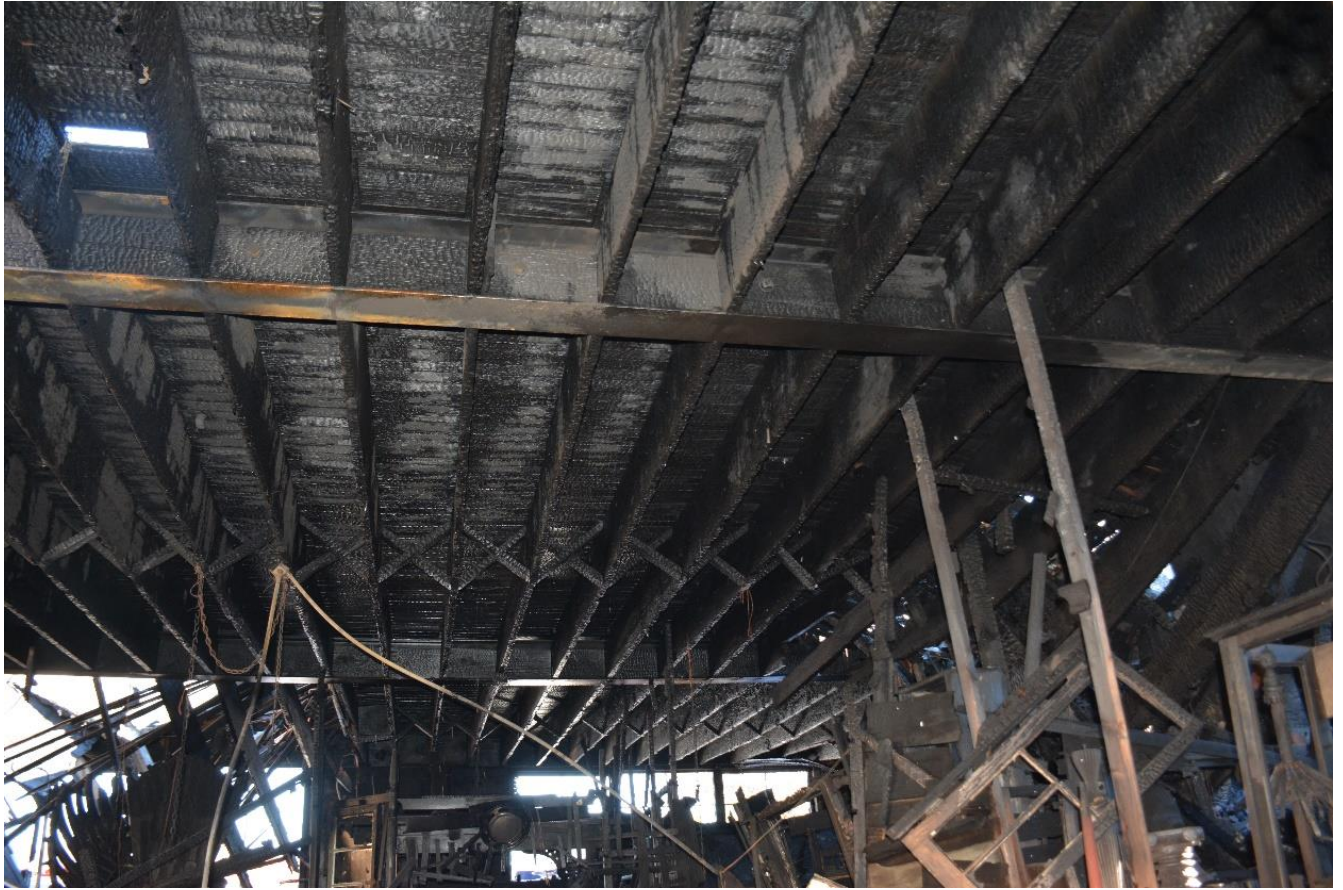
The second floor was of wood beam construction; its underside, the ceiling of the ground floor, was open wooden studs, with no drop ceiling or other partition present. (see photo next page) More severe charring was observed to the underside of the second-floor (i.e. ceiling of the first floor.)

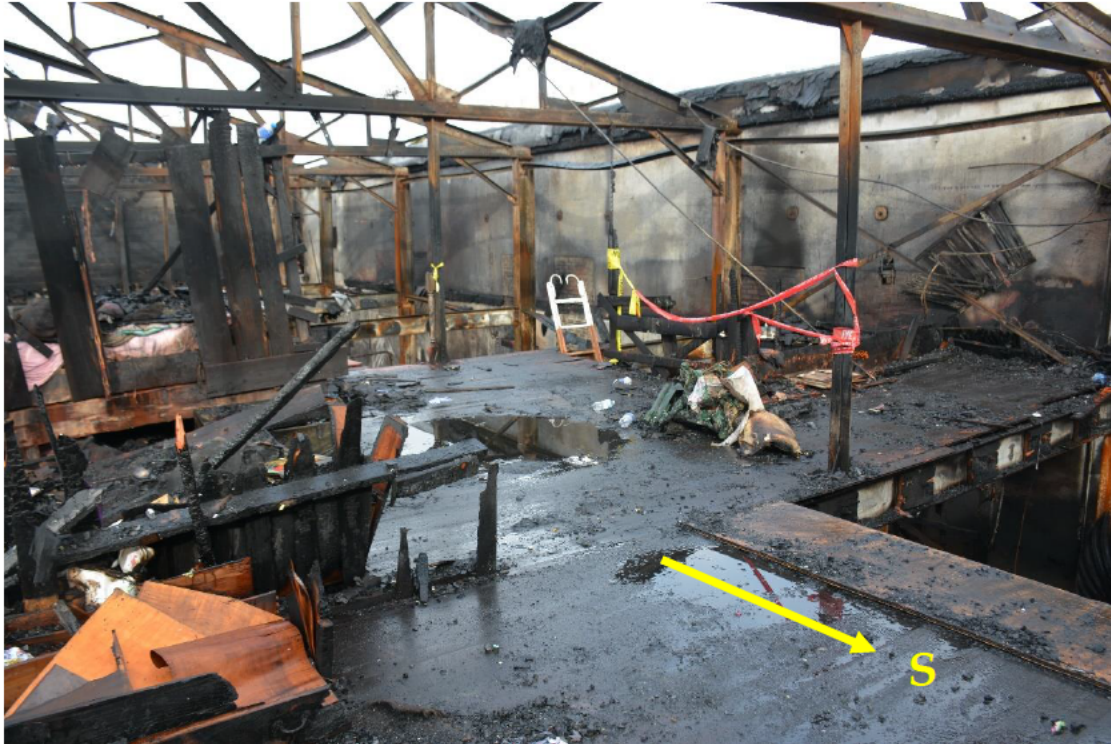
The upper wooden surface of the remaining second-floor was not as charred as its underside (see photo next page). Of the remaining intact portions of the second floor, investigators observed burn damage to be from bottom up. Some areas of the second-floor wooden members were minimally fire damaged, having been protected by either large carpets and furniture, or from roof collapse. The second-floor completely collapsed in the rear half of the structure (north). Fire investigators observed less damage to the structure as distance from the rear portion of the building increased.

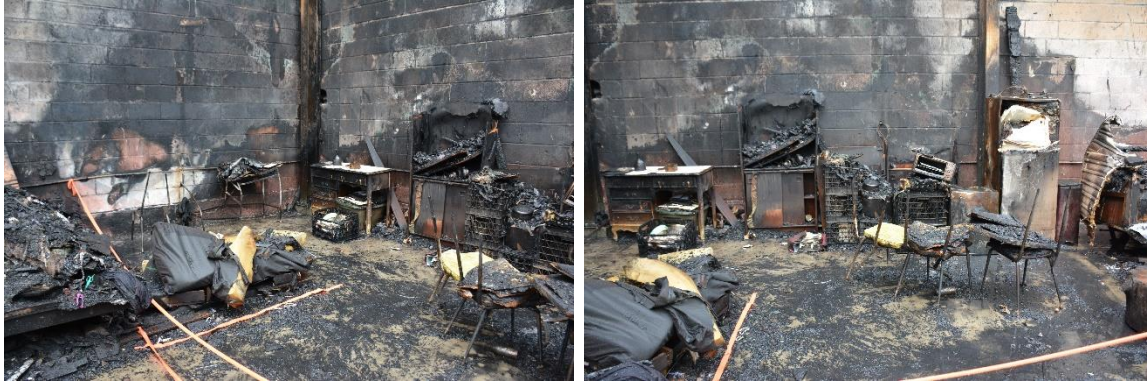
Investigators observed that items in the northwest corner had less fire damage at their lower points that were closest to the ground (see photo next page), and areas of pink paint were still visible on the concrete block walls. A wooden chest and storage cabinet were minimally fire damaged toward ground level, as were plastic crates to the east. All exhibited more fire damage above floor level. This was similarly observed on a dorm-sized refrigerator and a full-sized refrigerator along the north wall and east of the crates. (see right photo next page) Fire damage on the refrigerators was concentrated up high, versus down at floor level. An area of clean burn

was observed along the west wall, several feet from the northwest corner. (see left photo below)

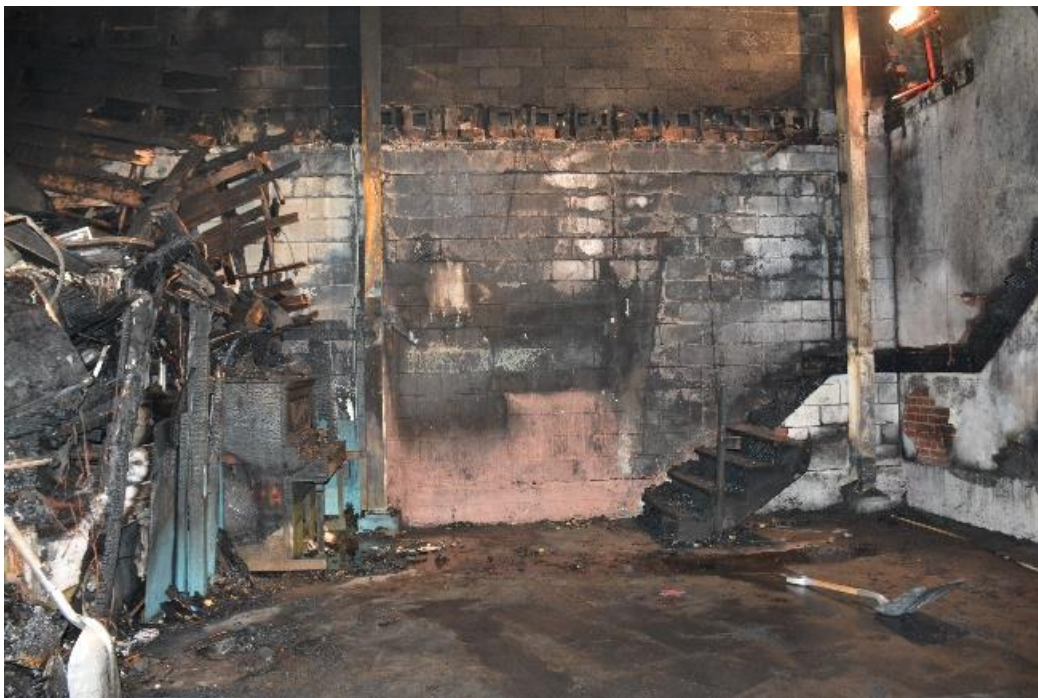
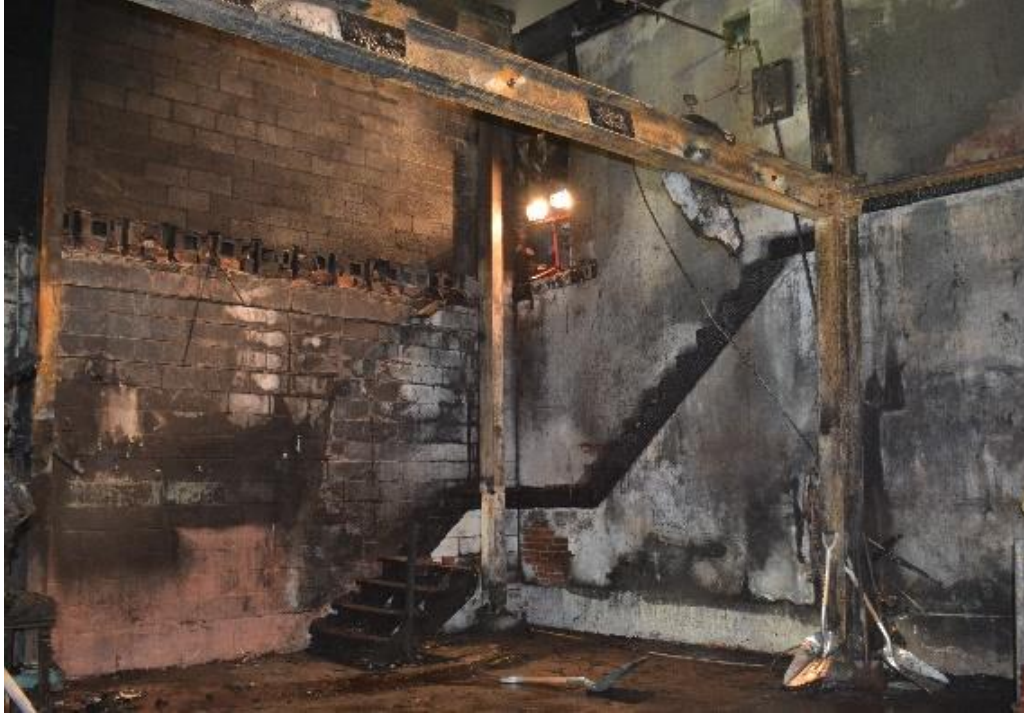
Once the northeast corner was cleared of debris, investigators observed remnants of a rear wooden staircase ascending the north and east walls. (see photo next page) Soot deposits were observed upon the concrete block north and east walls around the staircase. However, the first four wooden stairs were still in place, and in this same area (to the west of the stairs) a portion of pink paint was still visible on the north wall. Additionally, more fire damage was observed several feet above floor level, and extending upward. Less damage was observed to items down low, including a decorative piano and pieces of wood to the west of the stairwell. Blue paint was still visible on the lower portions of the pieces of wood. Yellow paint was observable on the piano. (see photo below)
