Main Street Memo: Bathroom Floors

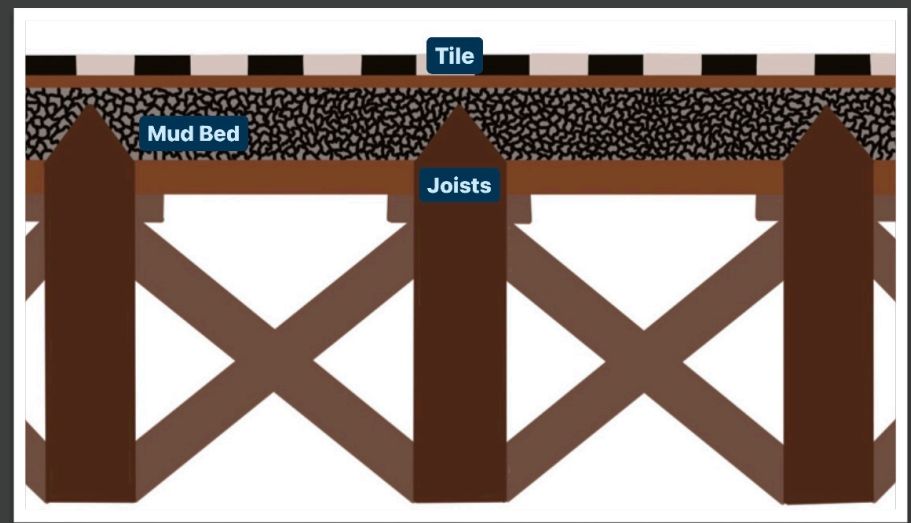
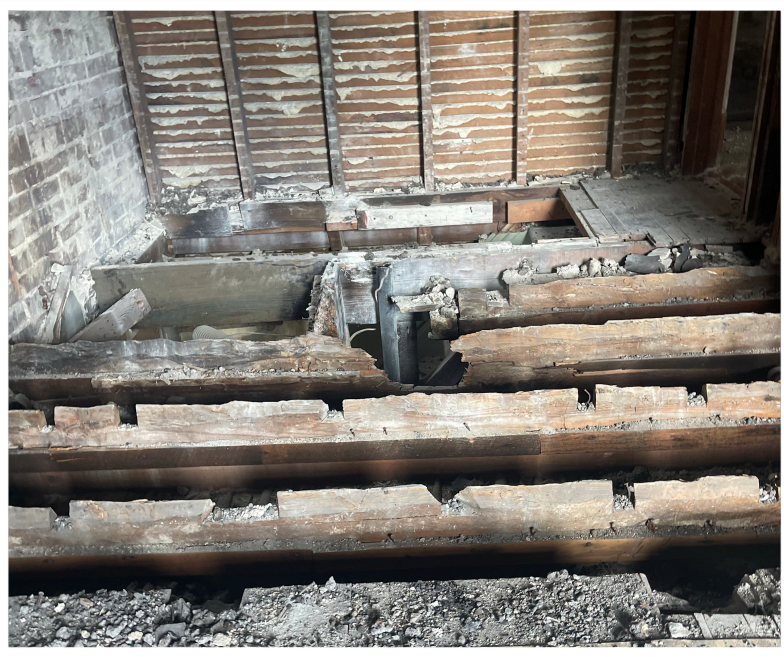
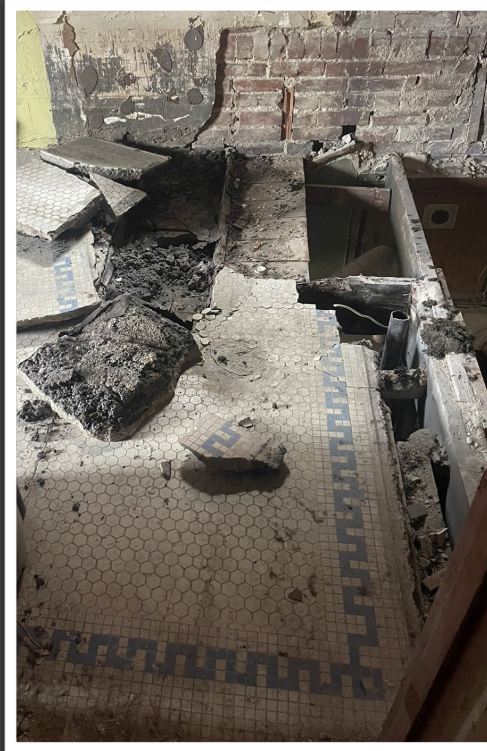
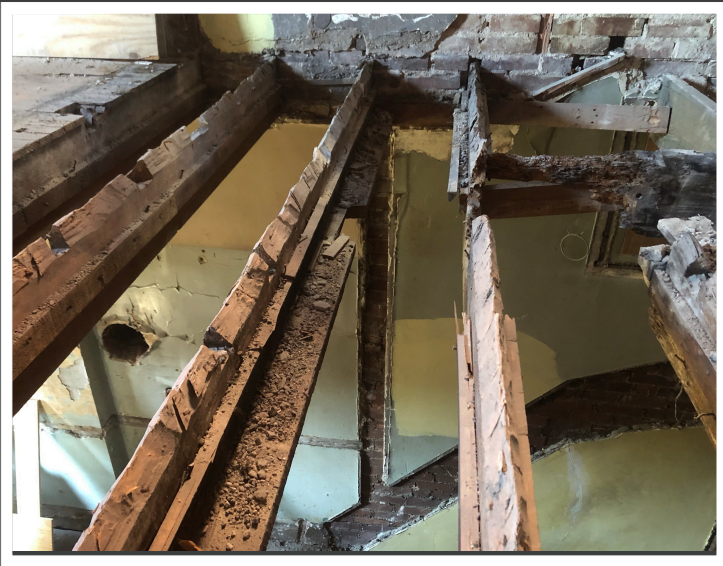
- ▶ Found in tiled bathrooms over wood joist construction in buildings built prior to 1940.
- ▶ The mud bed and chamfered joists was to allow even tile placement.
- ▶ Joists were notched and chamfered which weakened the floor assembly.
- ▶ 3-5" of mud set added significant weight which posed a collapse hazard.
- ▶ Due to tile, sounding is not a reliable technique to assess floor integrity.
- ▶ Due to thickness and tile, TICs are not reliable in detecting heat signatures.
- ▶ Years of water damage would commonly rot joists under cast iron tubs.
- ▶ Legacy tiled bathrooms pose an incredible collapse hazard due to a culmination of aforementioned factors. Use extreme caution when overhauling.
