Construction Concerns: Residential Stairways Article and photos by Gregory Havel March 8, 2010

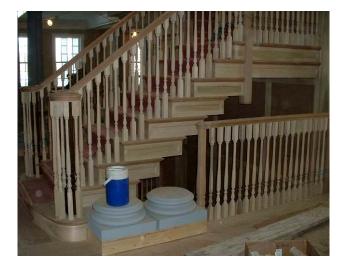
Photo 1 (*below*) shows an open stairway between the floors of a large house. It is built with the following:

- wood stringers (the beams that support the stairway, one on each side and sometimes one or more in the middle);
- hardwood boards for *treads* (the walking surface of the stairway);
- plywood for *risers* (the panel that closes the vertical space between the back of one tread and the front edge of the next tread above);
- hardwood *banisters* (the handrail on an open stairway);
- and hardwood spindles (the

vertical supports filling the space between the banister and the stair treads).

Photo 2 shows the underside of the stairway in photo 1 before it was enclosed and the wood trim attached. The stringers are Douglas-fir planks, with double stringers on the sides. The treads and risers are attached to each other and to the stringers with screws and construction adhesive. This stairway was designed and built to be sturdier than many are today, or were in the past.
