Fire in the Empire State Building

BY BRUCE HASSETT

FIRE REPORT

EMPIRE STATE

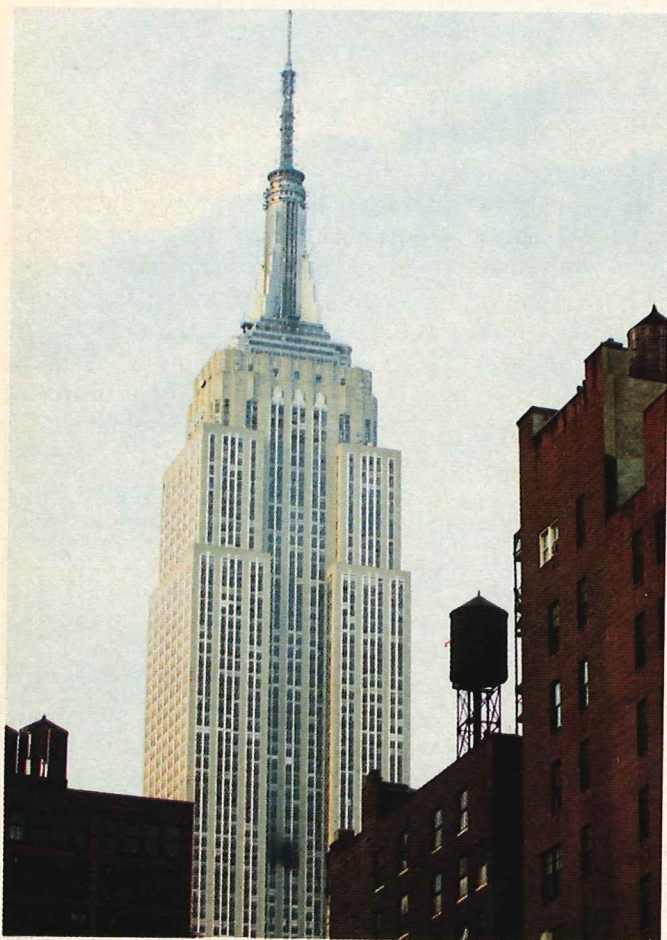
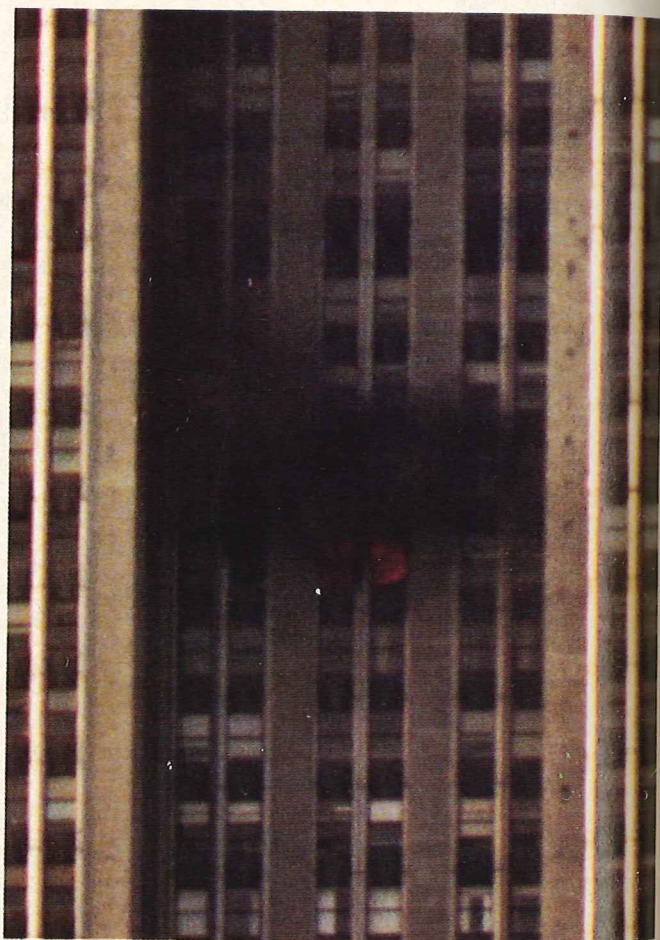
Fortunately the building's heavy, fire-resistive construction features and floor area compartmentation contained the fire long enough for suppression forces to extinguish it. However, convection currents blown from the oven-like fire suite, through an interior corridor, and into the fire tower air shaft made advance on the fire extremely difficult. Communication to occupants above the fire floor was impeded because the building's public address system was inoperable. A painstaking search of the 35 floors above was a long and arduous process. (Photos by Dave Cantor.)

● The heavy, old-style construction was a major factor in confining the fire to the area of origin. The Empire State Building, at 23 pounds per cubic foot, weighs about three times more than the typical skyscraper of today. Built on a steel skeleton, its exterior walls are constructed of eight inches of brickwork; its wall columns are eight inches of limestone backed with eight inches of brick; its floors are three inches of cinder fill on four inches of concrete topped with a cement finish; and its steel beams and interior columns are protected with thick concrete fireproofing. Although the fire melted the exterior windows and there was some smoke damage to the floor above, vertical extension via autoexposure was not a serious problem because of the integrity of the outer walls and building facade.

Furthermore, horizontal extension was inhibited because the fire floor was compartmentized. Office spaces were enclosed by the solid masonry walls. Although this creates oven-like conditions within the fire area itself, it certainly is preferable to the rapid fire extension that occurs in large, open floor spaces such as are found in many of today's high-rises. The 51st floor contained 11 occupancies, the largest of which was 5,205 square feet. Compartmentation is particularly important in high-rise buildings due to the limited opportunities for horizontal ventilation and the practically nonexistent opportunities for vertical ventilation.

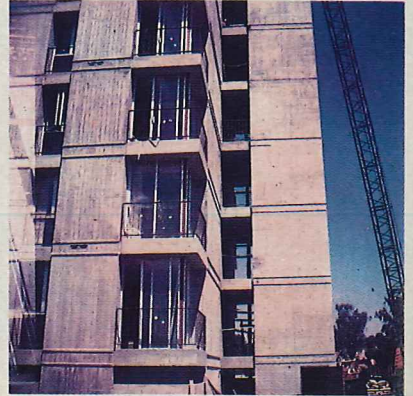
A California university installed this excellent exterior fire tower on dormitories.

Short of adequate horizontal exits the exterior, smokeproof tower with an atmospheric break remains by far the best exit from a high-rise.

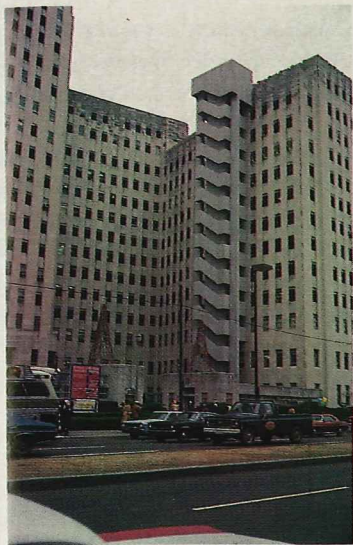
This outside fire escape was added to a New Orleans hospital when interior exits were found to be inadequate.

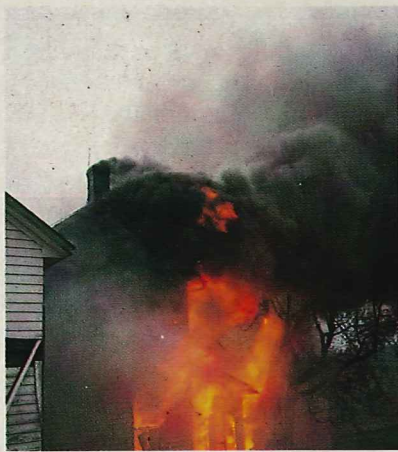
This fire is "free-burning" on the first floor. Directly above, huge quantities of toxic smoke are being generated from the degradation of heated material.

There is no such thing as a clean-burning fire in ordinary combustibles. All around the fire combustible materials are being degraded into toxic gases. Elmer Chapman, a former division commander in New York City's high-rise-loaded midtown and a recognized expert on
