October 17th of 1966 was a most tragic and mournful day in the history of the New York City Fire Department (FDNY). This would be a day that claimed the lives of 12 members of the department and touch the heart and soul of every member of the department.

There were Many Warning Signs

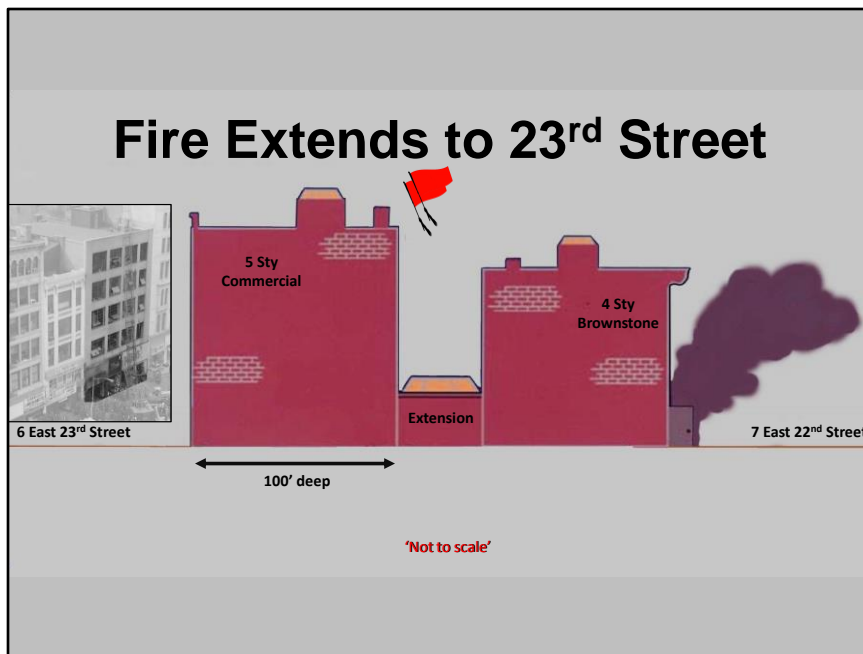
As fire operations would progress in 7 East 22nd street. The Deputy Chief would be advised that a fire alarm monitoring company, the Holmes Protective Company had received an alert at 9:46 PM and dispatched an employee to investigate the address at 6 East 23rd Street. Upon arriving and entering the first floor a light smoke condition was present. This information would represent another '**Red Flag**' of critical information. The Deputy would assign the Chief of the 7th Battalion and members of Ladder 3 to proceed to that address. Encountering no progress in the building on 22nd street with the possibility of fire extension into a building on 23rd street a **2nd Alarm** was struck. That would have Engines 1, 5, 18 and 33 respond. Engine 5 with a hose line accompanied by the members of Ladder 3 would proceed to the basement on 23rd street to navigate their way to a rear cinder block wall. They experience an odor that smelled like gas but no fire. They had no idea that this wall was only 65 feet deep into the occupancy. It was discovered after the tragic event that the Art Dealer from 22nd street breached the rear basement wall of the 23rd street building for the purpose of enlarging their workspace to manufacture picture frames that would be finished with volatile paints and lacquers.

A Deputy from Division 1 would assume Command on 23rd street. Engine 18 would be instructed to stretch a hose line into the 1st floor Wonder Drug store accompanied by members of Ladder 7. They stretched this line to the rear 100ft/30m into the store because smoke was issuing from the floor molding atop what was a 5in/127mm layer of Terrazzo flooring supported by ordinary lumber floor joists. That is a mixture of crushed marble, quartz, granite, glass chips poured with a cementitious binder. This floor did not offer any indication of heat from the fire raging and degrading the floor joist below.
