Captain Joshua Laird  
Line of Duty Death (LODD)

**AFTER ACTION REPORT AND  
IMPROVEMENT PLAN (AAR/IP)**

**August 2022**

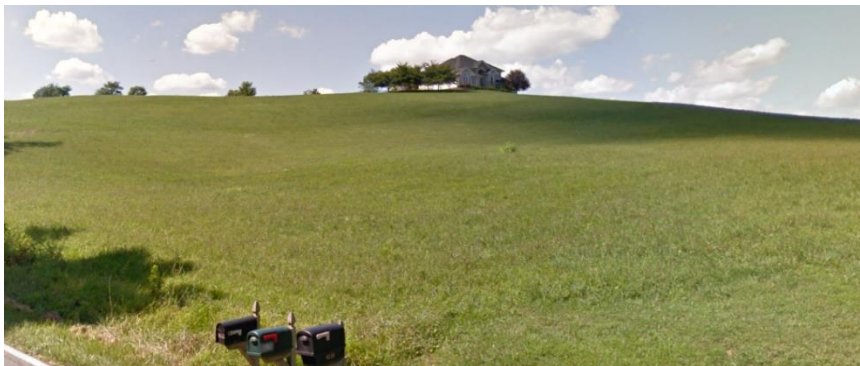
Figure 12: View from Ball Road depicting the 16% elevation change crews had to transverse.

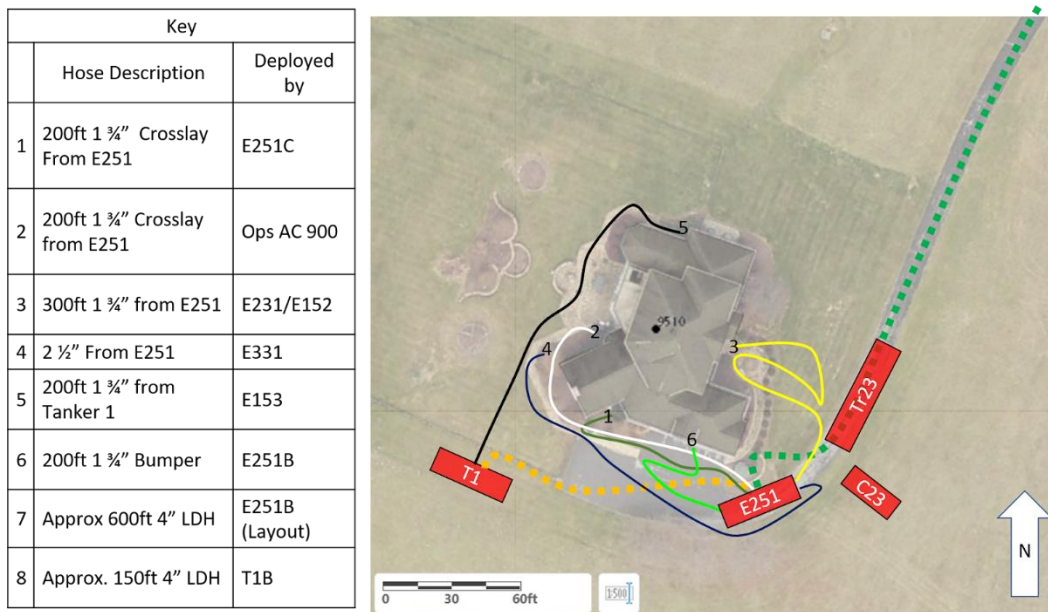
Figure 22: Hoseline deployment at fire scene.

Engine 251’s driver got out, wrapped the post with his supply line not leaving any appliances, got back in, and laid out approximately 500 feet to the residence. While providing his initial on-scene radio report, E251A requested a “RID” (rapid intervention dispatch: one engine, one special service, one ambulance, one Battalion Chief, and the DFRS Safety Officer) and a “tanker task force” (five tankers and one engine). The estimated fire flow before the Mayday was 300-400 gallons per minute (GPM) based upon the deployment of two 1 ¾” hose lines.

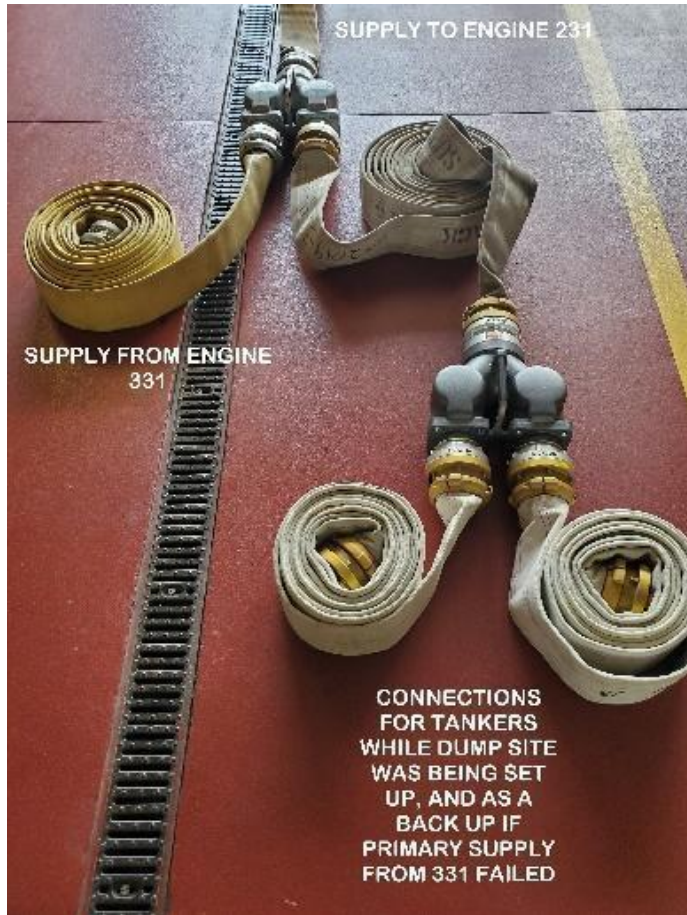
Figure 24: Siamese connections at end of driveway and Ball Road.

At the end of the driveway on Ball Road, E331B and T33 unloaded equipment from T33 necessary for the dumpsite. This included the Siamese from T33 and E331, two single-lane 2,000-gallon dump tanks, and hard sleeves. Two LDH Siamese were used to allow multiple units to connect to the LDH going to the fireground at one time. The setup of the two LDH Siamese appliances at the end of the driveway is depicted below.

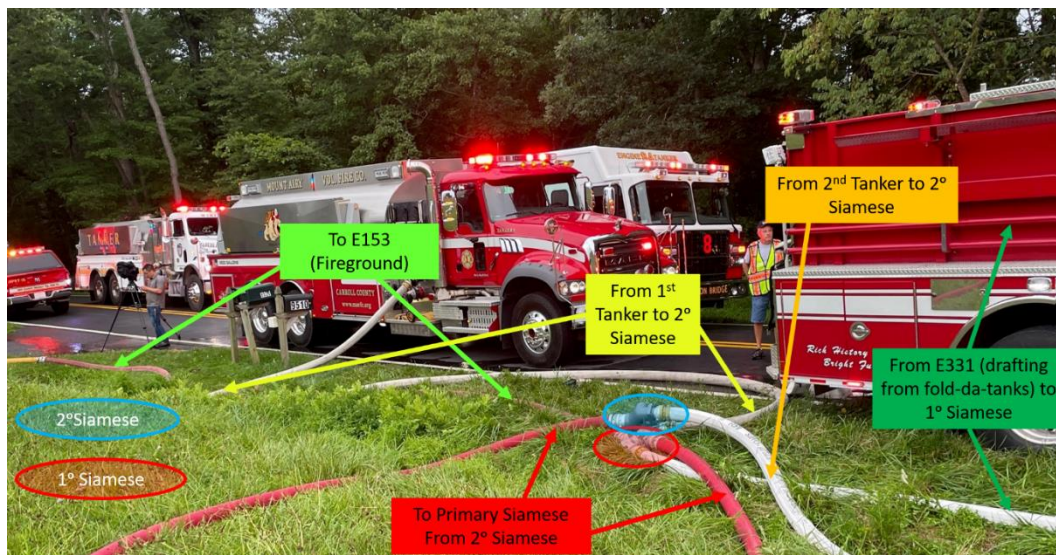
Figure 25: DH Siamese connections at end of the driveway with labels.

When the WSO arrived at the end of the driveway, he assisted T33B and E331B with making the hose connections to send much-needed water to the fire scene. Water was initially supplied to E153 by T33 and T23. E331 did not send their tank water to the fire scene.

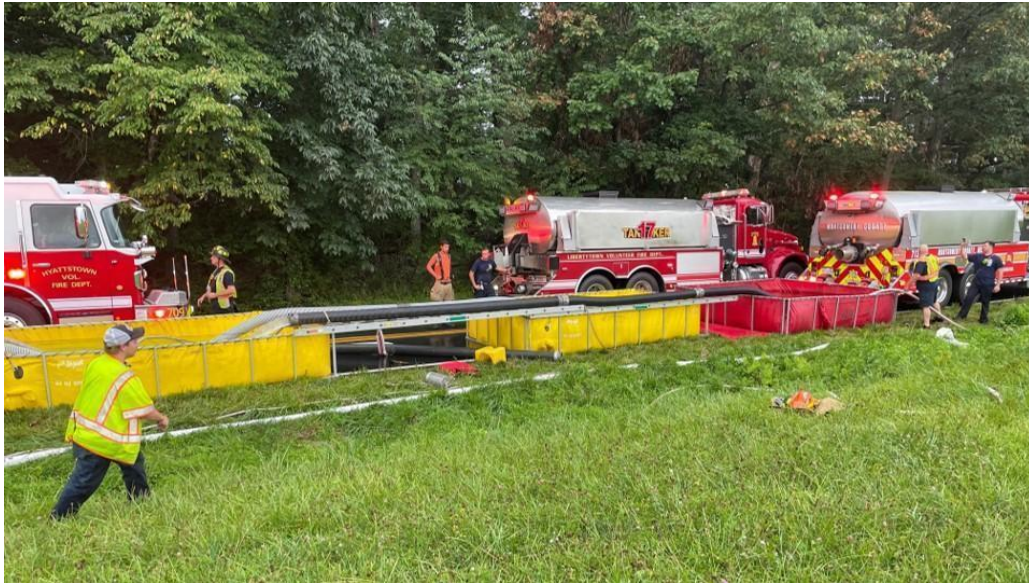
Figure 28: Water transfer between dump tanks.

After offloading multiple tankers, the water supply to the fireground was switched from a direct pumping operation, through the LDH Siamese operation, to a portable water tank operation with Engine 331 drafting from the dump tanks. Carroll County Tanker 1 arrived and was positioned behind Engine 331, upon which Carroll County Tanker 1 connected to one side of the secondary LDH Siamese and acted as a nurse tanker.

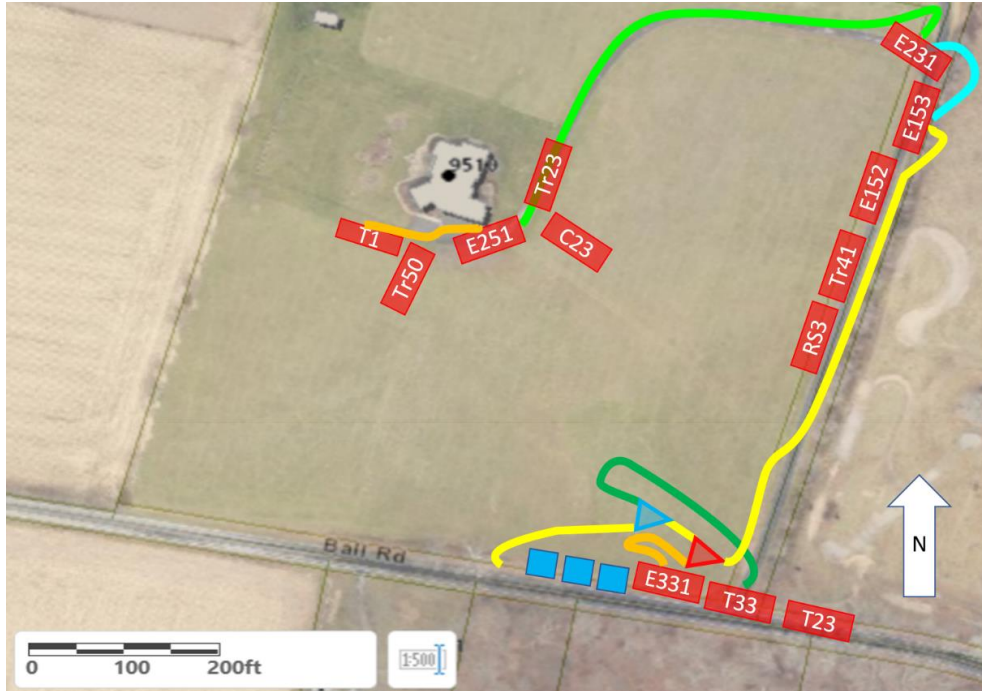
Figure 29: Overview of apparatus positioning and LDH hose.

Engine 251 did not have an interruption of water for the remainder of the incident. Throughout the incident there were multiple resource requests made by the E251A, the IC and the WSO. These resource requests brought over 40 major pieces of apparatus to the scene. The following is a list of when the resource grouping requests were made, by whom as well as how many engines tankers were on each assignment.

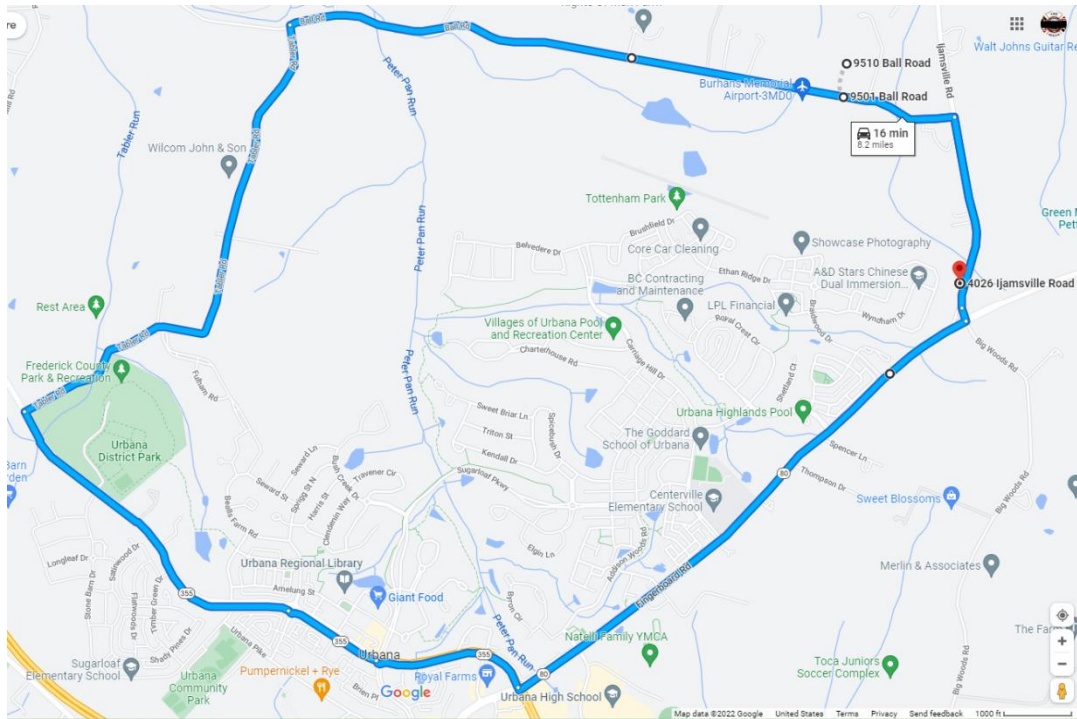
Figure 31: Tanker shuttle Route

From the fire scene tankers traveled west to Tabler Rd, turn left (Southwest) on Tabler Rd to Route 355, turn left (Southeast) to Route 355, turn left (Northeast) to Route 80, turn left (North) to Ijamsville Road, stop at the fill site 4026 Ijamsville Road, turn left on Ijamsville Road and the left on Ball Road to access the fire scene. The tanker shuttle route was approximately 8.2 miles.

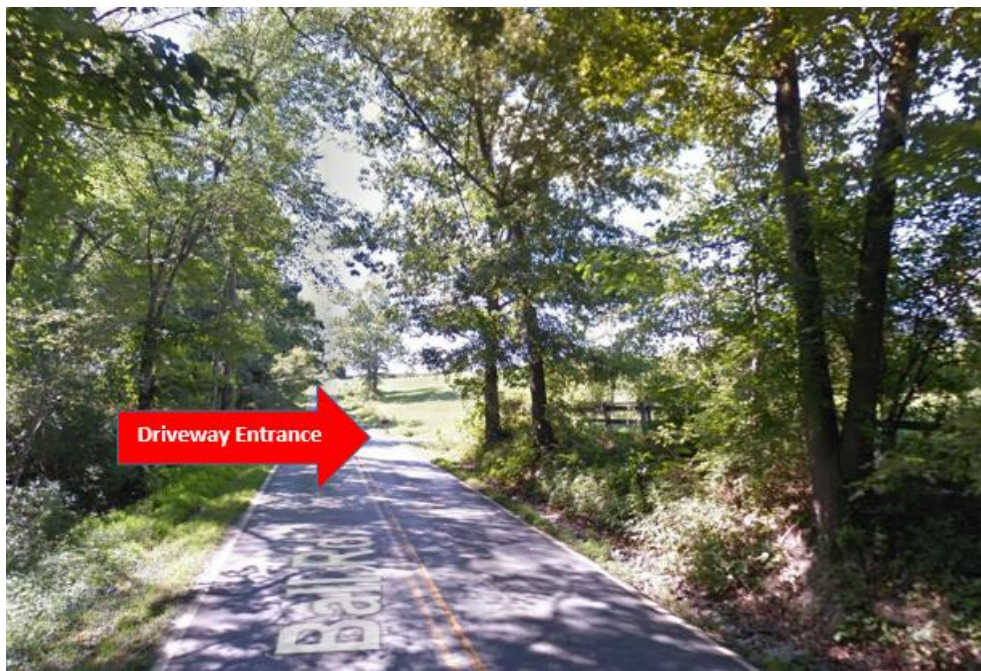
Figure 32: View of the driveway as E251 would have viewed it as they approached.

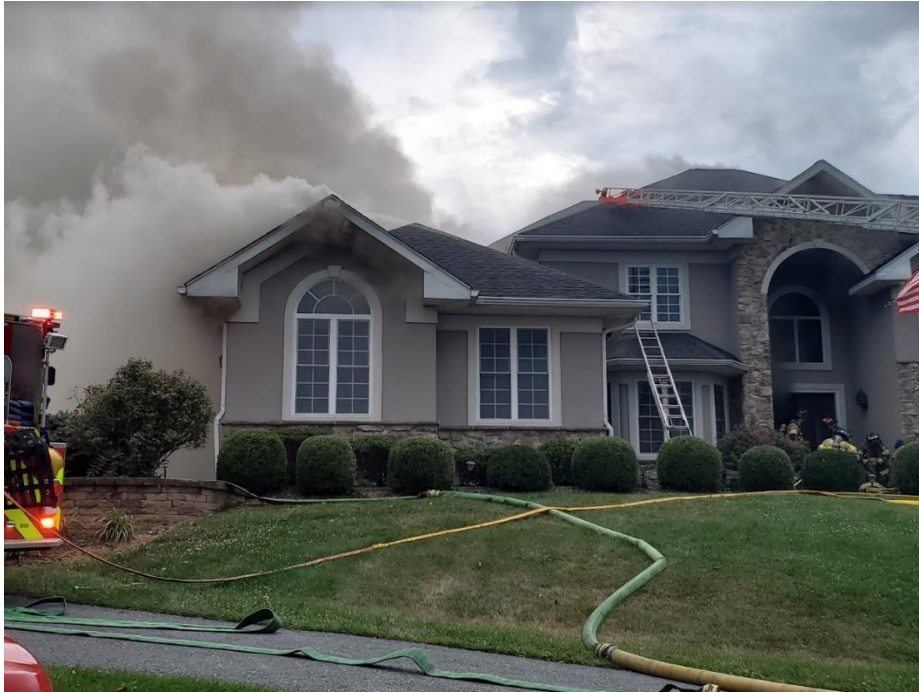
*Figure 35: View of Side Alpha of the structure immediately prior to the Mayday transmission.*

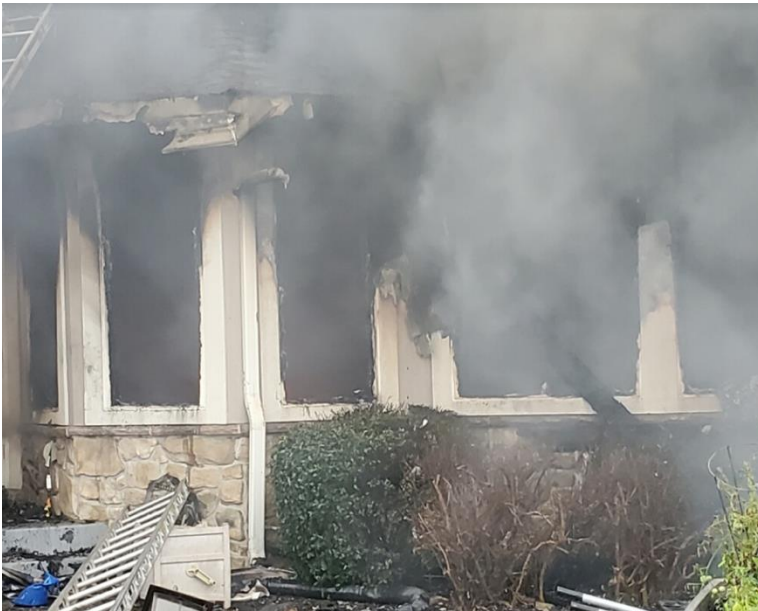
*Figure 37: Ladder after being removed from the window on Side Charlie of the structure used for the rescue attempt of Captain Laird.*

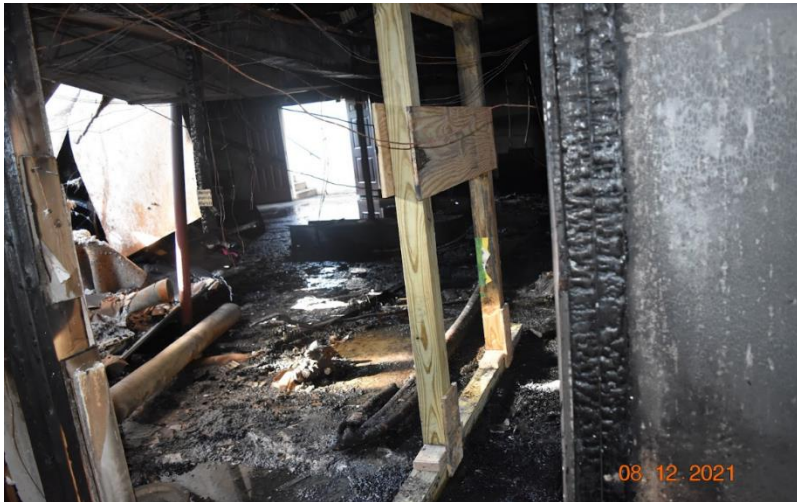
Figure 39: View of the distance and path from door in the interior basement wall separating the basement to the exterior basement entrance on Side Delta.

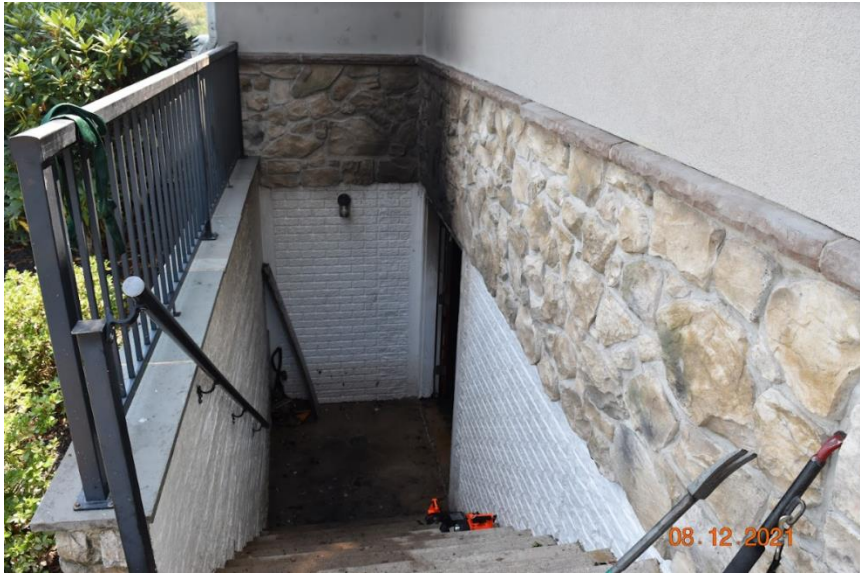
*Figure 41: View of the exterior entrance and stairwell on Side Delta of the structure leading into the basement.*
