U.S. Fire Administration/Technical Report Series

# Highrise Office Building Fire One Meridian Plaza

Philadelphia, Pennsylvania

USFA-TR-049/February 1991

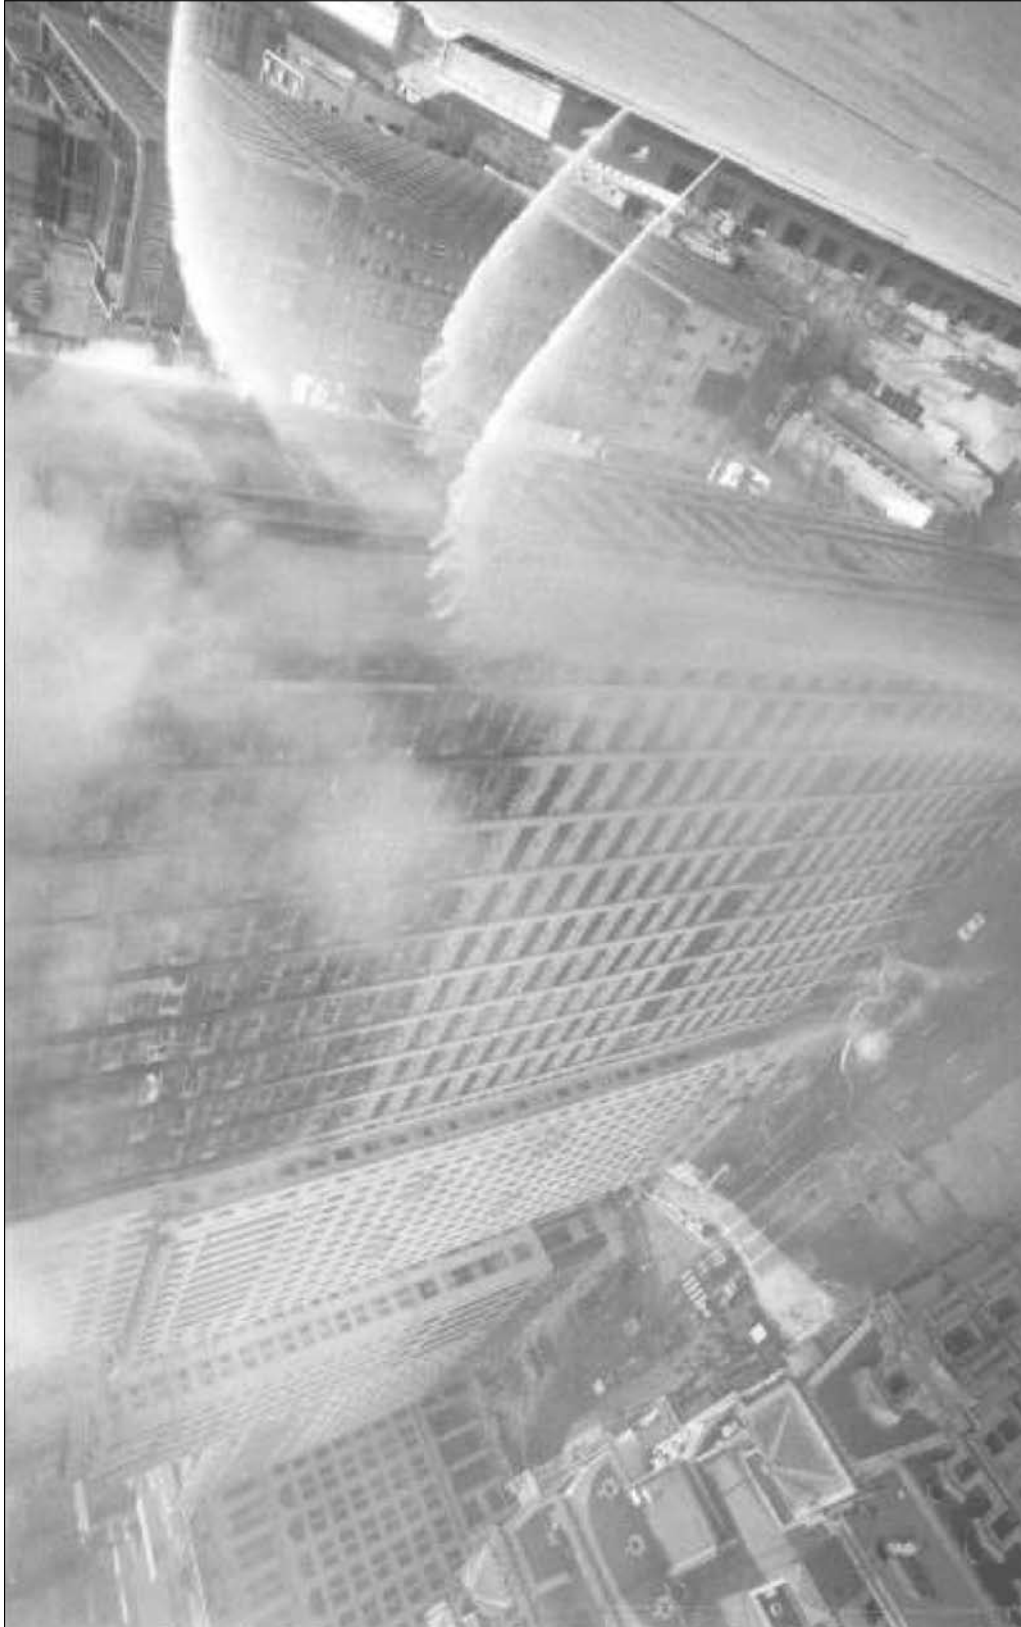
*Philadelphia Inquirer* photo by Michael Maly  
Aerial view of exterior firefighting operations after dawn on February 24, 1991.

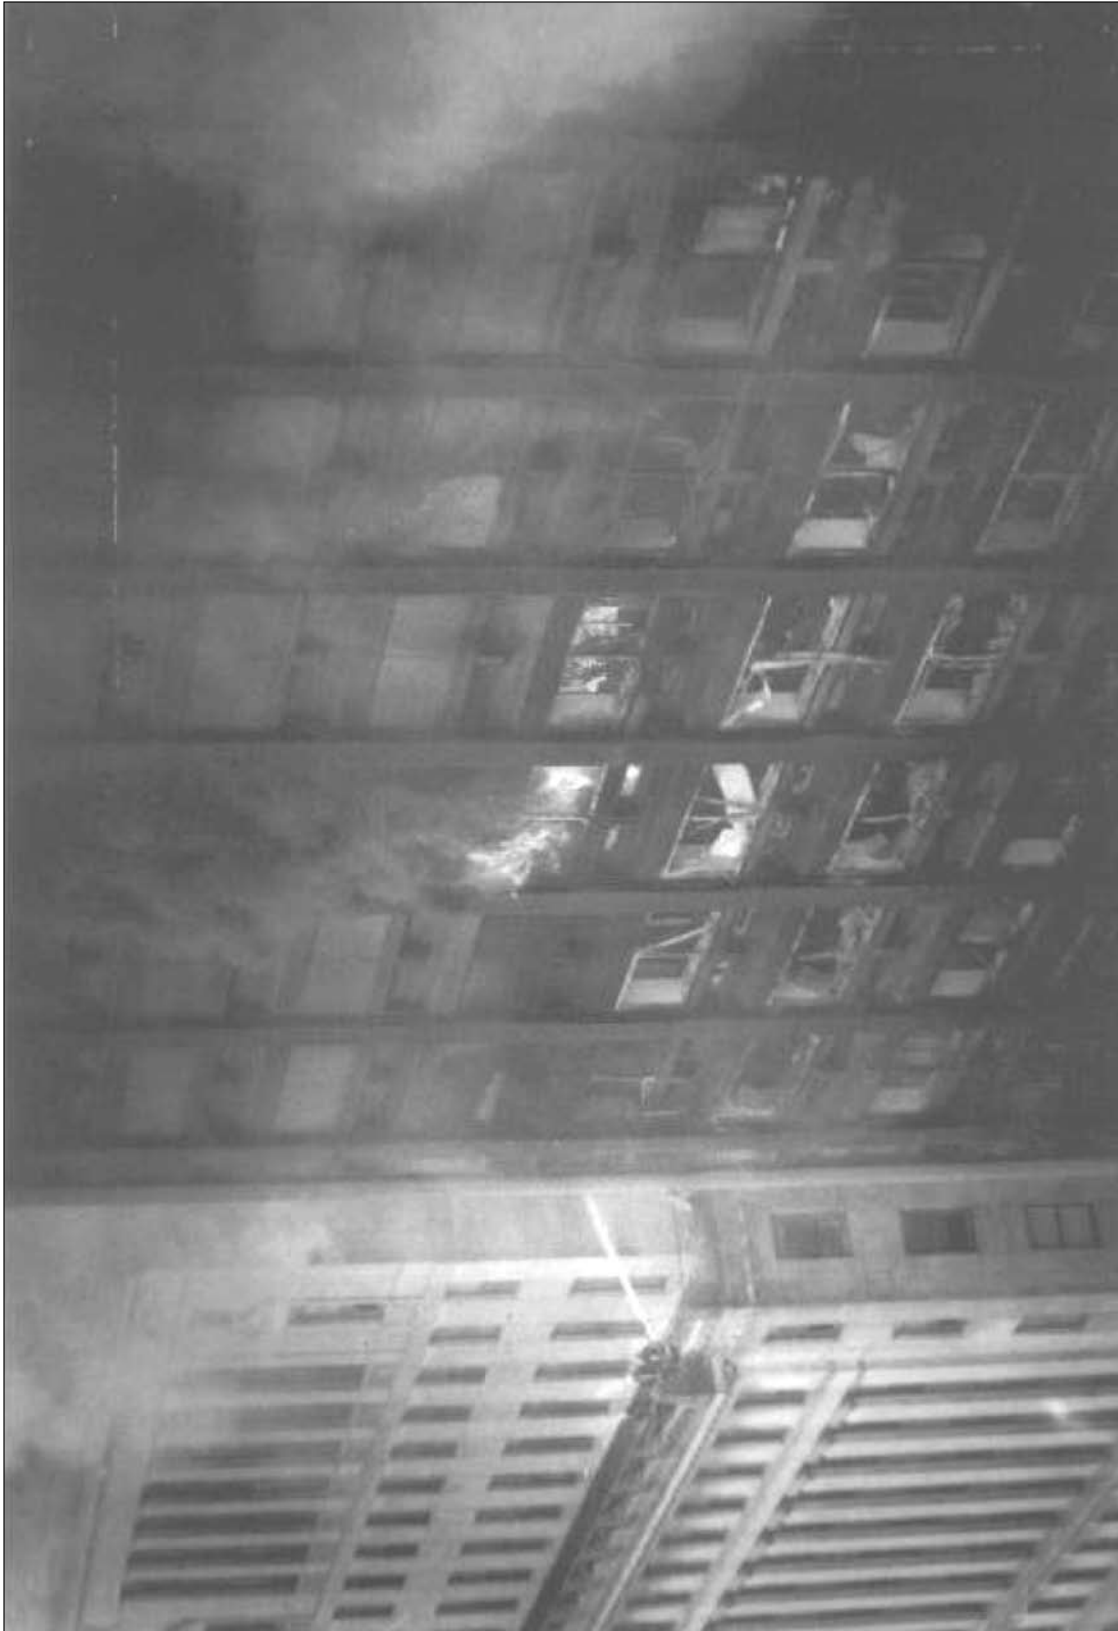
*Philadelphia Inquirer* photo by Michael Mally  
**Exterior firefighting efforts from the Girard Building #1, east of One Meridian Plaza. The two buildings are connected on lower floors.**

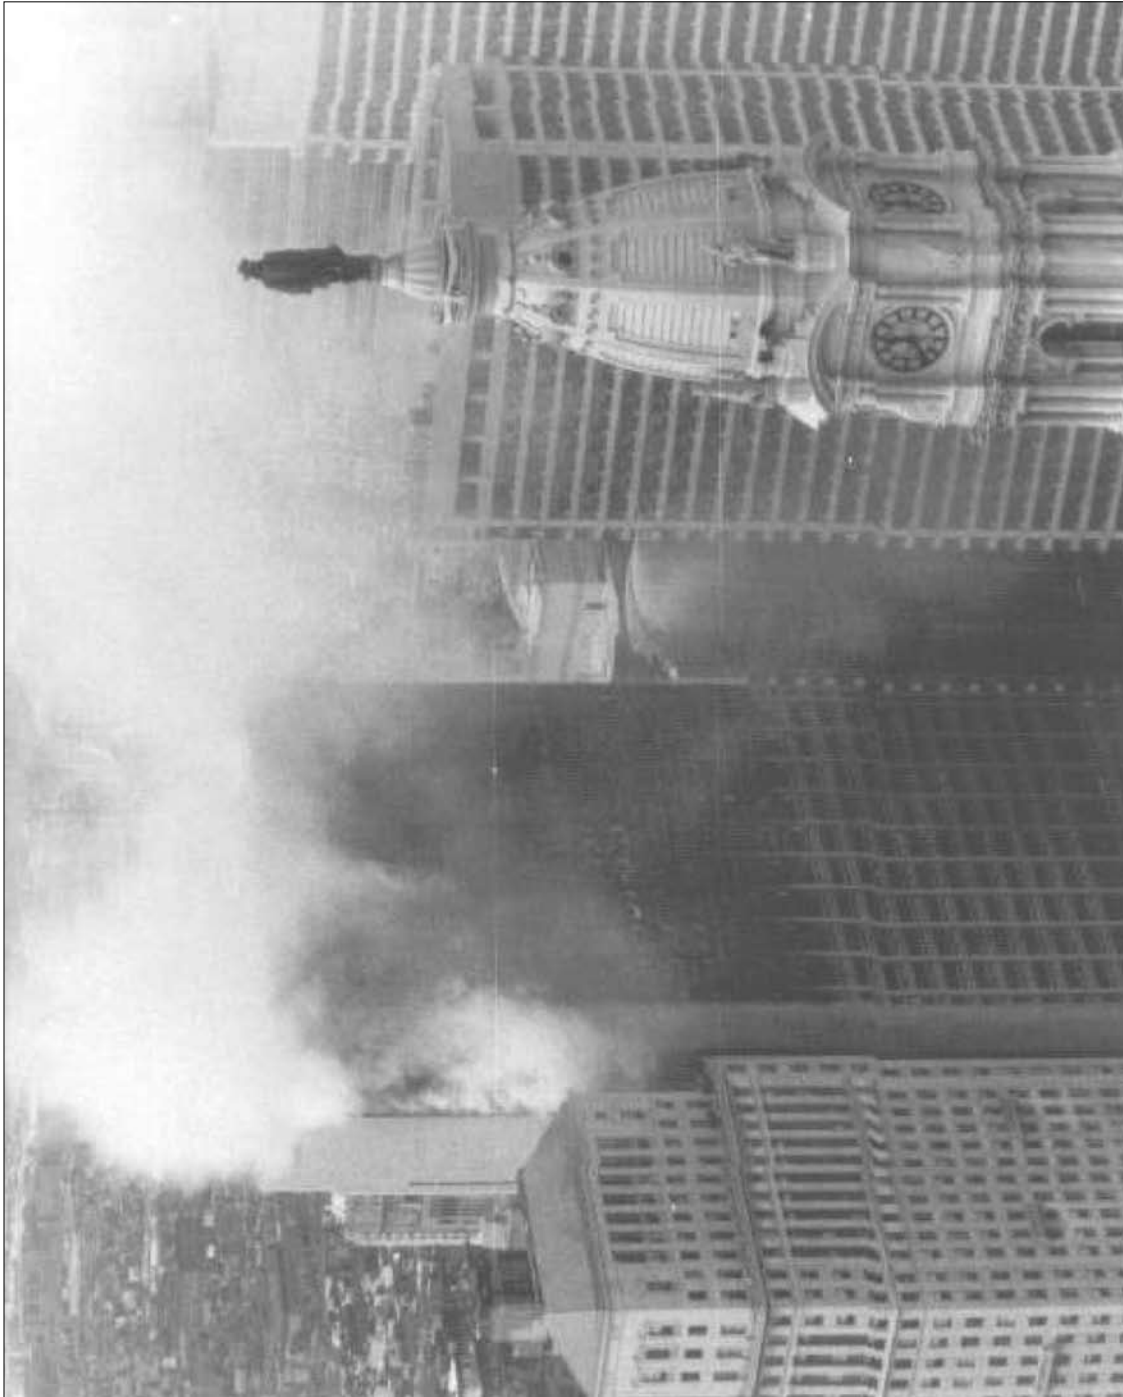
*Philadelphia Inquirer* photo by Rick Bowmer  
**Smoke pours from One Meridian Plaza as William Penn looks on from atop Philadelphia City Hall the morning of February 24, 1991, after interior firefighting efforts have been suspended.**

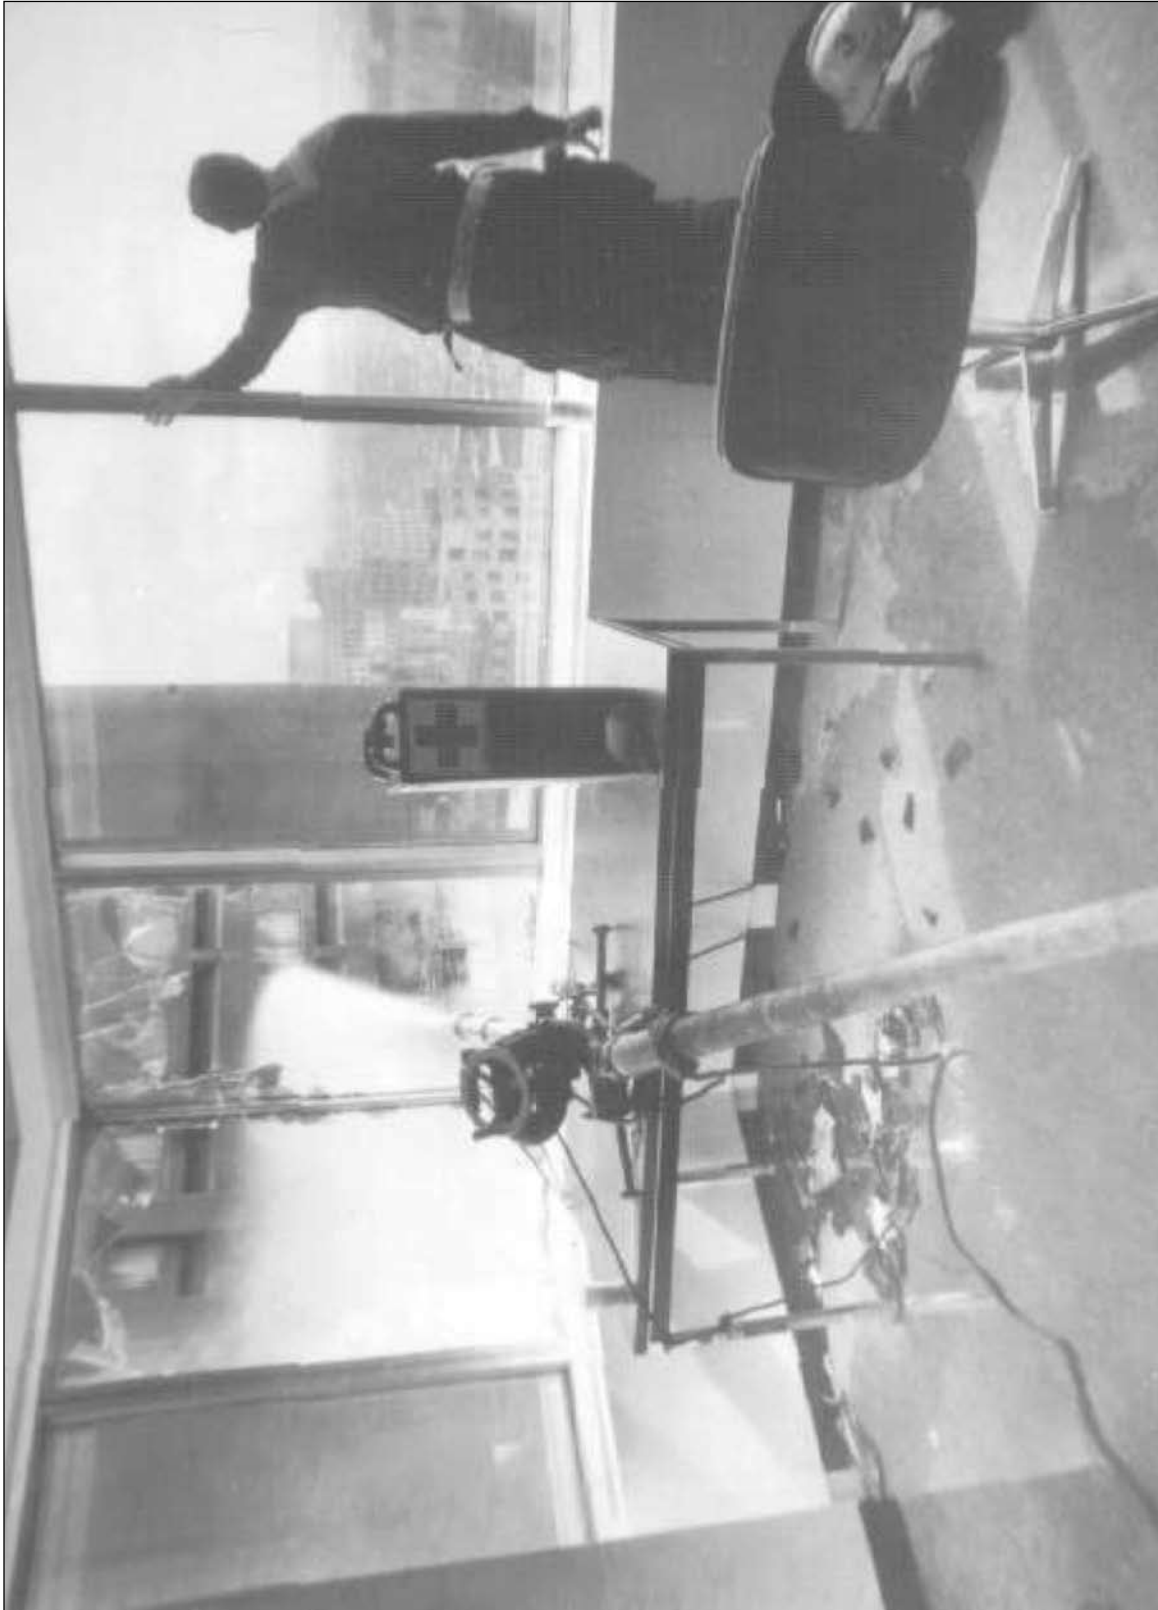
**View of deluge set operating from One Centre Square.**

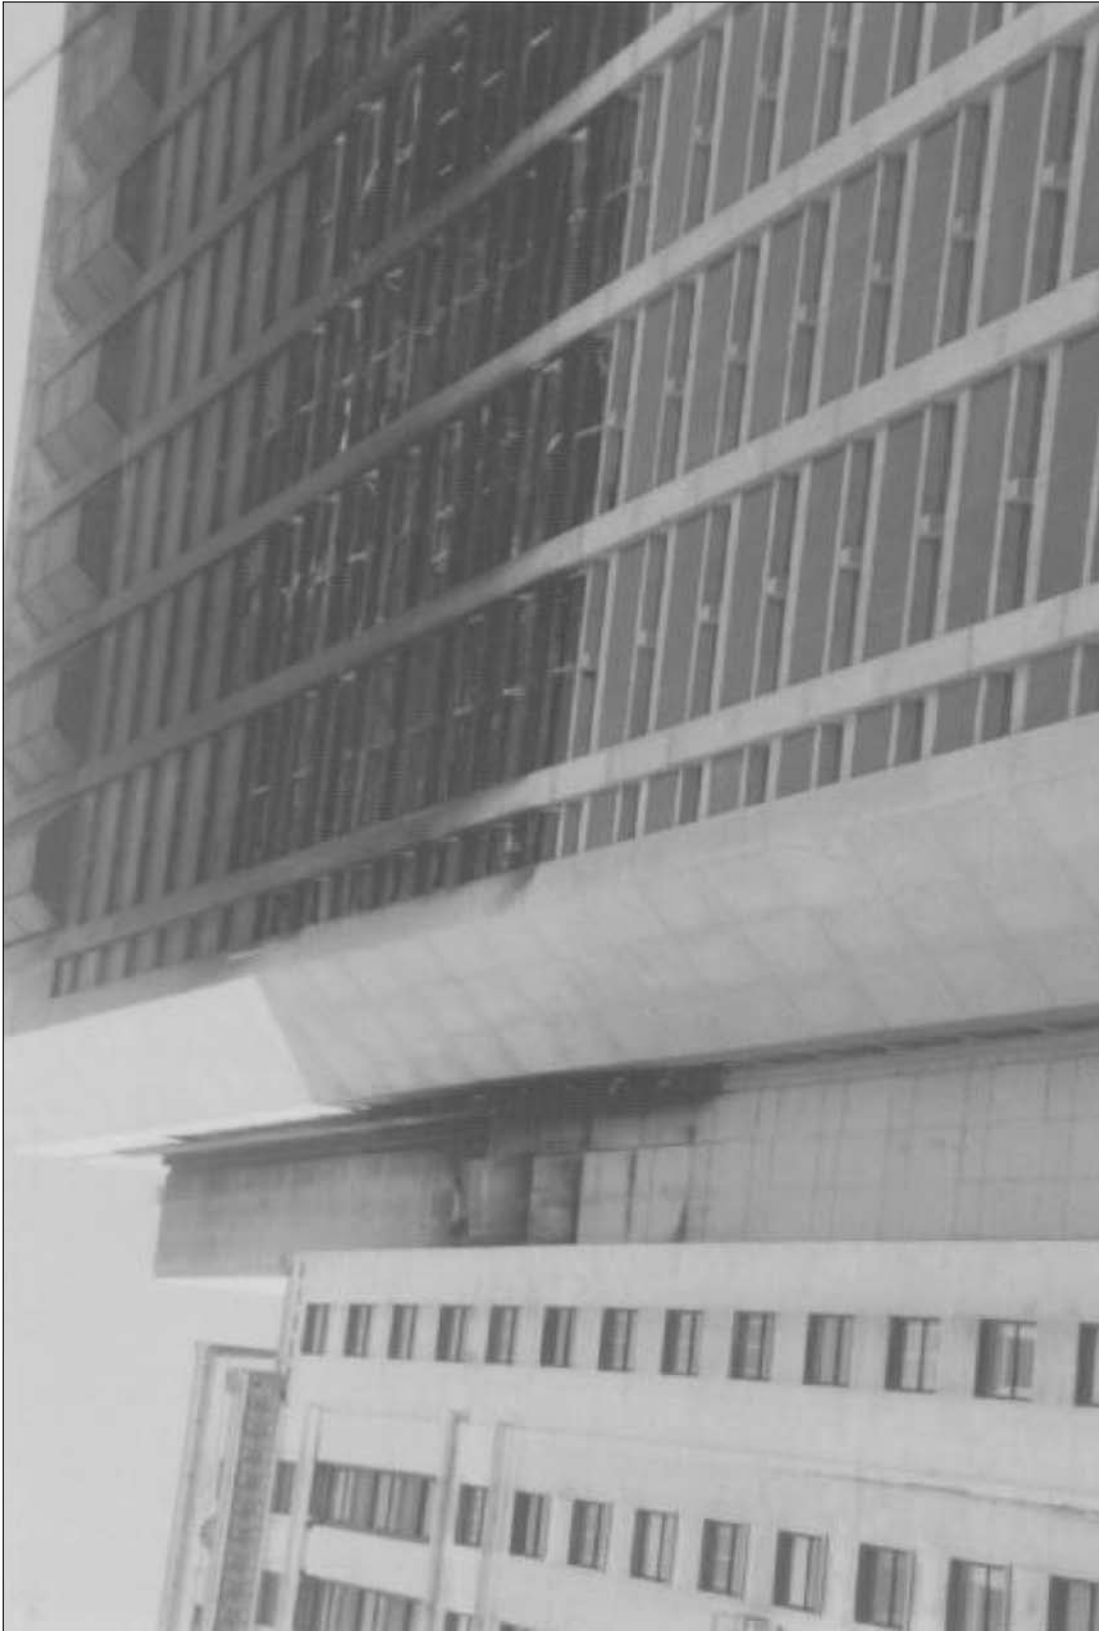
This stairway connected the One Meridian Plaza Building with the adjacent office building.

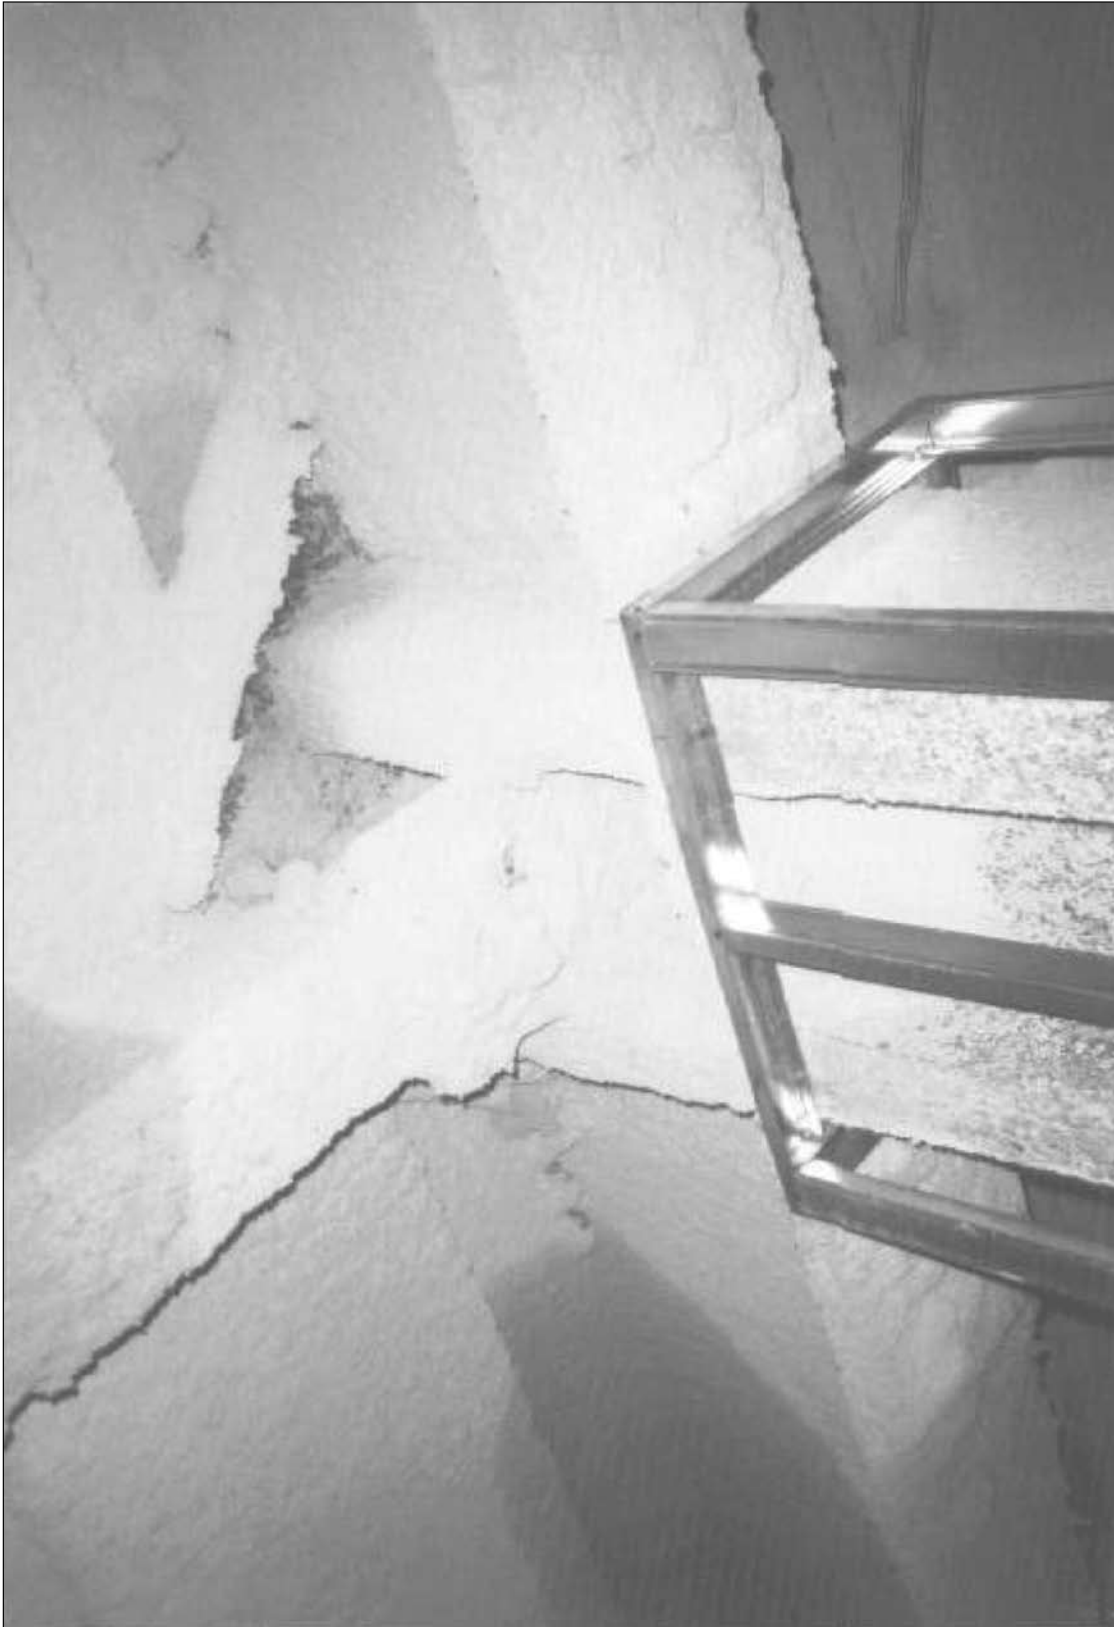
Detail of typical Type 1B construction, 6th floor. Note the spray-applied fireproofing and framing for gypsum wallboard.

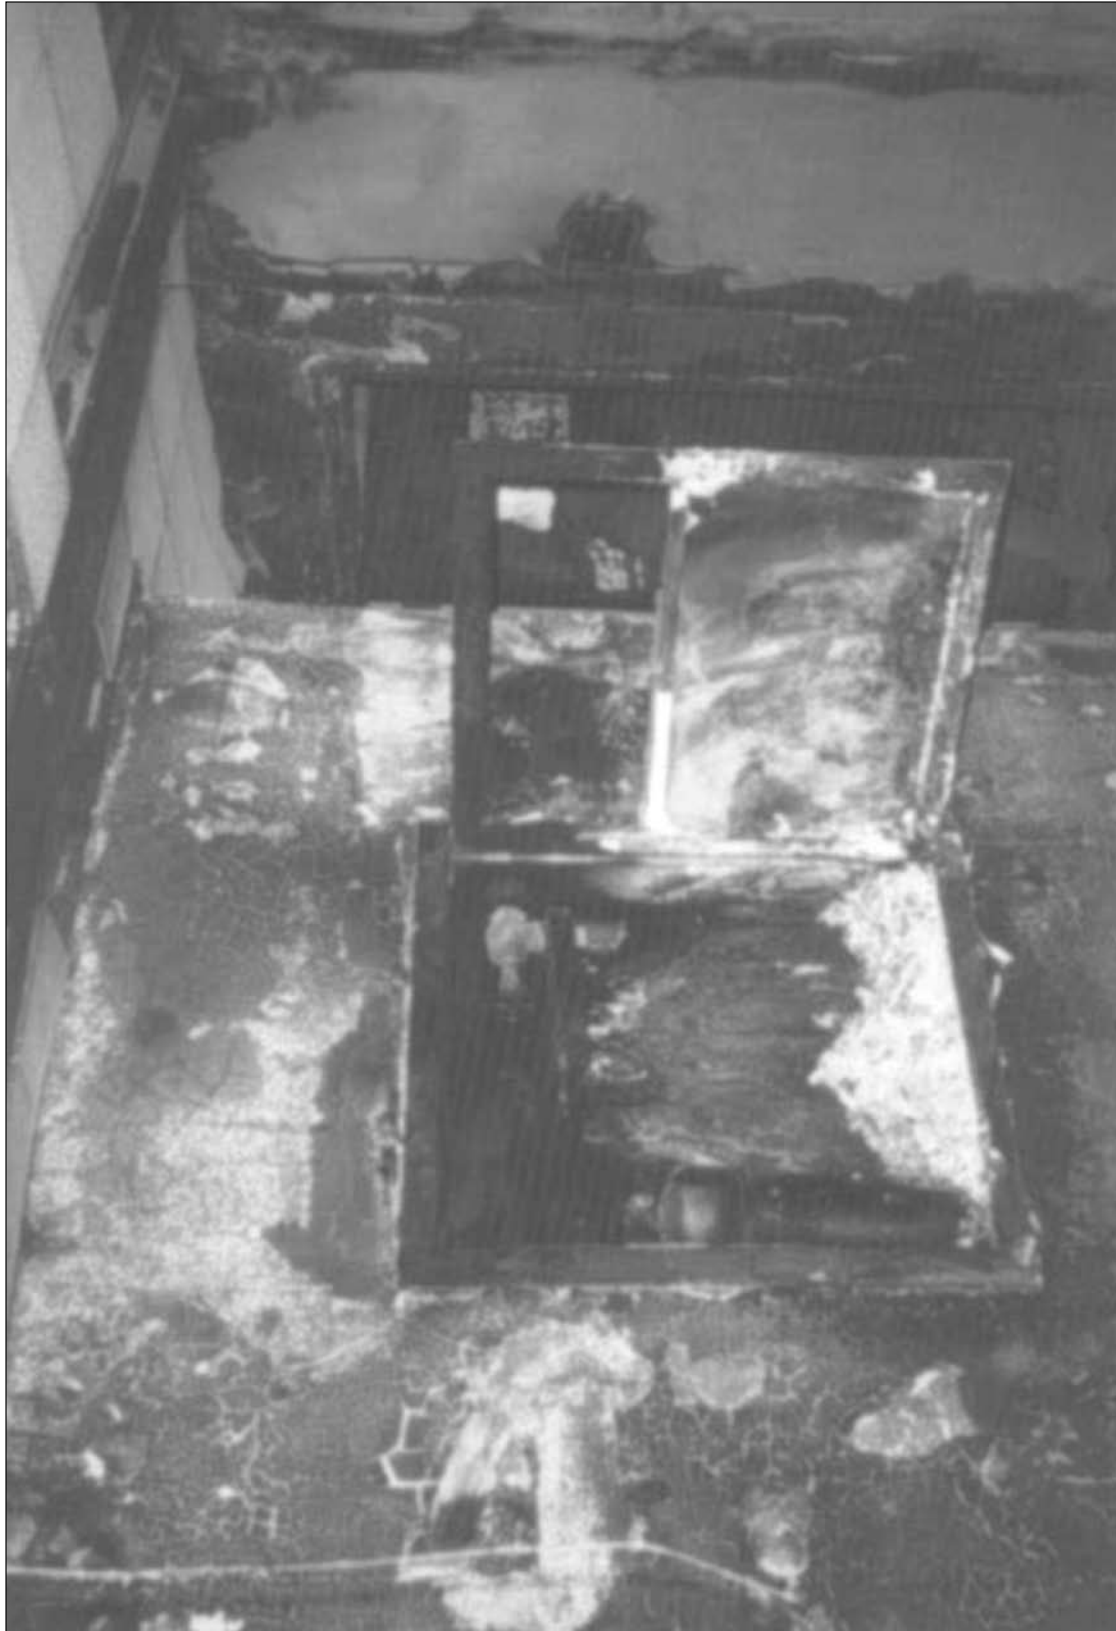
Occupant use standpipe hose cabinet on 26th floor.
