**Oakland Fire Department
Origin and Cause Report**

Incident # 2016-085231

December 2, 2016

1315 31st Avenue

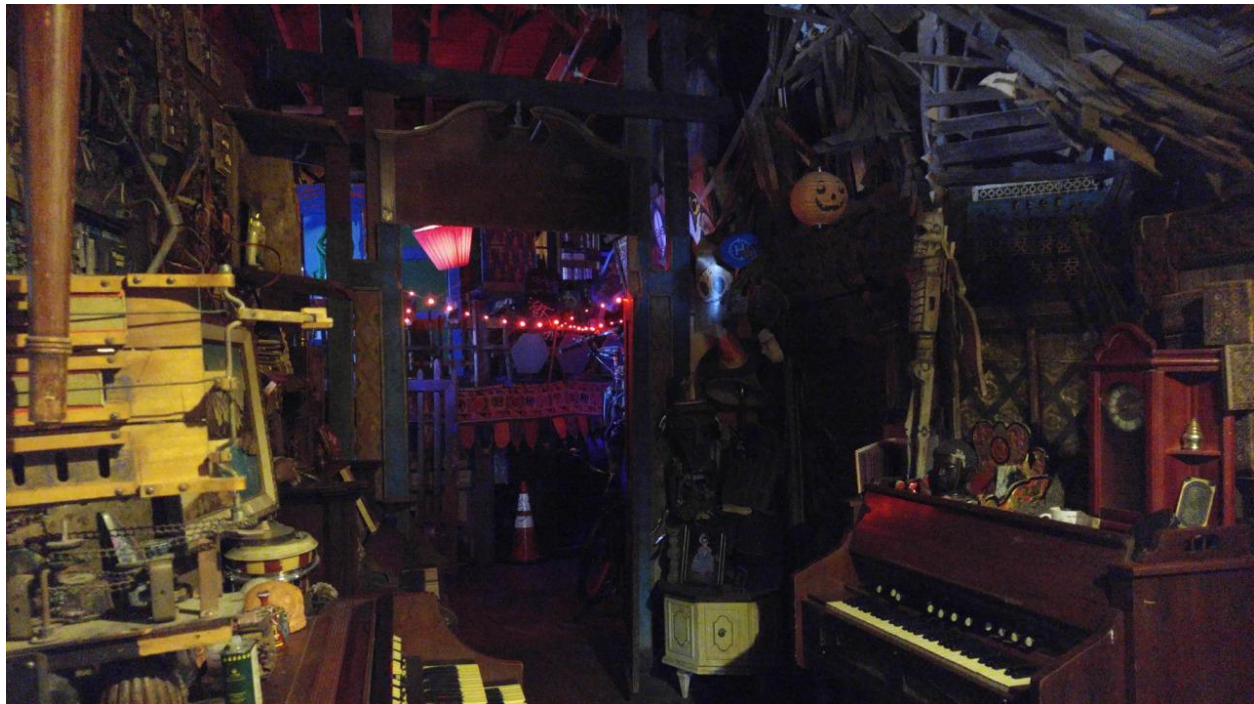
The main entrance to the ground floor was through the man-door on 31st Avenue. From there, makeshift hallways led erratically deeper into the building. The hallways were not constructed of traditional materials such as drywall-covered, wood-framed walls. Instead, the walls of the hallways were assembled together from aggregates of salvaged and scavenged materials, such as pianos, organs, windows, wood benches, lumber, and innumerable other items stacked next to and on top of each other. (see photo below)

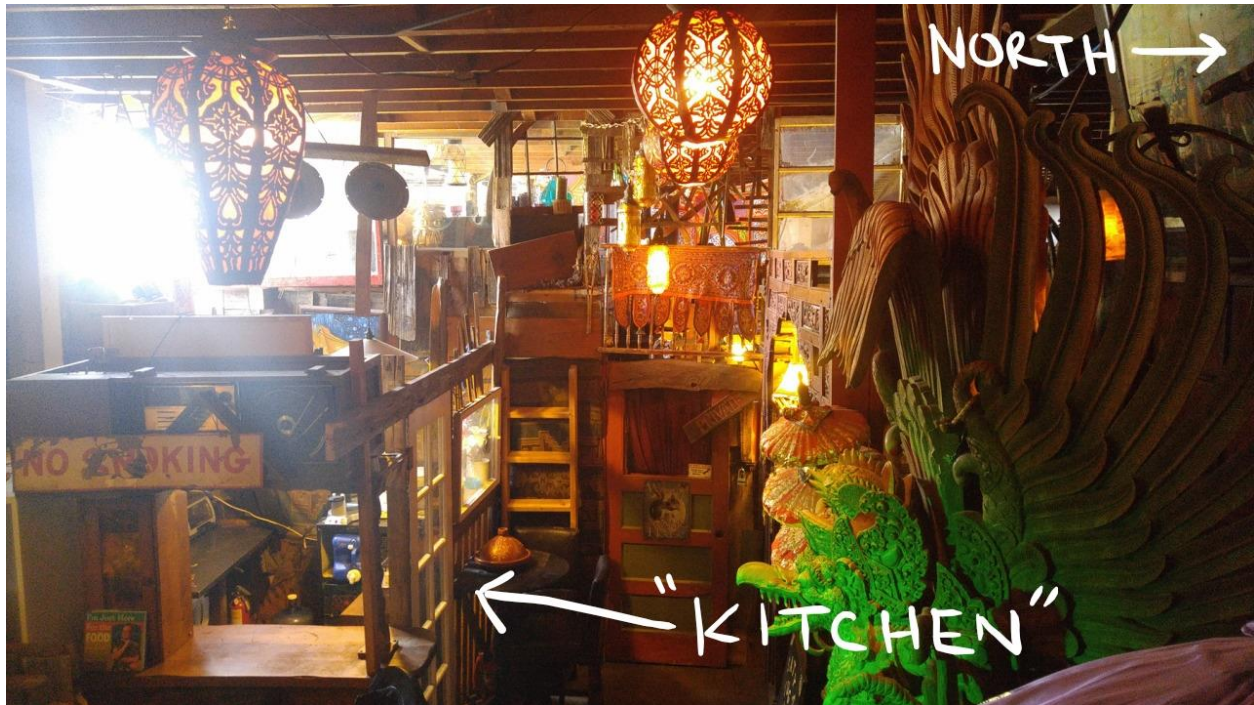
Inside the front door to the west was an area the residents referred to as “the kitchen.” West of the kitchen, in the southwest corner of the building, four people had live-work spaces. (see photo below)

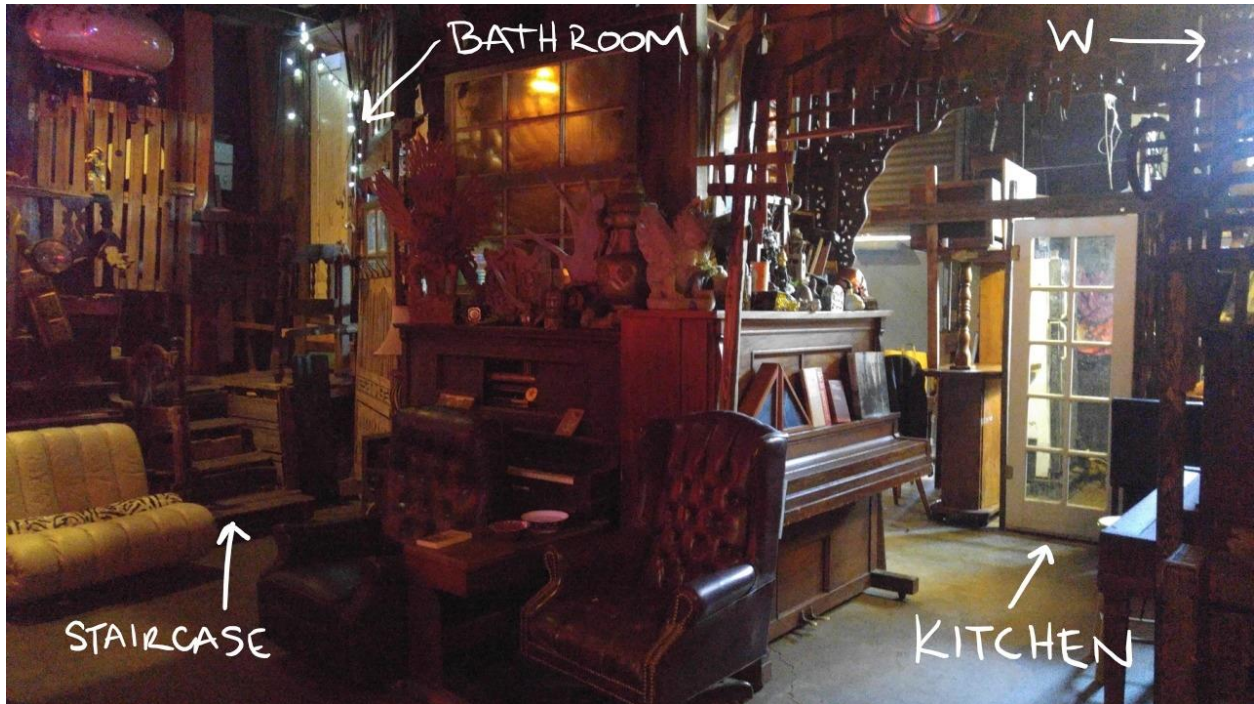
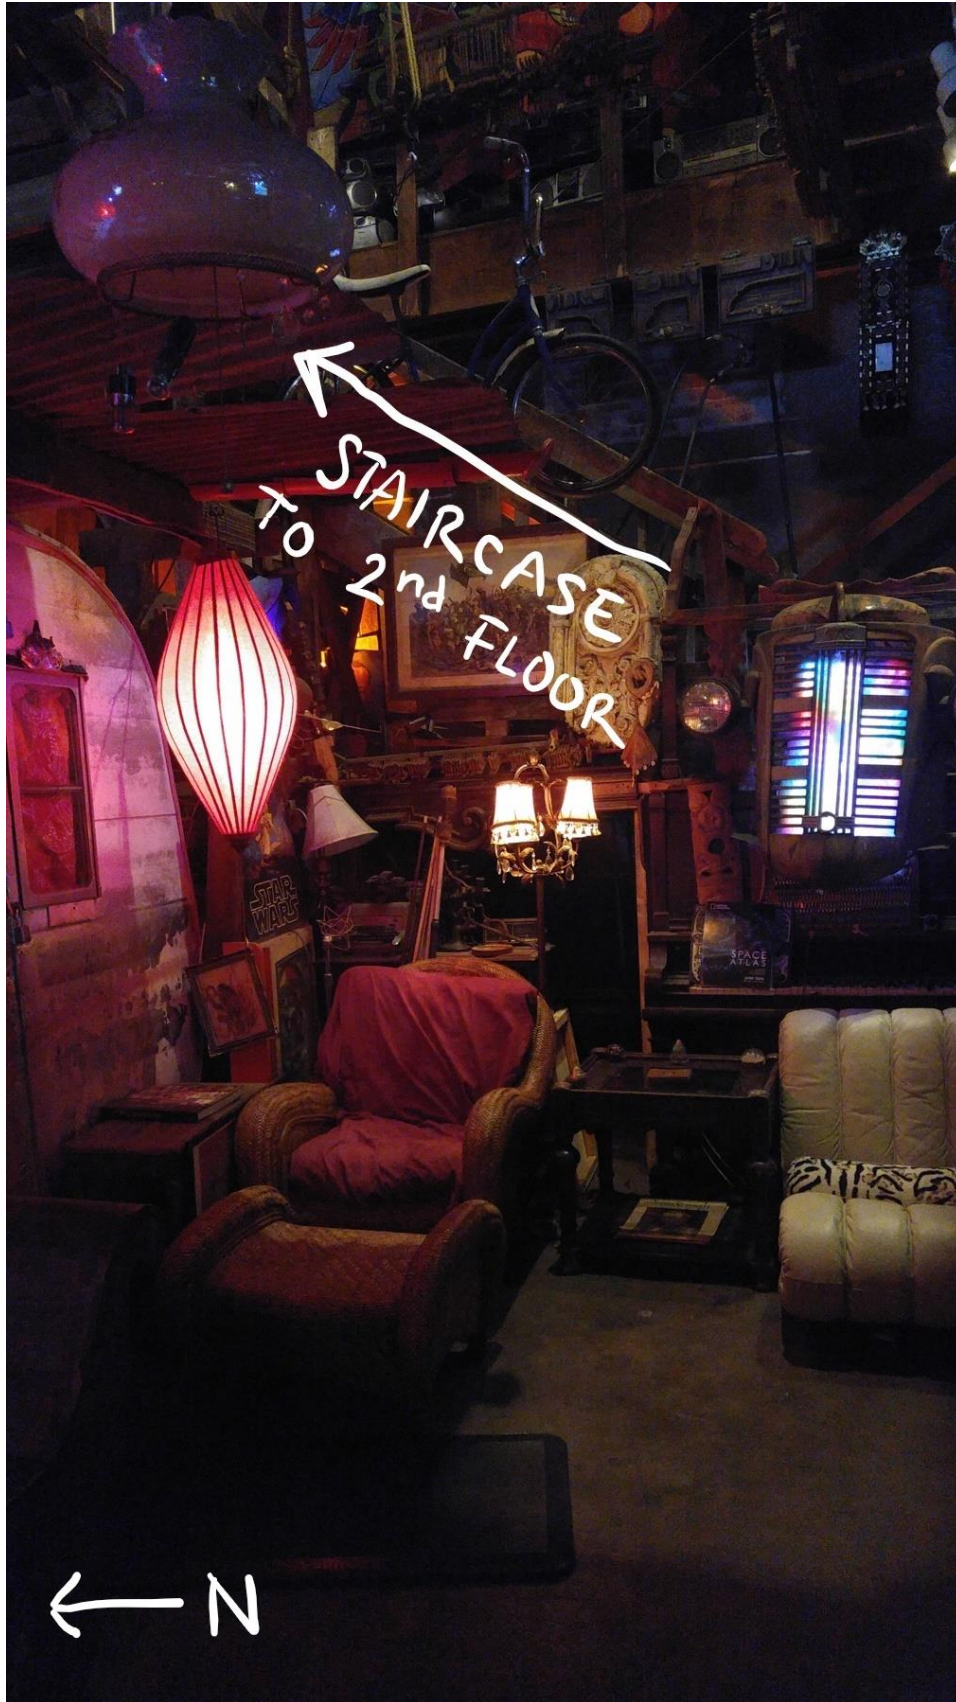
The front staircase was located along the east wall at the front of the structure. It was constructed of various wooden planks and wooden studs, as well as portions of wooden pallets at its top where it accessed the second floor. One of two bathrooms was elevated slightly off ground level where the lower staircase landing was located. The orientation of the staircase was such that it first led eastward where it bordered the east wall, then turned north (rearward), where it then turned slightly west at the very top of the staircase at the second floor.

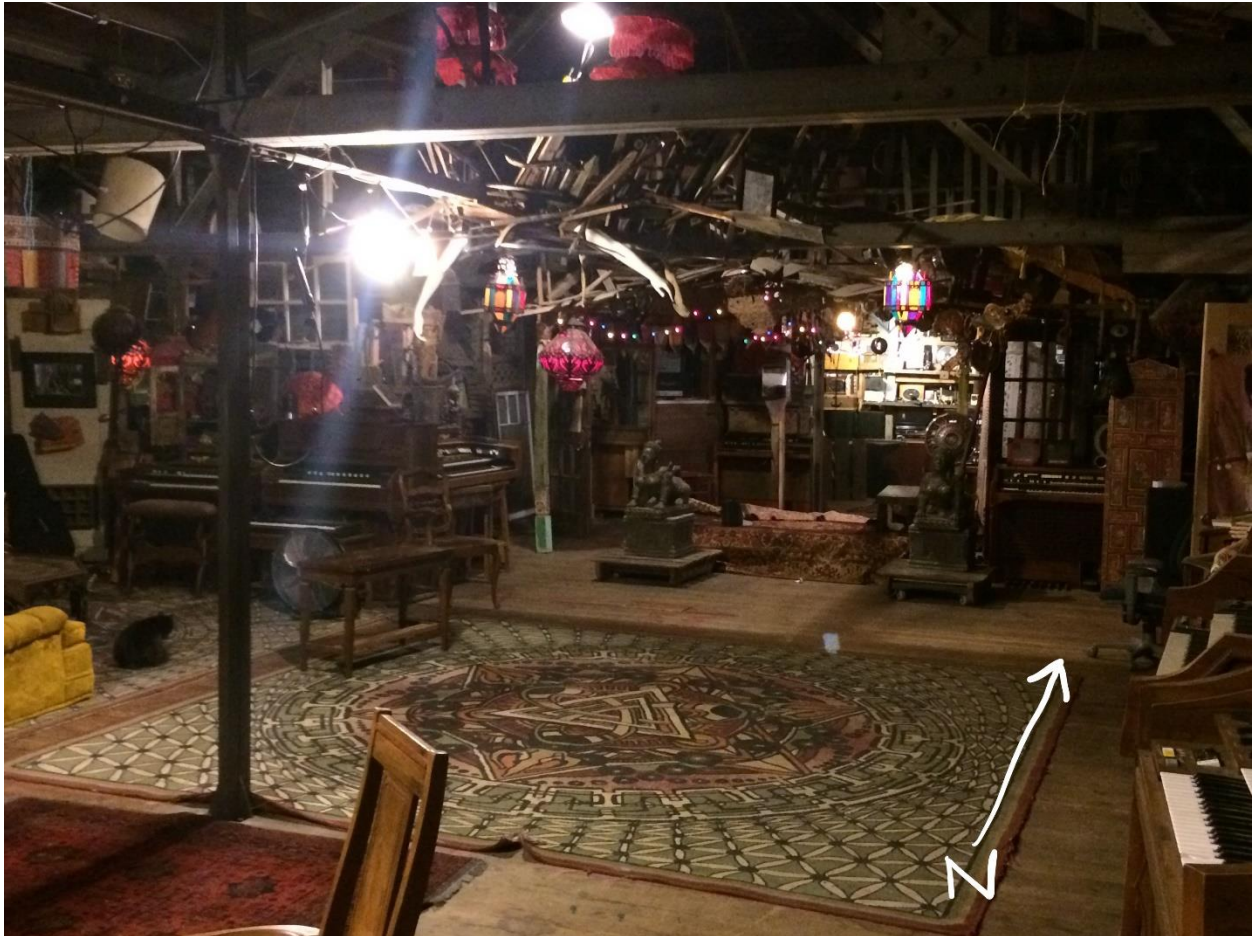
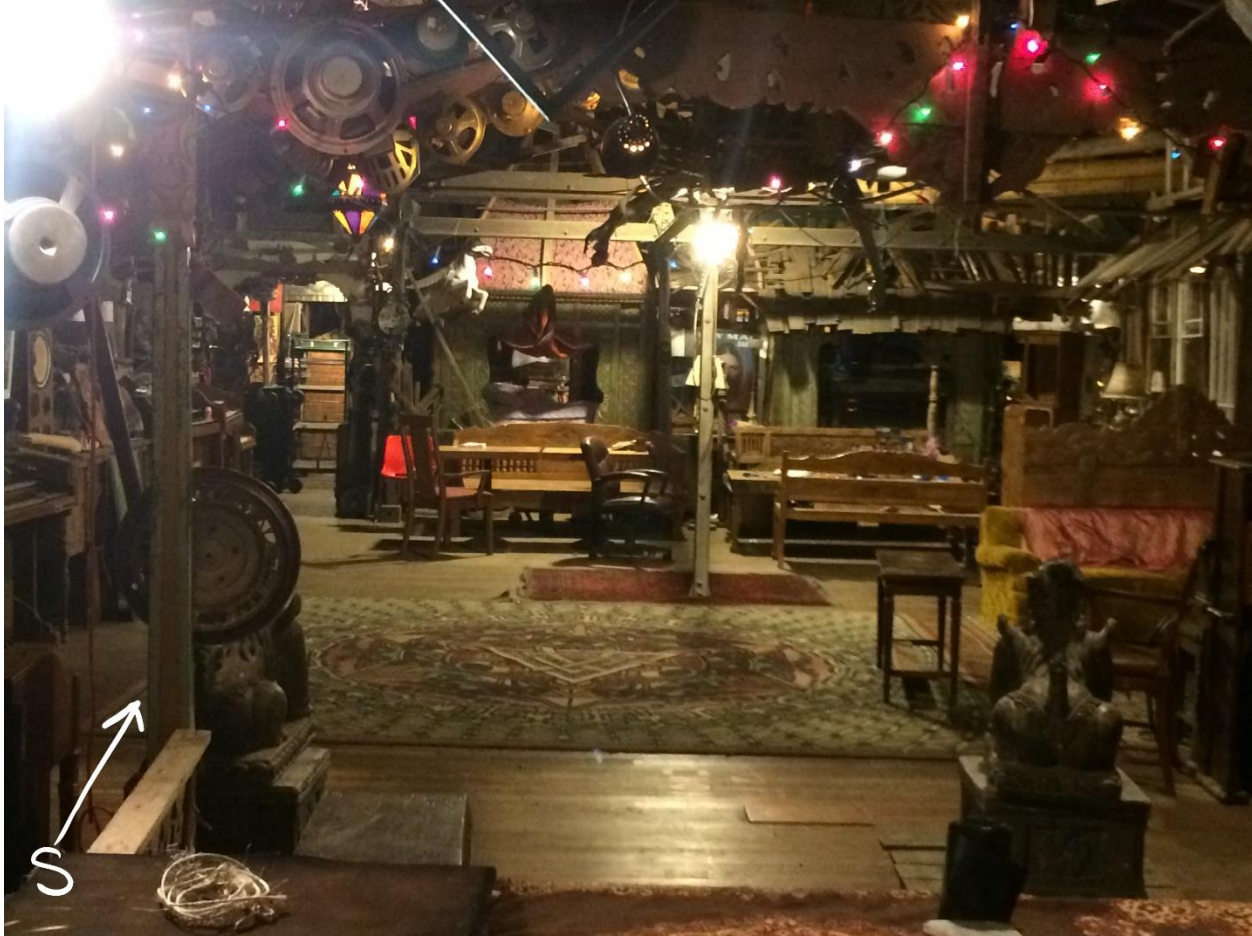
The second story contained fewer living spaces and hallways, and an open area for events was the predominant feature. A family lived in a space at the south end and two other tenants were reported to have living spaces on the second floor; one along the east wall and one in the northwest corner. Most of the space was open with areas of couches and chairs for people to socialize. There was an area at the north end of the second floor where musicians or disc jockeys set up when events took place. (See photos below)

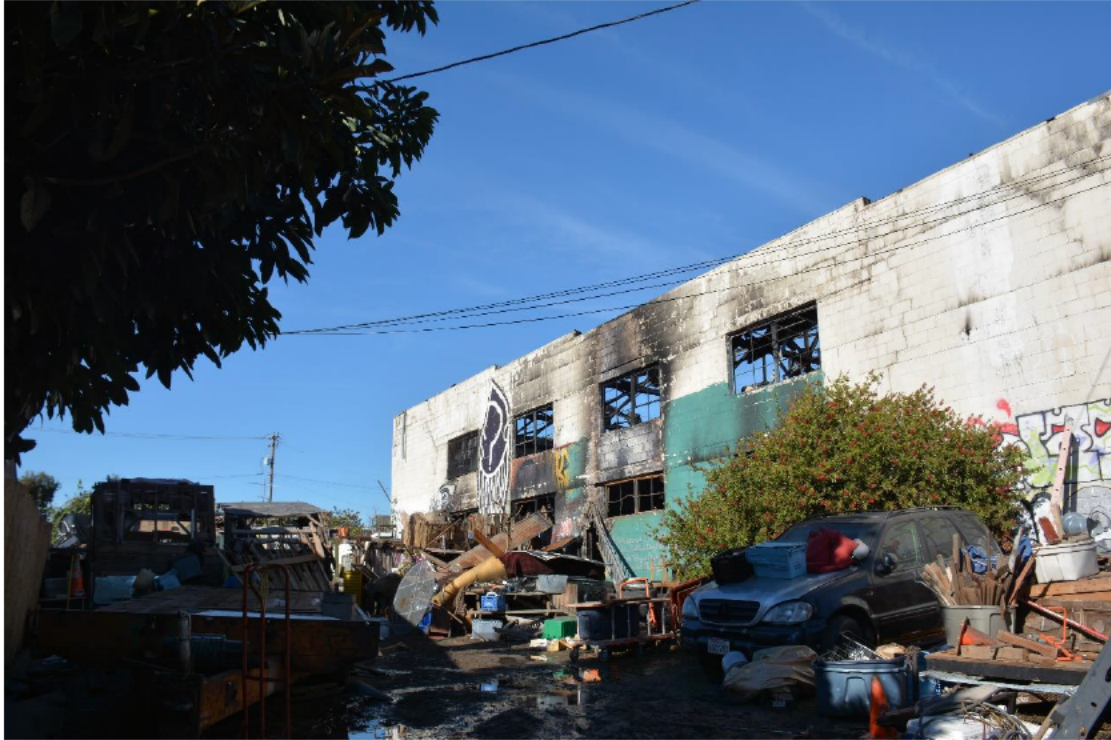
The B-side of the building bordered an open lot containing a large amount of discarded items. A non-permanent structure used as living quarters and fashioned out of various materials was located toward the north (see photo below). Windows were present on the B-side on the first and second levels, along the rear (north) two-thirds of the building. The only window with any glass remaining was the first floor southernmost window. The second floor rear-most (north) window contained metal mesh over the window opening. In the right-most (south) first and second floor windows, the upper pane was in an open position, swung outward from the top hinge.
