Construction Concerns: Appearance

November 30, 2015

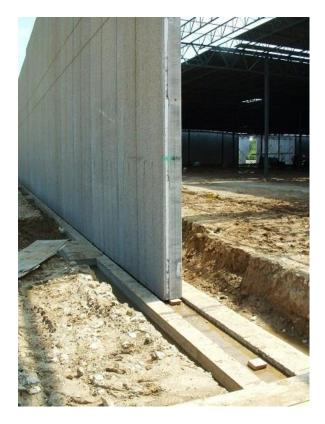
In the 21st century, it is not always easy to determine a building's construction type simply by walking around it and through it.

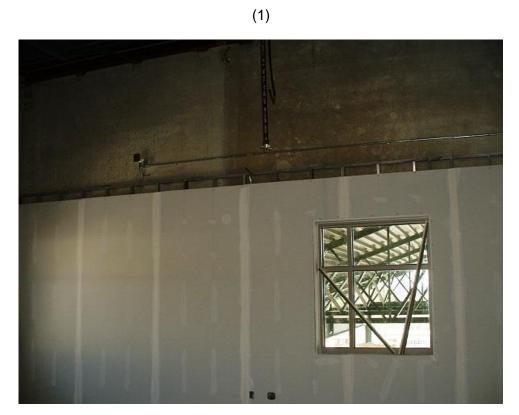
The "big box" stores from the late 20th century are usually easy to study. They are usually of Type II (noncombustible) construction, with exterior walls of insulated precast concrete wall panels (photo 1) or concrete masonry units (CMUs). The interiors can be either painted wall panels or CMUs or they may have metal furring strips and gypsum drywall board attached to the interior (photo 2). The ceiling is often the exposed steel bar joists and steel roof deck, although sometimes a suspended ceiling grid is installed with lay-in acoustical tiles.

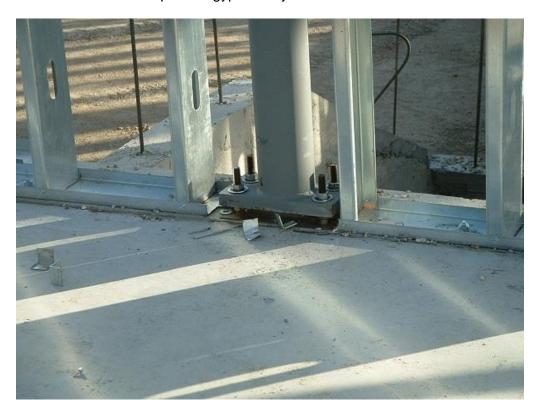
Today's smaller retail establishments are not always so easy to study. Although the interior is commonly finished with gypsum drywall board, we may not know whether this is glued directly to masonry, screwed to metal furring strips attached to masonry, or if it is a metal stud wall.
